# Wareham Historical Society Historic Building Survey

October 21, 2013

Great Neck Union Chapel  
Old District School No. 6  
Old Methodist Meeting House  
Fearing Tavern Museum  
Captain Kendrick House

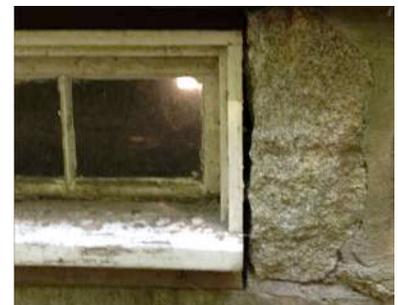
The structure is built on top of a one and one half foot granite block foundation that is in excellent condition (UC-4). It is said that these blocks were part of the original foundation and set on top of the new concrete foundation when the Historical Society moved the building in the 1970s. Aside from the windows that do not appear to be original and could be better detailed to match the original windows (UC-5) (thicker frame and sill and the sash should sit on top of the sill instead of behind it), the foundation is in very good condition. There is a small bulkhead door at the east end of the Chapel that appears to have been rebuilt or even added

UC-4 Stone foundation

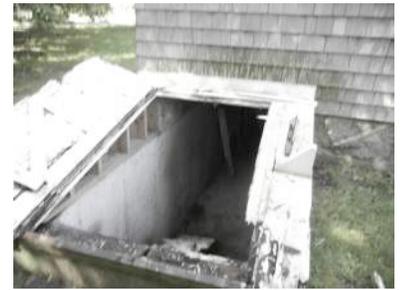
when the building was moved. The doors and interior steps are in very poor and even dangerous condition (UC-6). They should be repaired or replaced very soon. At the minimum, the opening should be protected with heavy plywood immediately to prevent injury. The deterioration of the stairs and bulkhead door appear to be caused by high levels of moisture. This could be a result of roof runoff falling on the doors or storm runoff finding its way into the basement, where it becomes trapped and supports mold growth and rot. Installing a dehumidifier in the basement would help remove this trapped moisture. Positively pitching the grade away from the building or installing a perimeter drainage system are two other ways of managing storm water runoff (UC-7).

UC-6 Bulk head door

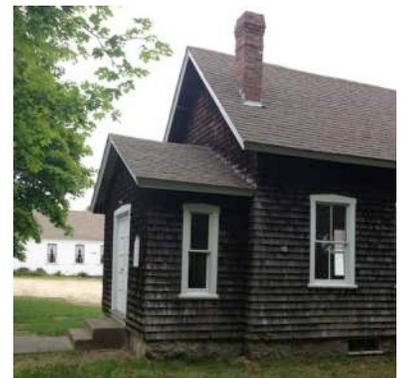
UC-8 Entry vestibule & sanctuary

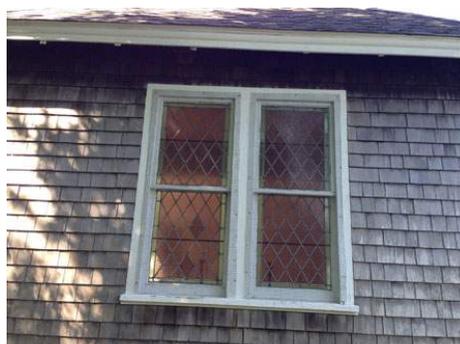
The windows are typically two-over-two wood double-hung units with two one-over-one units either side of the vestibule (UC-14). All of them are in fair condition but the glazing is typically failing. All of the double-hung window sash should be carefully removed, the glass completely re-set, the windows reglazed and the sash repainted and reinstalled. The two leaded-glass windows at the back of the chancel are in generally good condition, but the sash should be repainted and the wire mesh protective screens replaced with bronze or stainless steel to prevent staining (UC-15). All of the exterior window casings should also be repainted.

UC-15 Leaded glass windows

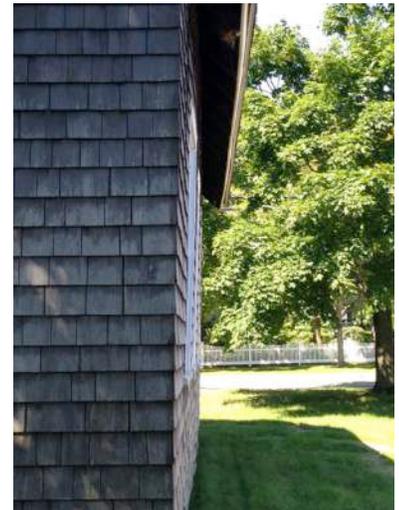
UC-21 North wall of Chapel

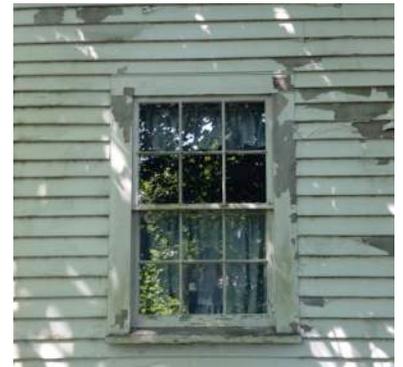
MH-6 Peeling paint

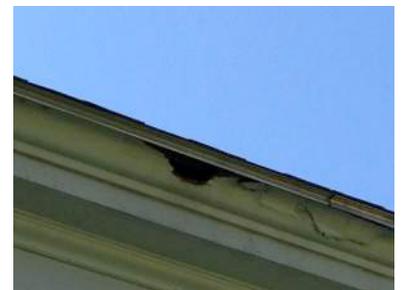
MH-7 Rodent damage

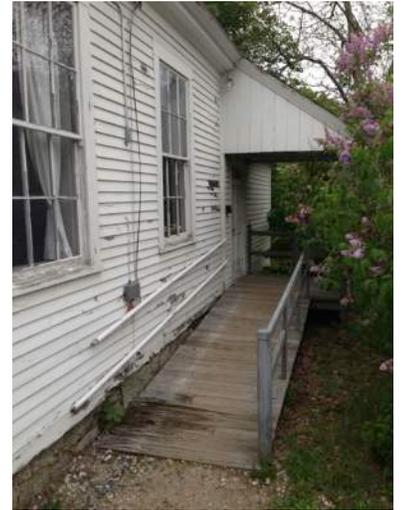
MH-11 Accessible entrance & ramp

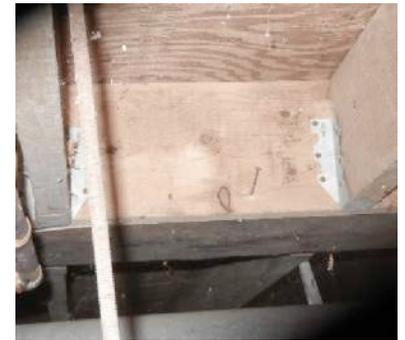
MH-17 Reinforced floor framing

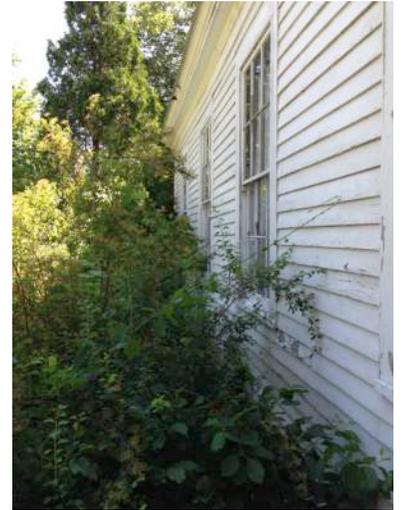
*I noted the wood clapboards close to the ground have signs of rot and decay due to the ground cover too close to the clapboard sheathing and the overgrown shrubs and plantings around the perimeter promoting a wet environment (MH-19). The current conditions will at a minimum result in decay and rot of the clapboards and in the worst case create an attractive environment for insect infestation that could ultimately damage the building*

MH-20 Overgrown plantings

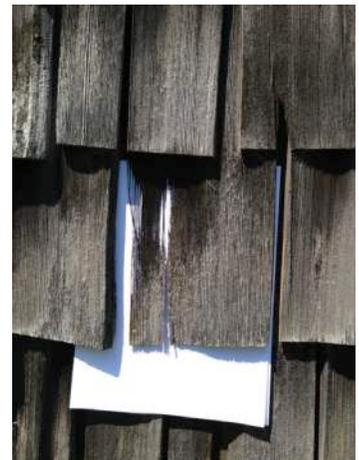
FT-6 Worn out wood shake siding

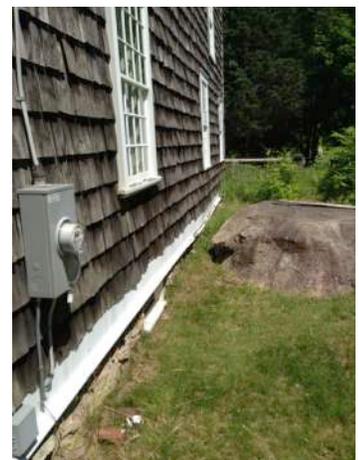
FT-7 Bulging east wall

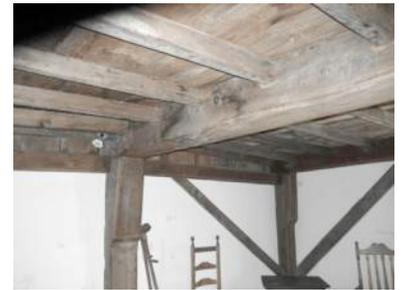
FT-12 Post & beam frame

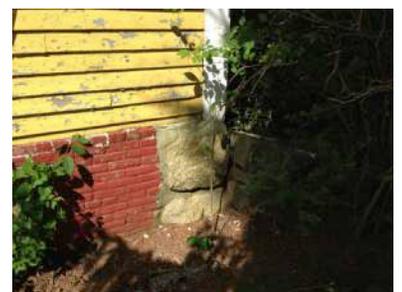
KH-4 Coated brick foundation

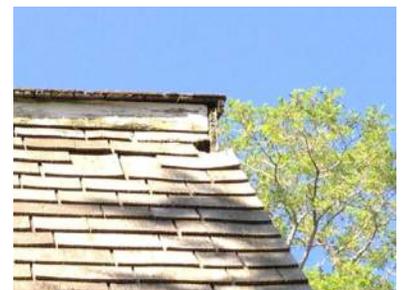
KH-13 – Missing & worn out roof shingles

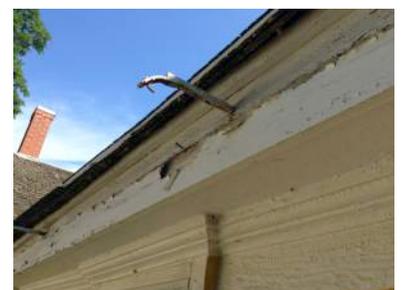
KH-14 Existing gutter hangers

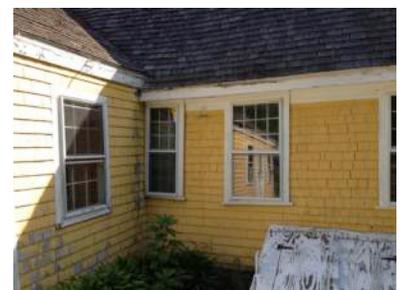
KH-15 Missing downspouts

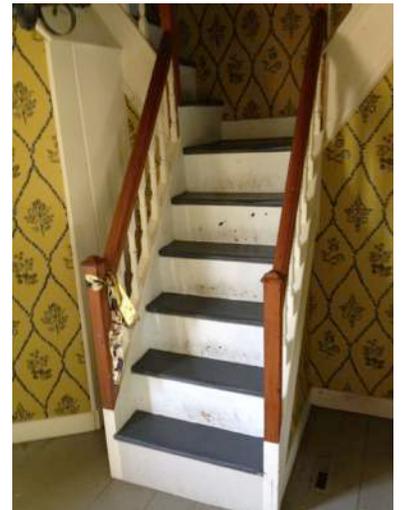
KH-17 Existing “Good Morning” stair
