Conditions Assessment & Feasibility Study

Tremont Nail Factory

Wareham, Massachusetts

June, 2009

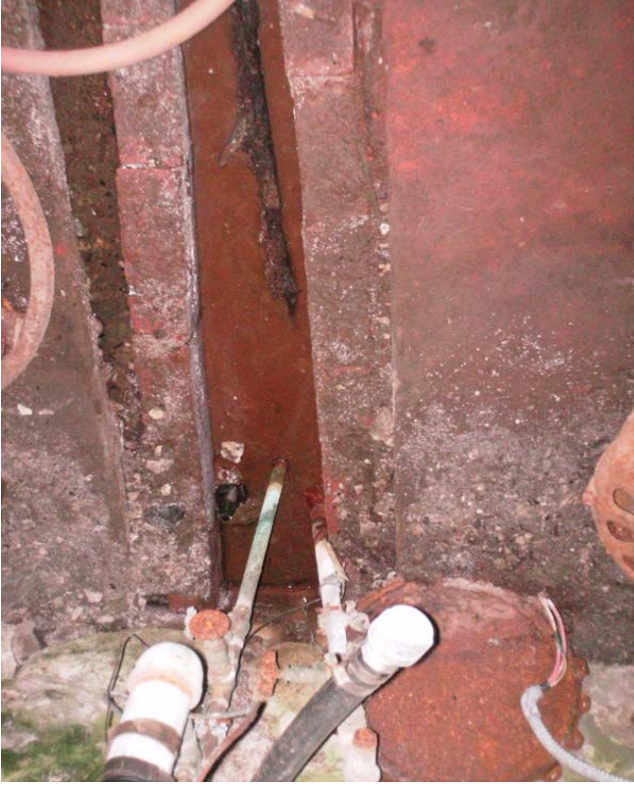
#6) Trench in basement where water was noted to be continuously flowing. (Office "A")

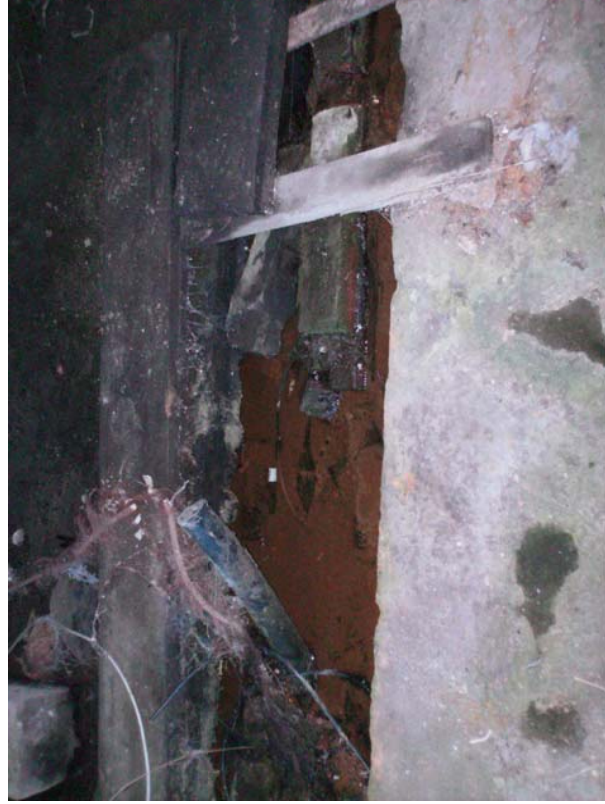
#7) The water in the ditch was flowing to the point that it was undermining the adjacent slab. (Office "A")

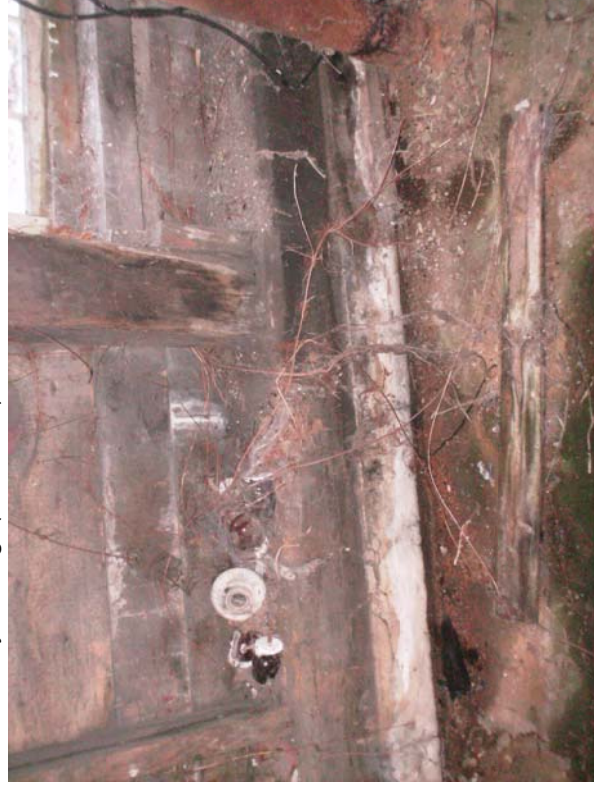
#8) Vegetation noted to be growing through the stud wall at the walk-out basement. (Office "A")

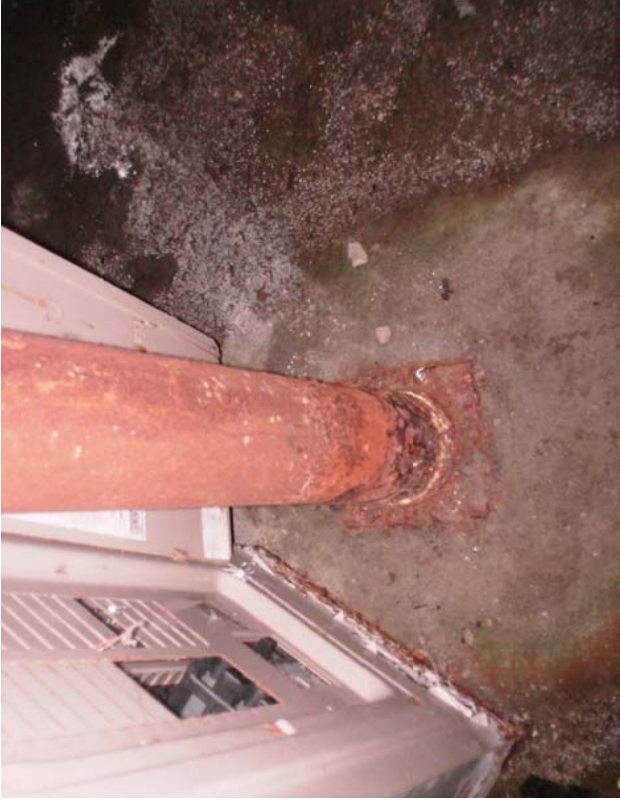
#10) Steel lolly column not secured to the foundation and has significant surface rust. The column should be replaced and mechanically fastened to a proper foundation. (Office "A")

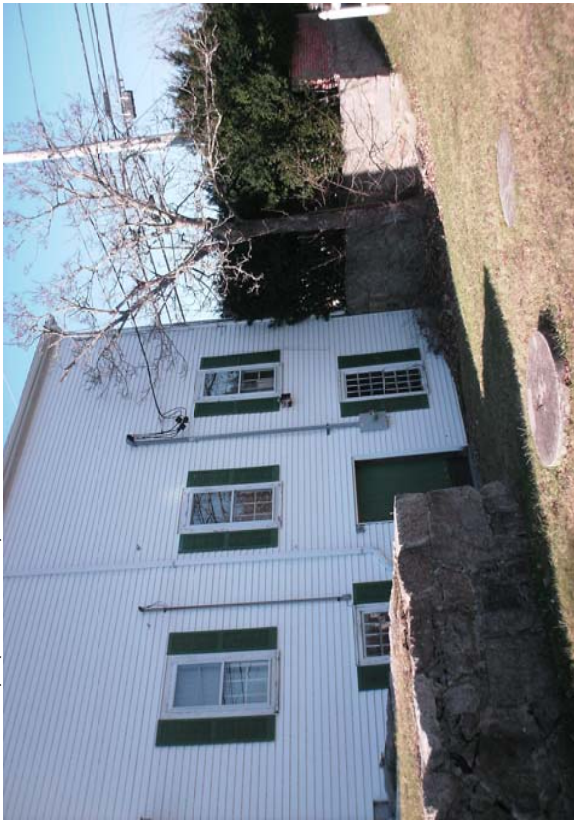
#15) View of walkout basement. (Note the stone retaining walls around the building and deteriorated clay masonry wall.) (Office "A")

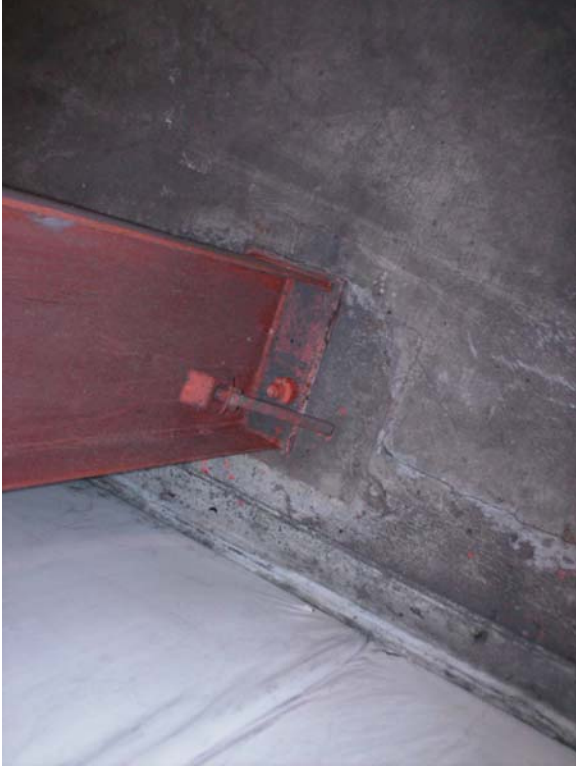
#18) Connection of cross bracing cable to column (Steel Bldg.)

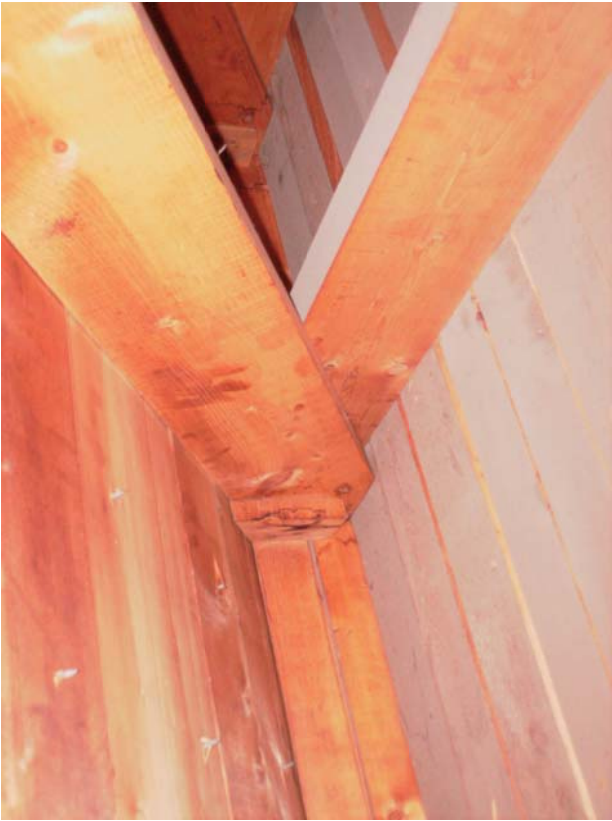
#21) Roof rafter to exterior wall connections, no tie downs were observed. (Restroom)

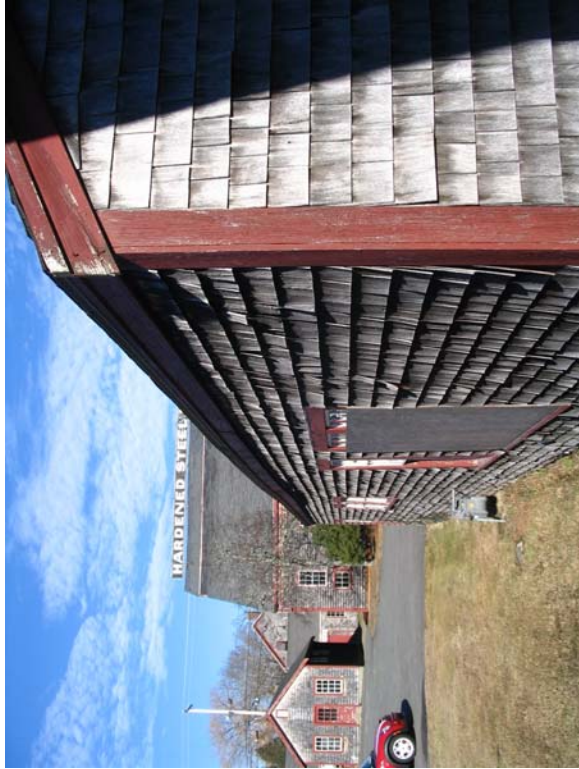
#23) Bow in wall at top plate due to the roof loading and inadequate roof tie system. (Pickling)

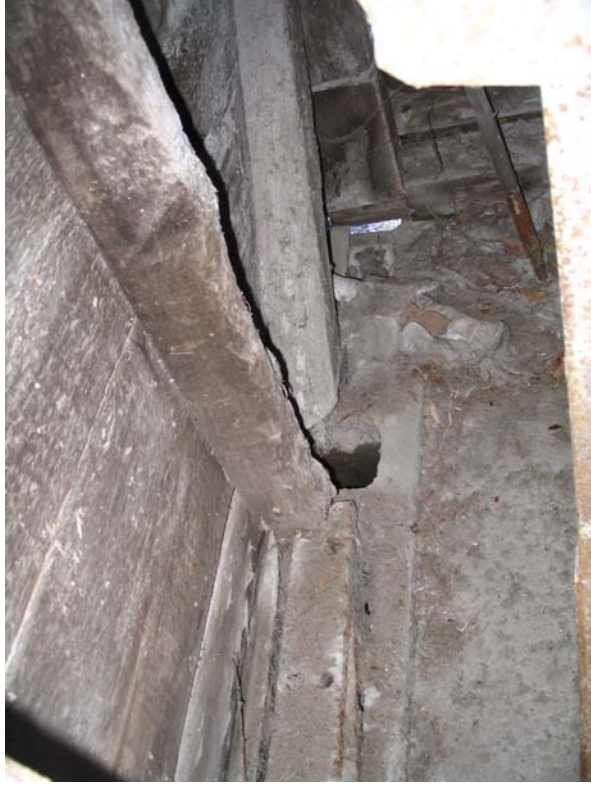
#24) Considerable deterioration of the sill. The sill should be replaced if the building is to be saved. (Pickling)

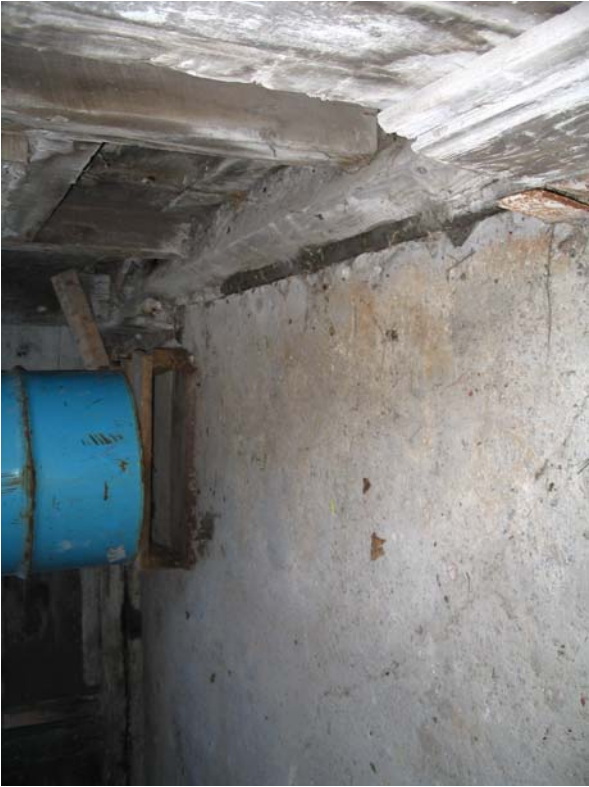
#25) Rotation of the sill due to deterioration (Pickling)

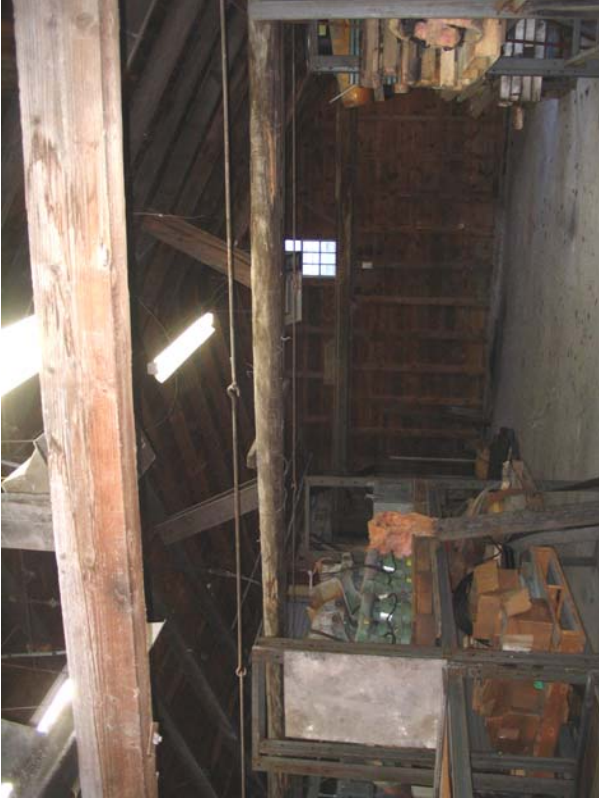
#26) Timber cross members at top of wall were attempted to be turned into tusses. Also, steel ties used to try and prevent the wall from spreading. (Pickling)

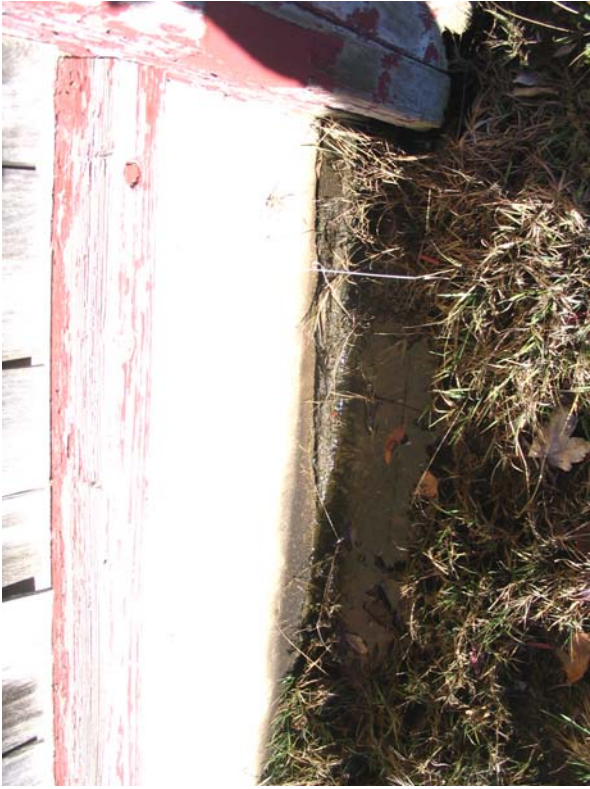
#29) Standing water located next to CMU foundation wall. A water management system should be implemented at this site. (Packaging)

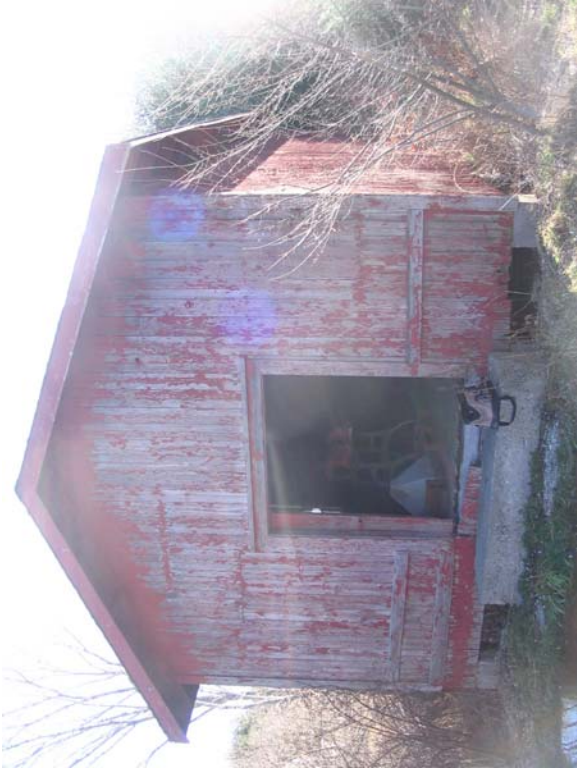
#33) Front view of shed, note that the siding is in poor condition and the exposed ends of the floor boards are deteriorated. (Shed)

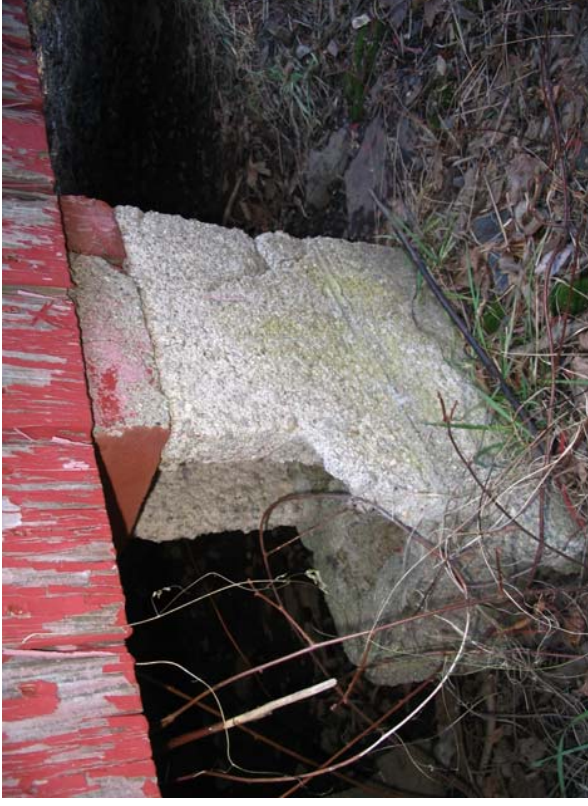
#34) Broken CMU support, Note that the CMU is not reinforced or grouted. The foundation should be replaced with steel reinforced sonotubes and "Bigfoot" footings. (Shed)

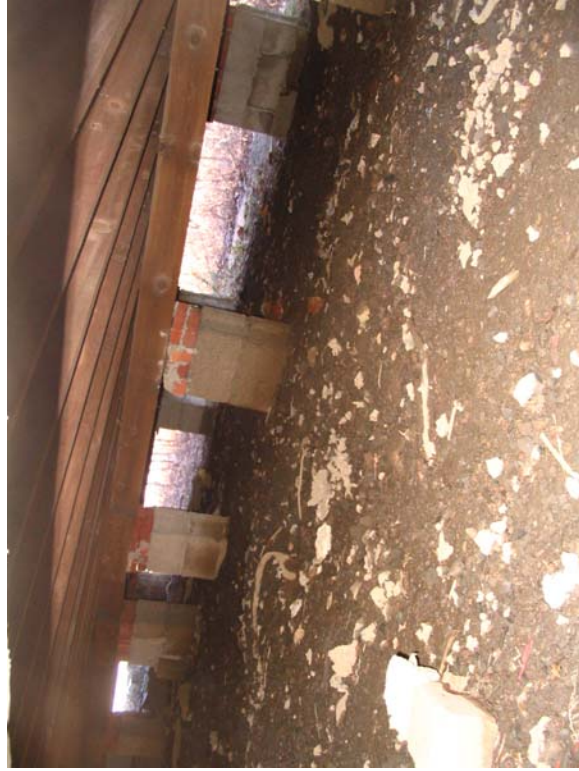
#35) Clay brick infilled between CMU and foundation. (Note: no connection of shed to pier.) (Shed)

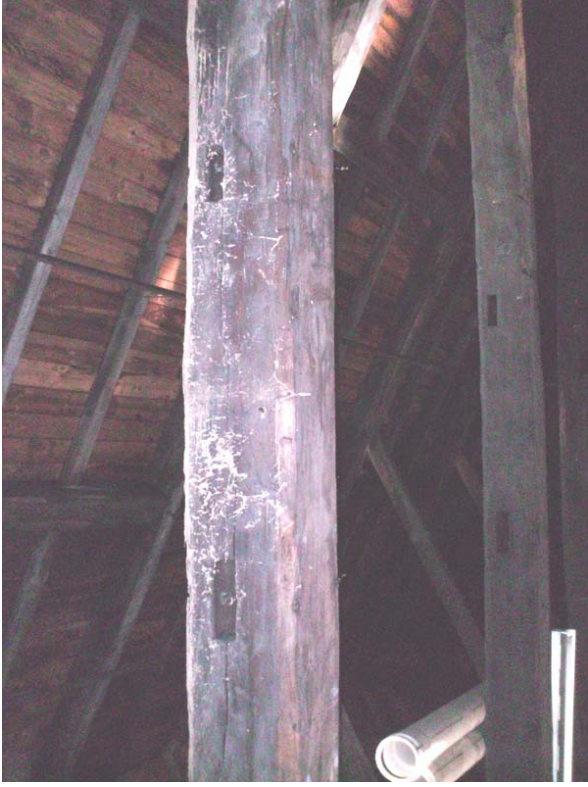
#38) Lateral bracing should be replaced at the lower chords of the truss to prevent the lower chord from buckling and rotating. (Freight "A")

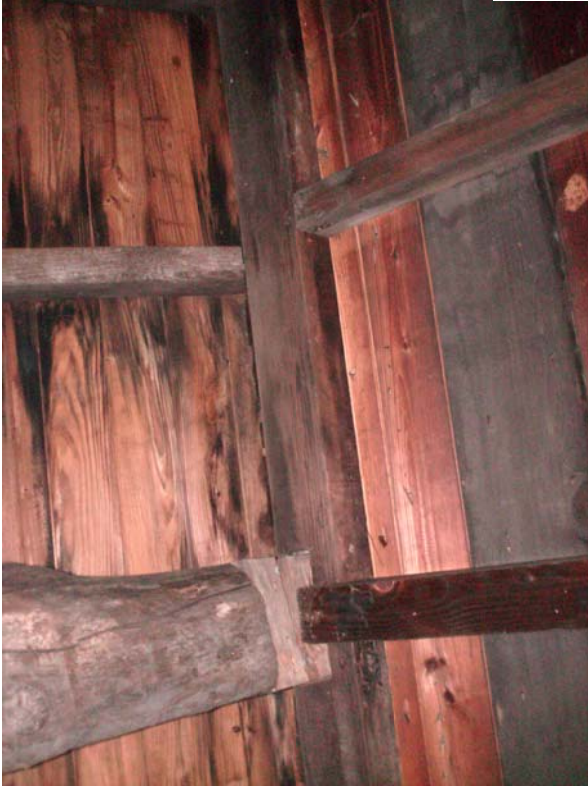
#41) Post under truss has been replaced. (Note the shim between the post and truss.) This post should be replaced with a properly sized full height post. (Freight "A")

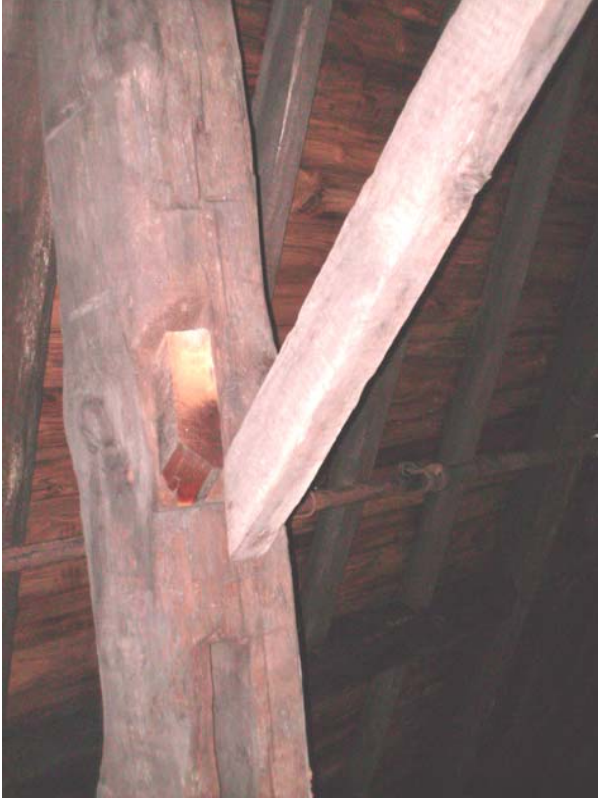
#42) Truss diagonal bracing cut-out and replaced, new bracing is smaller and toe nailed to truss. (Freight "A")

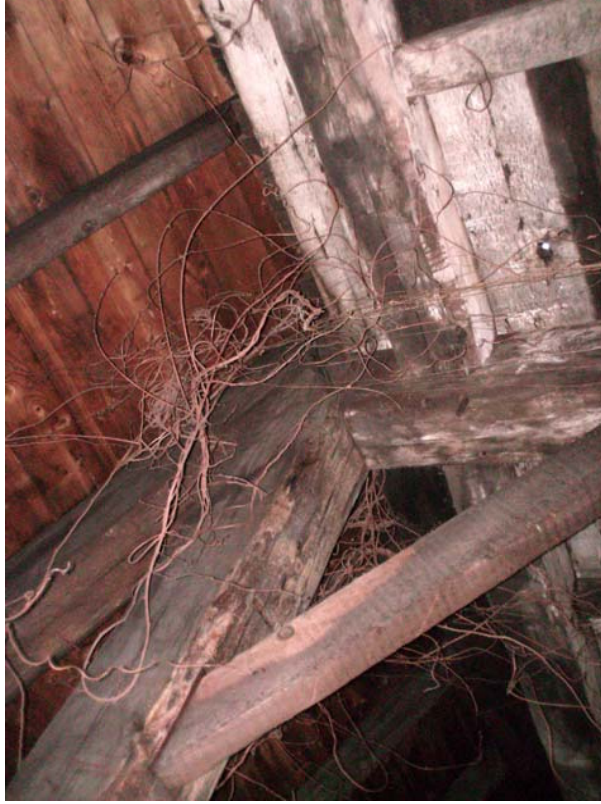
#43) Vegetation growing through the wall sheathing and into the building. (Freight "A")

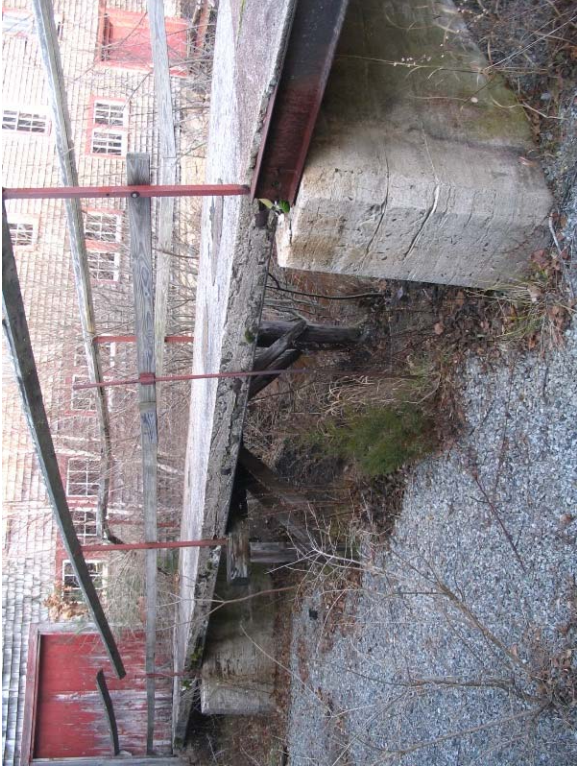
#62) Concrete bridge and platform, the bridge is in poor shape and should be removed or replaced (Factory "ALL")

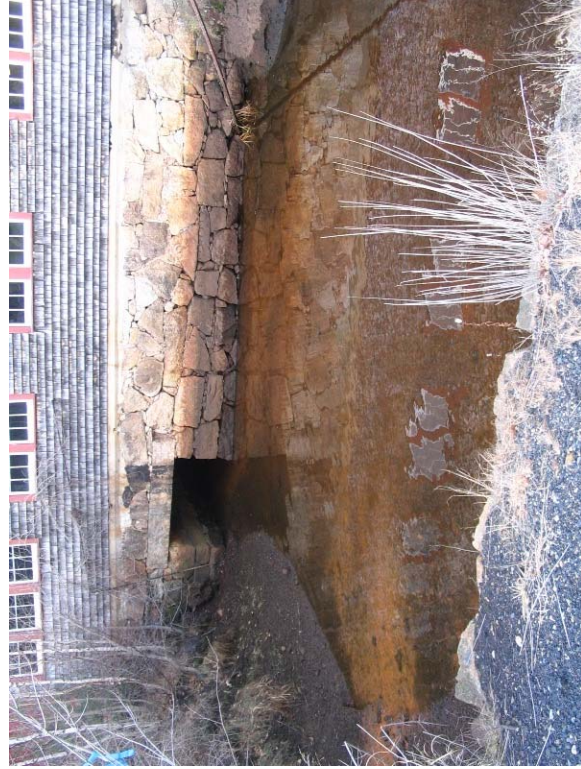
#64) Culvert exit from under the building. (Refer to "Inspections of underwater structures" Report dated March 2008 by Inner Tech Marine Services, LLC for culvert condition.) (Factory "D")

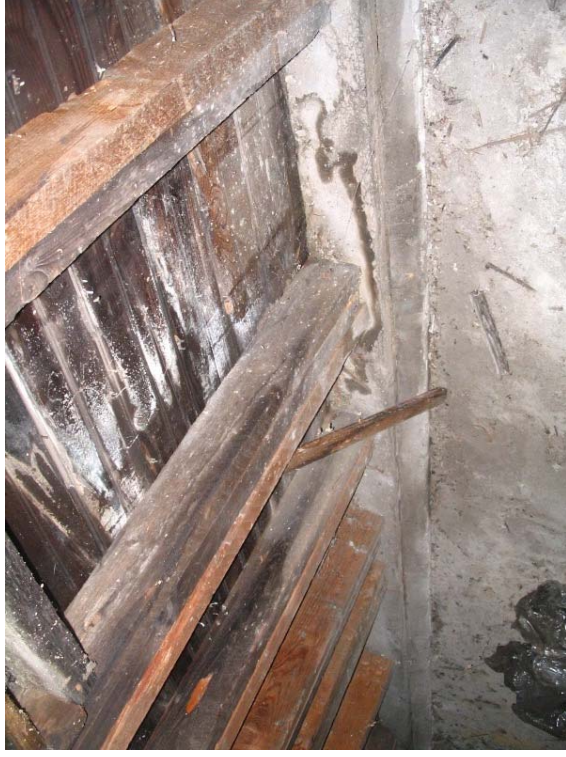
#81) Water staining and minor deterioration of sill and stud wall on low grade side. (Factory "C")

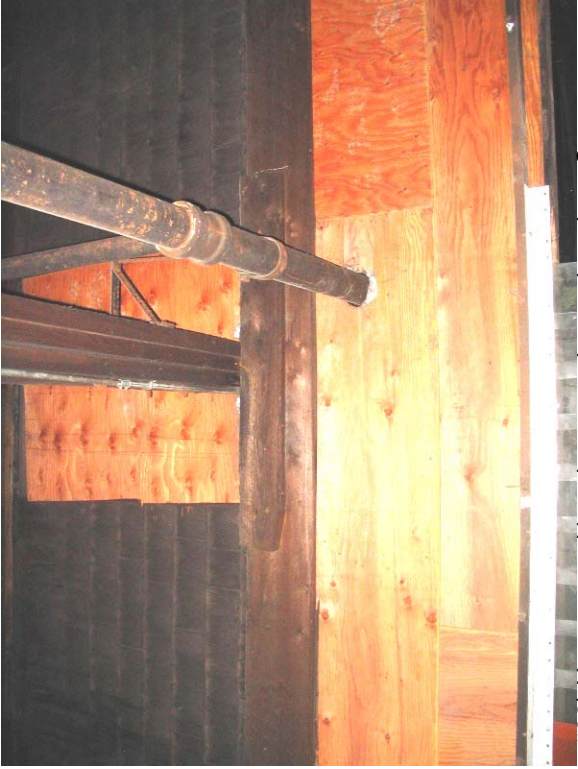
#82) Unsupported header at semi-truss location. Support posts and new header should be placed. (Factory "C")

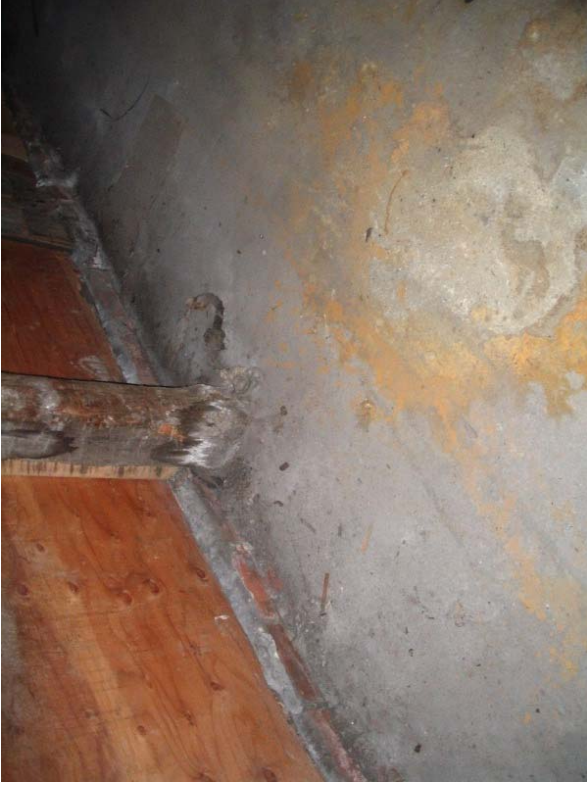
#83) Deteriorated post base with no connection to foundation. (Factory "C")

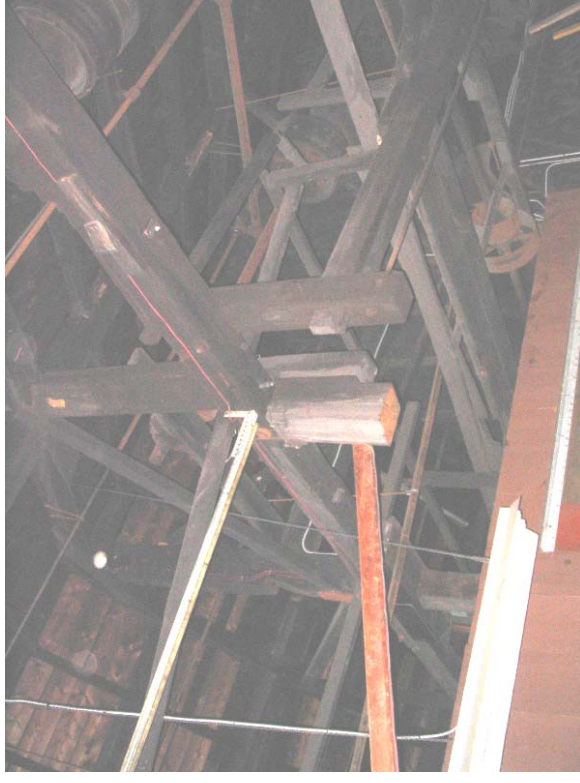
#85) Post cut under main truss; this was observed at various locations throughout the factory (Factory "D")

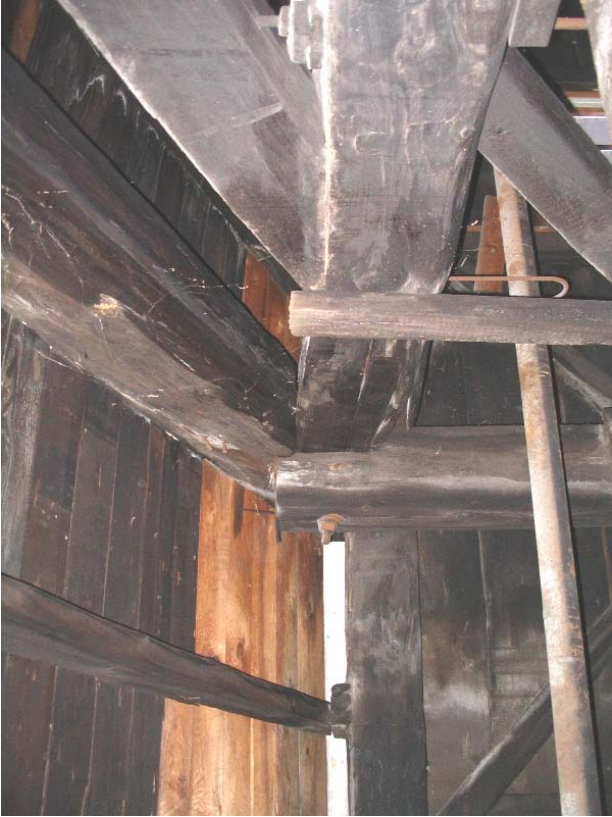
#86) Truss connection to end post. Note the shear failure of the truss at the support. (Factory "D")

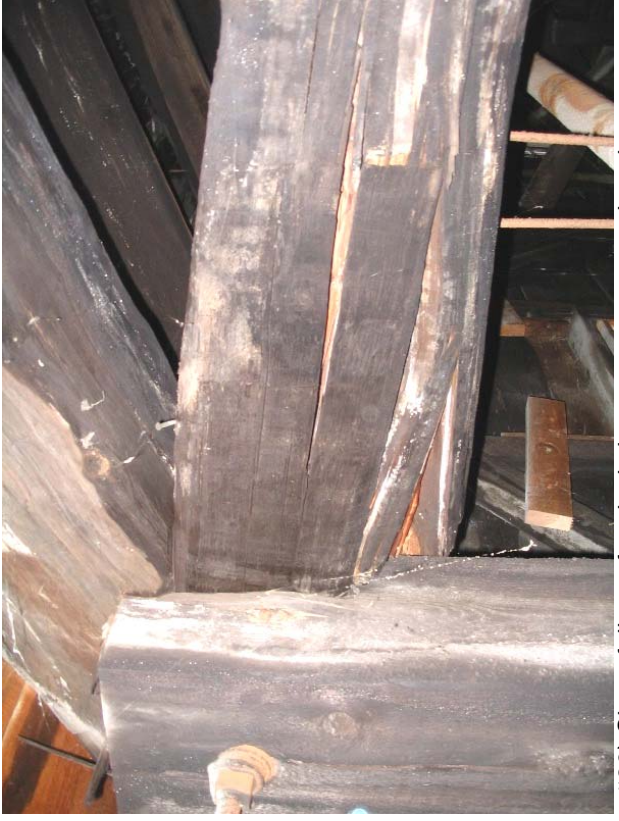
#89) Shear failure of main timber truss at support location. Note only half of the bottom chord bears on the support post. (Factory "D")

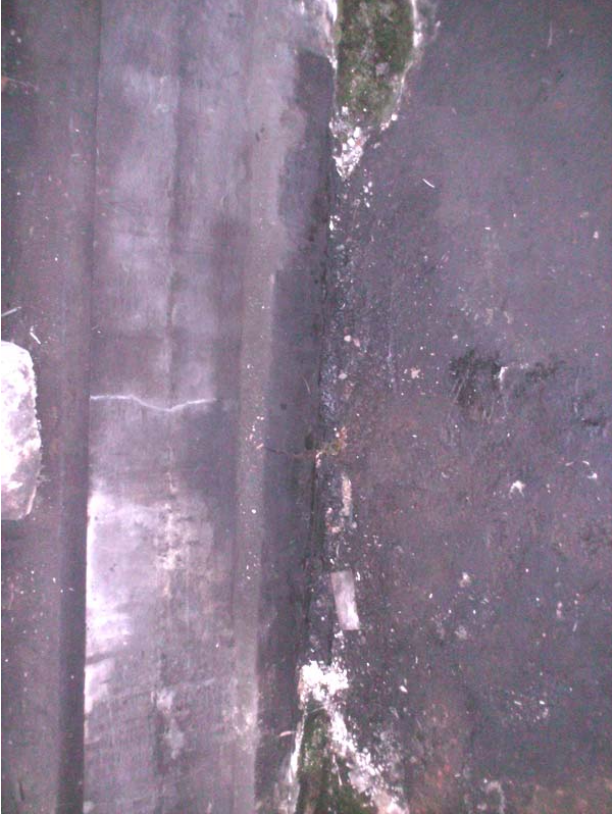
#103) Minor cracking noted in the concrete foundation wall along the low grade side of the factory (Factory "D")

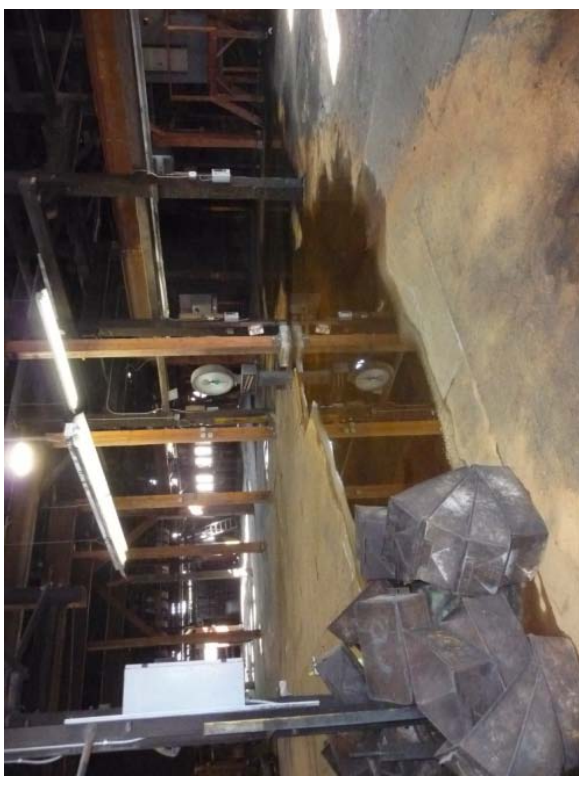
Existing Conditions: Nail Factory

- Framing – timbers poor to fair; sheathing poor to fair; catwalks & stairs poor; infill good
- Foundation – water infiltrated, fair
- Floors – poor to fair
- Blacksmith shop chimney - poor
