**ARCHITECTURE
+ ACCESSIBILITY**

ACCESSIBILITY AUDITS

WAREHAM, MA

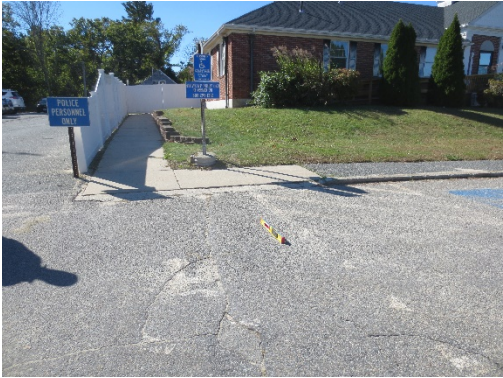
Police Station				
5.	Accessible Parking The designated accessible parking space and the associated access aisles have slope >2%, @ up to 3.8%.	Re-grade the parking spaces and their associated access aisle. Unit Cost: \$1,500 per space or aisle Quantity: 2 (1 space + 1 aisle)

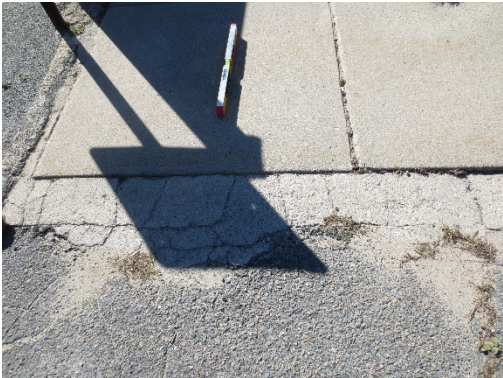
\$3,000
6.	Curb Ramp The bottom surface of the curb ramp is uneven/ broken.	Re-build the curb ramp. Unit Cost: \$1,250 ea. Quantity: 1

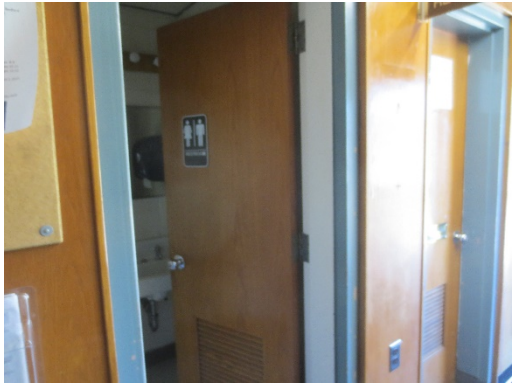
#	Issue	Mitigation	Photo	Cost
12.	Signage Permanent room sign is not mounted on the latch side of the door and lacks tactile/Braille elements.	Install tactile/Braille signage on the latch side of the door. Coordinate with location and height requirements. Unit Cost: \$100 per sign Est. Quantity: 7

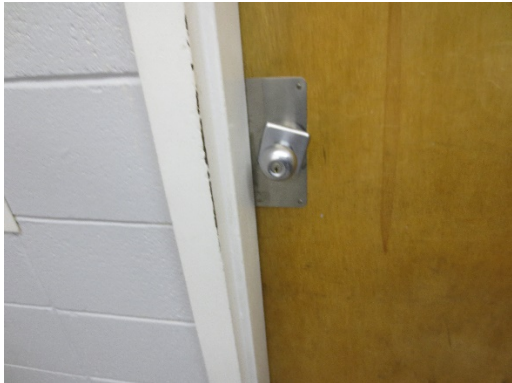
\$700
13.	Interior Door Hardware The door hardware requires tight grasping, pinching, or twisting of the wrist to operate.	Replace the door hardware with lever type. Unit cost: \$300 ea. Est. Quantity: 5

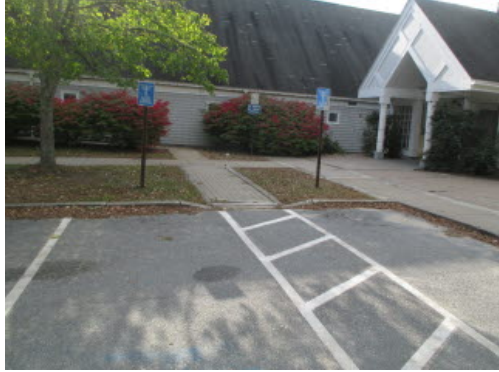
1.	Accessible Parking <ul style="list-style-type: none"> A van accessible space is not provided – the access aisle is <8' wide, @ 48". The access aisle between the two designated accessible parking spaces < 5' wide @ 48". 	<p>Restripe a portion of the parking lot to add a van accessible parking space (including at least one van space), as well as the associated signs and access aisles.</p> <p>Unit Cost: \$300 ea.</p> <p>Est. Quantity: 3 (2 spaces + 1 access aisle)</p>

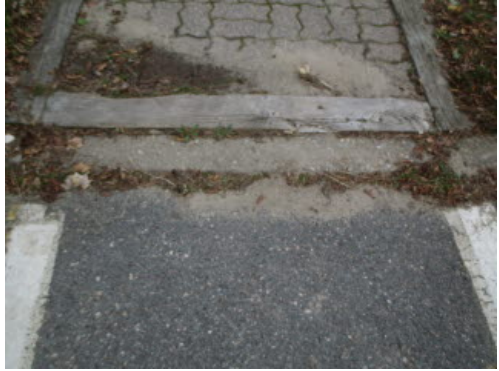
\$900
2.	Curb Ramp <p>The transition to the curb ramp is broken, uneven and has changes in level > ¼" that are not beveled at max. 1:2.</p>	<p>Repair the transition</p> <p>Unit cost: \$300</p> <p>Quantity: 1</p>

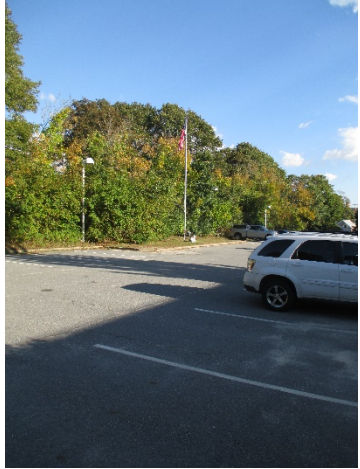
#	Issue	Mitigation	Photo	Cost
3.	Flag Pole The flag pole is not located on an accessible route.	No action necessary if flag is raised/lowered by municipal employees. Town to confirm. Unit Cost: \$0 Quantity: 1

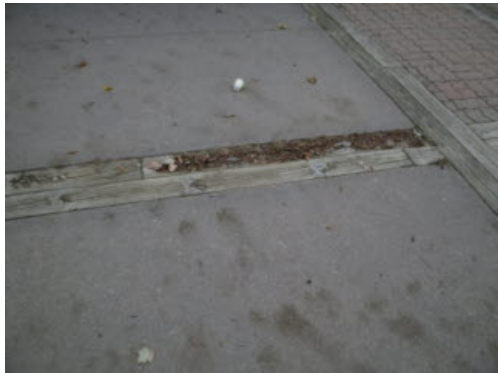
\$0
4.	Walkway Walkway to entrance has a section that is broken, uneven and has changes in level > ¼" that are not beveled at max. 1:2.	Repair the walkway. Unit cost: \$300 Quantity: 1

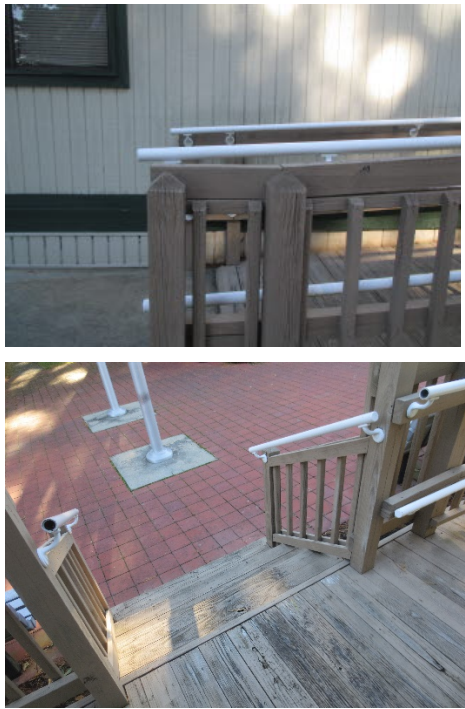
#	Issue	Mitigation	Photo	Cost
Route 195 Visitor Center				
1.	Route to Information Office The ramp and stair handrails lack the required extensions at the top and bottom.	Install compliant handrail extensions on both sides of the stairs. Unit Cost: \$50/lf Est. Quantity: 8 lf

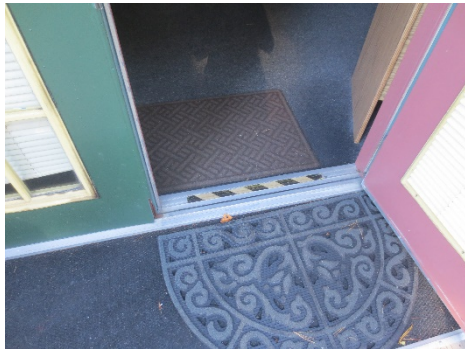
\$400
2.	Information Office Entry The entry threshold is >1/2" AFF and not beveled at max. 1:2, @ 1 1/2" tall with two abrupt vertical changes in level.	Replace the threshold. Unit Cost: \$100 ea. Quantity: 1

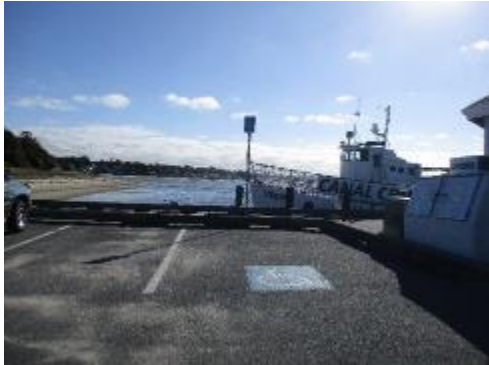
2.	Accessible Parking at Canal Cruises <p>The designated accessible parking space lacks an access aisle.</p>	<p>Restripe a portion of the parking lot to add a van accessible parking space, as well as the associated sign and access aisle.</p> <p>Unit Cost: \$300 ea.</p> <p>Quantity: 2 (1 space + 1 access aisle)</p>

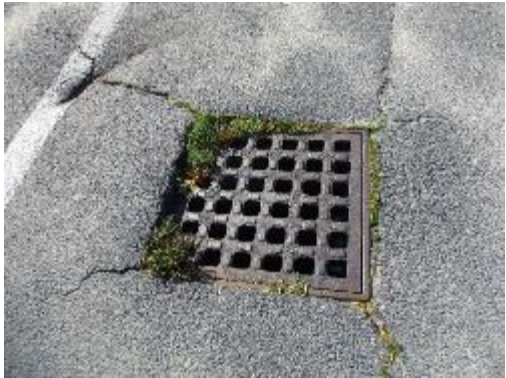
#	Issue	Mitigation	Photo	Cost
3.	Grate Along Accessible Route (Onset Pier) Grates along the accessible routes from the designated accessible parking spaces has openings > ½".	Replace the grate cover with one that does not have openings >1/2" wide. Unit cost: \$250 Quantity: 2

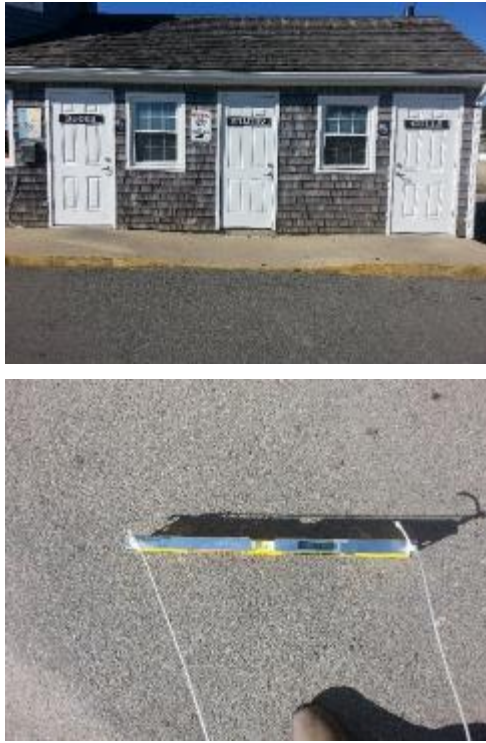
#	Issue	Mitigation	Photo	Cost
3.	Curb Ramp The curb ramp has running slopes >8.3%, @ up to 9.2%.	Re-build the curb ramp. Unit Cost: \$1,250 ea. Quantity: 1

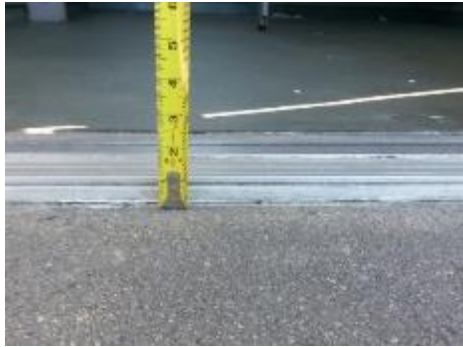
\$1,250
4.	Thresholds The door thresholds are >1/2" AFF.	Replace the thresholds. Unit Cost: \$100 ea. Quantity: 3

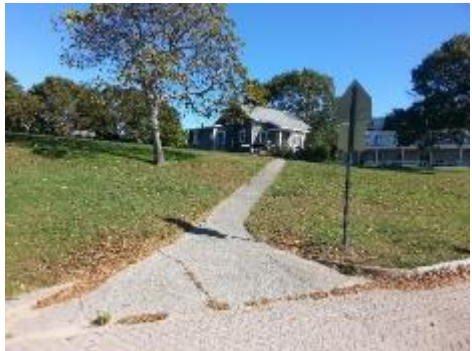
2.	Accessible Route There are excessive slopes along some of the walkways accessing the Comfort Station from the public sidewalk along Onset Ave, @ up to 13.9%.	Provide an accessible route to the Comfort Station from the public sidewalk. Additional study required. Note if the toilet rooms at the Harbormaster Office are open at the same hours as the comfort station, barrier mitigation of this route may not be required. Unit Cost: \$10,000 Quantity: 1

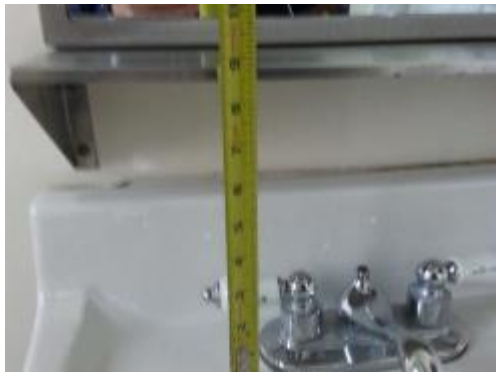
3.	Mirrors The reflective surface of the mirror is >40" AFF, @ 42 ½". This condition was observed in all the bathrooms.	Lower the mirror. Unit cost: \$500 ea. Quantity: 3

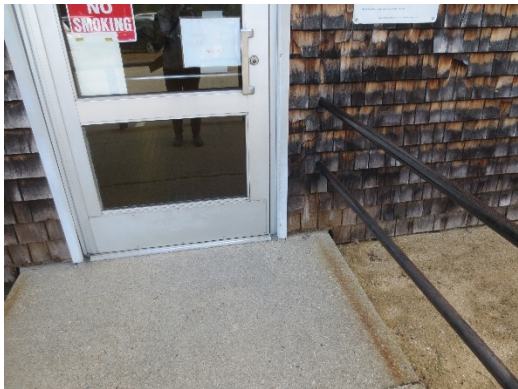
#	Issue	Mitigation	Photo	Cost
3.	Entry Door <ul style="list-style-type: none"> The entry door lacks the required min. 18" of maneuvering clearance on the latch pull side for a forward approach, @ 11". The entry door maneuvering clearance has slopes >2%, @ 2.8% on the exterior side. 	Install an automatic door opener. Unit cost: \$2,500 ea. Quantity: 1

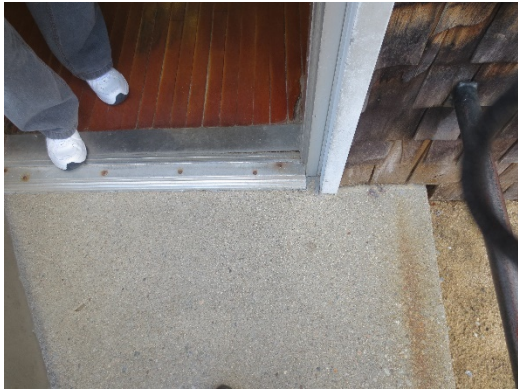
\$2,500
4.	Entry Threshold The entry threshold is >1/2" AFF beveled at 1:2, @ 1".	Replace the thresholds. Unit Cost: \$100 ea. Quantity: 1

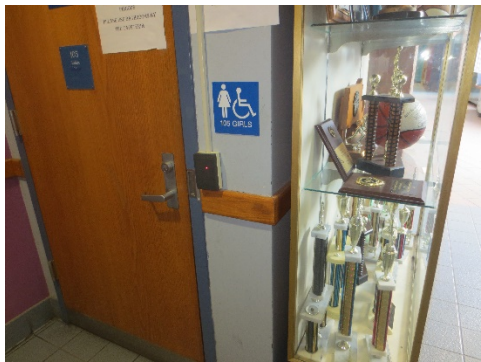
6.	Men's & Women's Multiuser Toilet Rooms <ul style="list-style-type: none"> The signage is mounted <48" AFF to the baseline of the lowest tactile character. The marble thresholds are not beveled at 1:2. The entry doors lack the required min. 12" of maneuvering clearance 	Relocate the signs. Unit Cost: \$50 ea. Quantity: 2 Replace the thresholds. Unit Cost: \$100. Ea. Quantity: 2 Install an automatic door opener. Unit cost: \$2,500 ea.

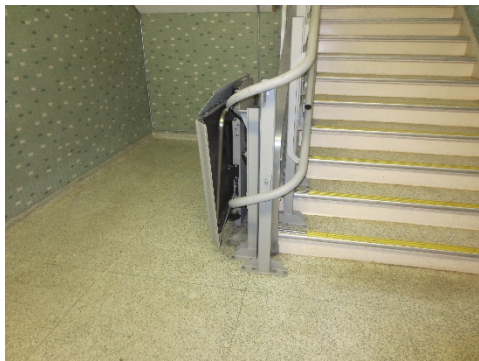
4.	Accessible Route to Bathrooms <ul style="list-style-type: none"> Neither leaf of the two sets of double doors provides the required min. 32" of clear width, @ 30" leaves. The route to the accessible unisex bathroom on the third floor requires the use of an inclined chair lift. 	Replace the double doors with at least one leaf that provides 32" of clear width. Unit Cost: \$500 Quantity: 2 Confirm the inclined lift is in working condition. Unit Cost: \$0 Quantity: 1

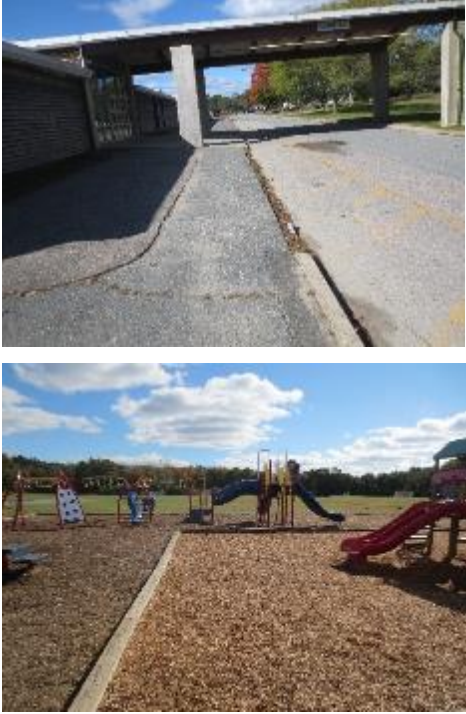
#	Issue	Mitigation	Photo	Cost
Decas School Playground, Bleachers, & Press Box				
1.	Accessible Route <ul style="list-style-type: none"> The accessible route from the accessible parking has cross slopes >2%, @ up to 4.6%. The playground entrance surface is broken/uneven. The playground, the bleachers, and the fields are not located on an accessible route due to the mulch/sand/grass surfaces. The playground lacks accessible elements and accessible routes between elements due to the mulch/sand surfaces. 	Provide an accessible route to the playground, the bleachers, and the fields. Additional study required. Unit Cost: \$15,000 Quantity: 1

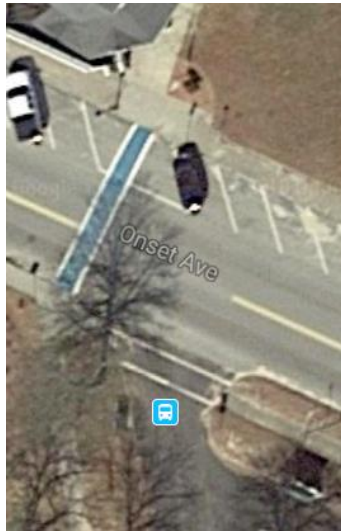
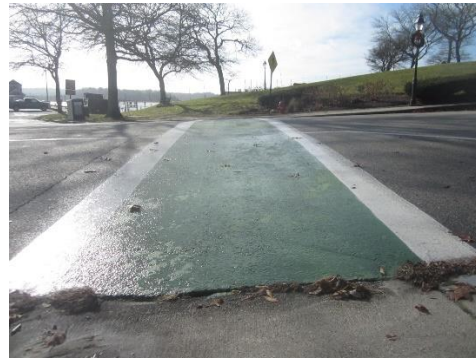
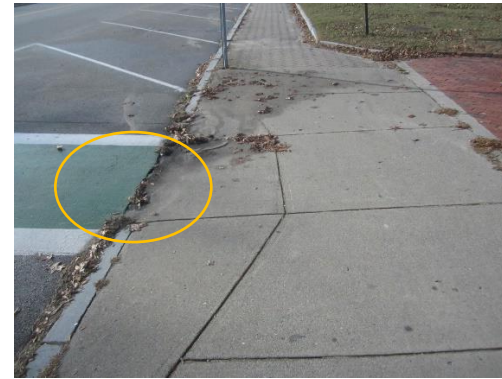
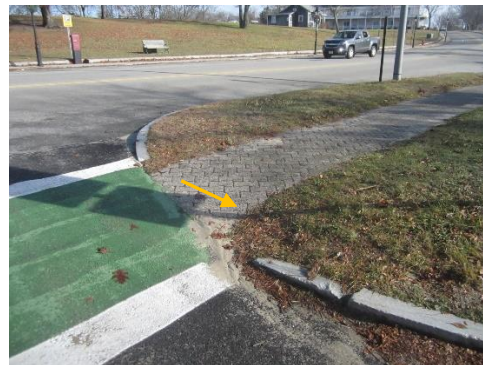
227 Onset Ave This intersection contains a curb ramp with a top landing that is not level and another with some broken uneven surface.

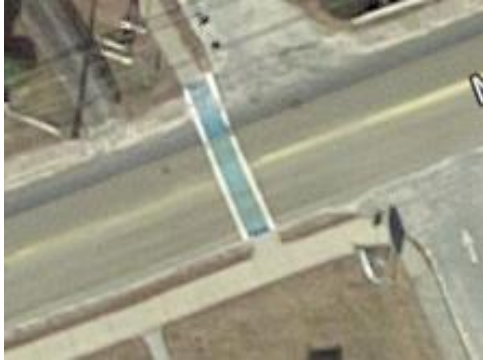
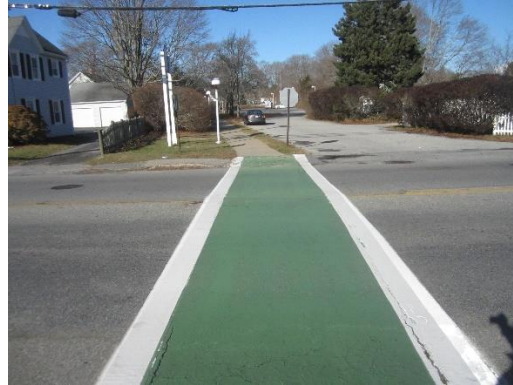
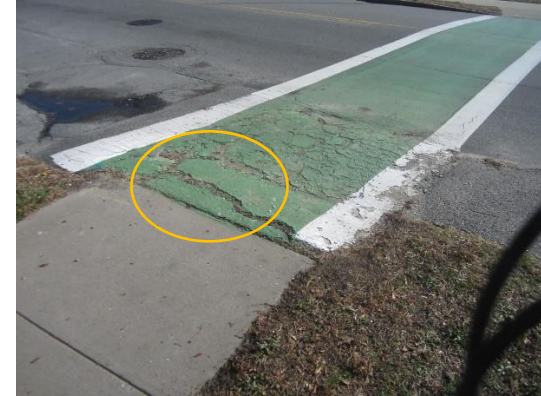
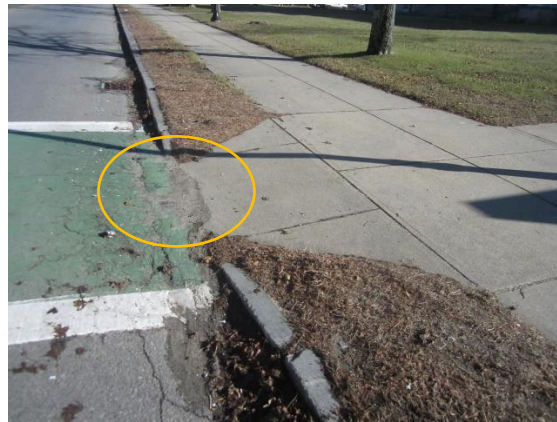
Marion Rd. at Viking Drive One curb ramp at this intersection has a running slope > 8.33% (@16%) and cross-slope > 2% (@5%). The other curb ramp has some sections of broken and uneven surface

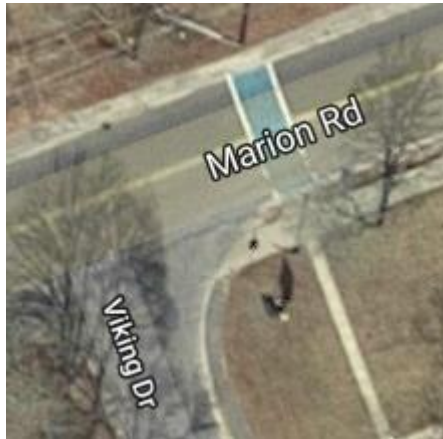
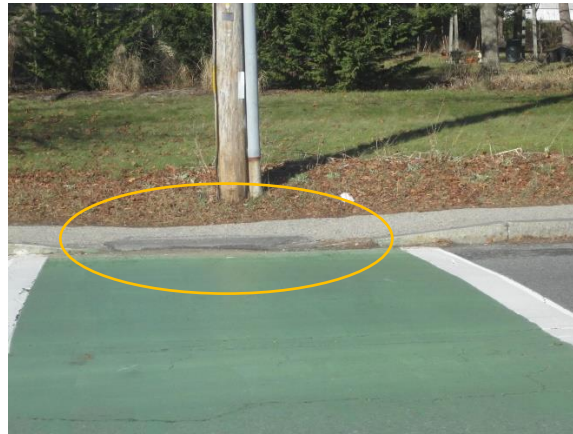
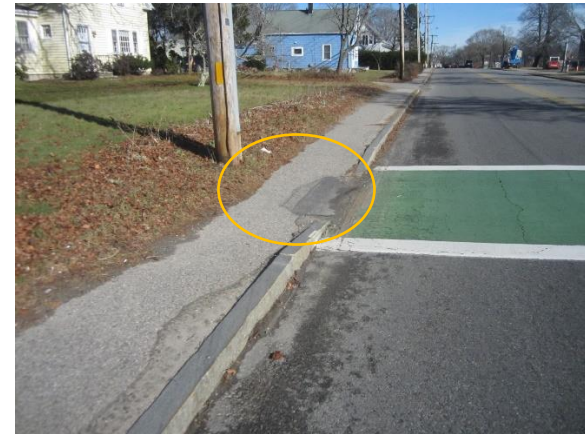
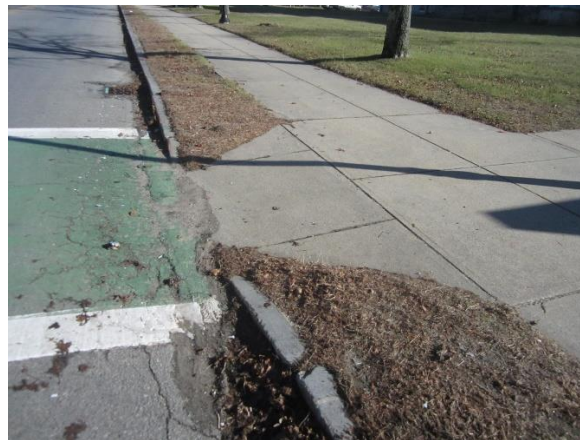
226 Main Street This intersection has one curb ramp with a change in level $> \frac{1}{2}$ " at one limited area.
