FIELD REPORT #1

Client:	Town of Wareham Planning and Community Development	Report Date:	March 25, 2024
Project:	Shell Point Place	A&M Project #:	3236-03
Location:	69 Great Neck Road	Contractor:	David Andrade
Weather:	Partly Cloudy	Temperature:	47 °F
Date of Site Visit:	March 25, 2024		
Time:	From: 11:00 AM		To: 11:55 PM
Present at Site:	Phil Cordeiro– A&M; David Andrade – Contractor/Owner		
Reported By:	Phil Cordeiro – A&M

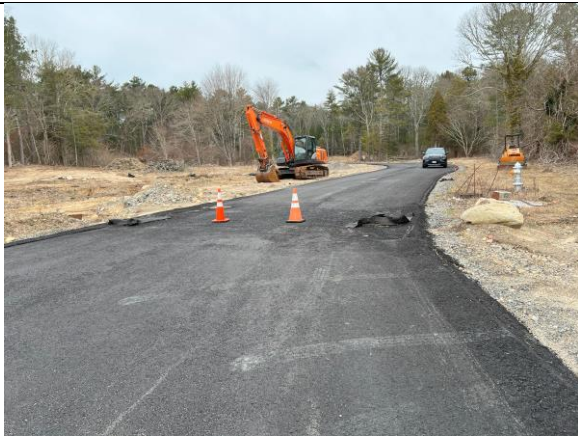
In A&M's opinion, the binder course is installed in accordance with the plan and in a satisfactory manner.

Photograph 1 – Roadway binder installation

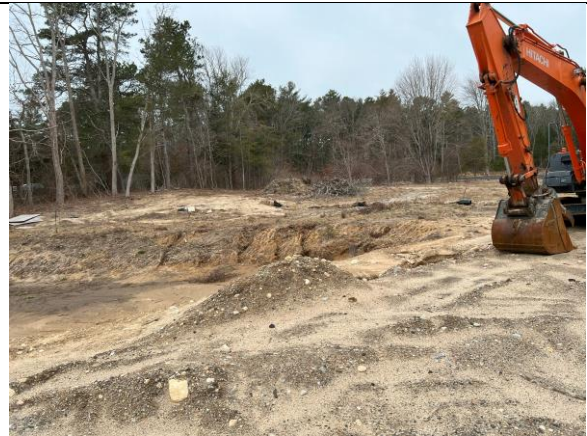
3. The system of leaching catch basins is installed, but no covers have been raised to finished grade.
4. The infiltration basin has been excavated but is not stabilized and requires the final installation of loam.

5. The outlet stone and flared ends have not been constructed as part of the stormwater basin.
6. The water quality unit for the stormwater treatment has not been installed.

7. Large sections of the stormwater basin had eroded during recent rainfall.
8. Roadway shoulders, etc. require grading and the application of loam.
9. No street trees, street signs or lights have been installed.

Photograph 2 – In progress Stormwater basin with erosion

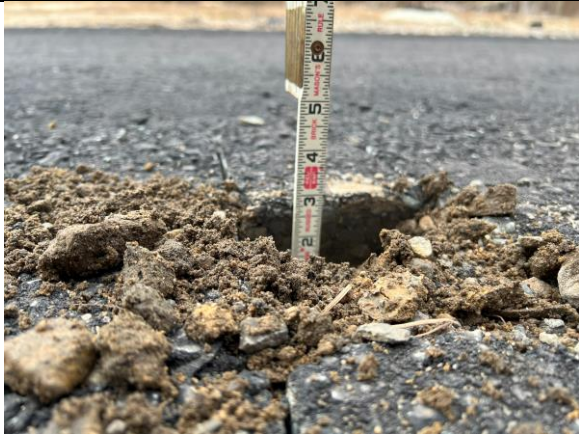
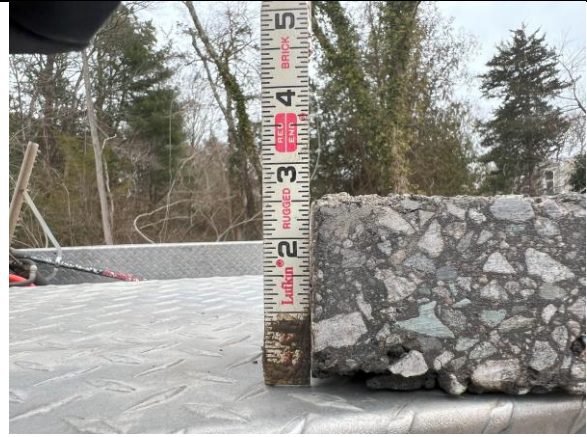
The applicant prepared three roadway cores at the recommendation of A&M at approximately stations 1+00, 2+50, and 5+00. A&M reviewed each core and the underlying gravel bedding. All three cores met the requirements for the minimum binder thickness of 2" HMA Type I-1 Binder in accordance with the record plans and the subdivision rules and regulations. A&M did not have the binder tested for adherence to the gradation specifications for binder but based on visual observations appeared consistent with prior experience. A&M reviewed the upper 6" of the gravel base, Type B, which also appeared consistent with the regulations and gradation without conducting an individual sieve test. A&M did not observe the lower 6" gravel borrow Type C base.

Photograph 3 – Roadway core (sta 2+50 +/-).

Photograph 4 – Roadway core (sta 2+50 +/-).

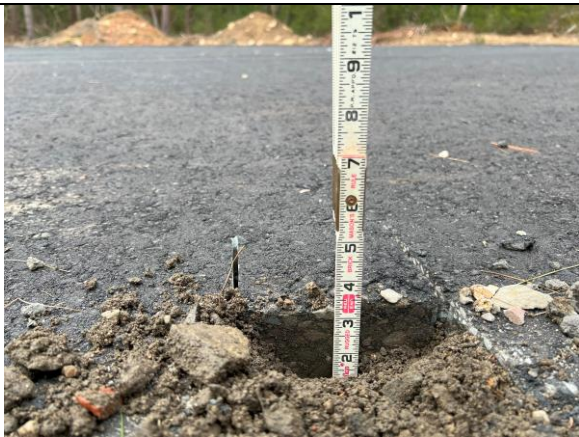
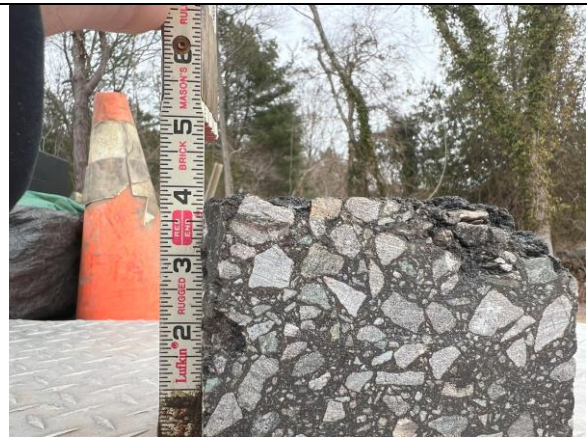
Photograph 5 – Roadway core (sta 5+00 +/-).

Photograph 6 – Roadway core (sta 5+00 +/-).

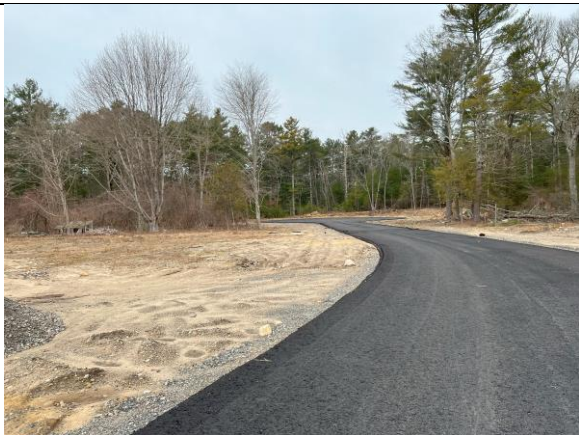
Photograph 7 – General state of Roadway, shoulders, etc.
