Wareham, Massachusetts
Capital Improvement Plan
Water Pollution Control Facility

**CAPITAL IMPROVEMENT PLAN
WATER POLLUTION CONTROL FACILITY
TOWN OF WAREHAM, MASSACHUSETTS**

Prepared by
GHD Inc.
1545 Lyannough Road
Hyannis, MA 02601

September 2015

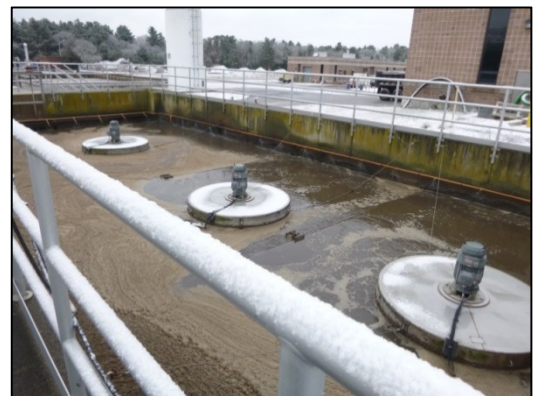
During a site walk-through, it was noted that several of the spray nozzles around the perimeter of the tanks are broken.

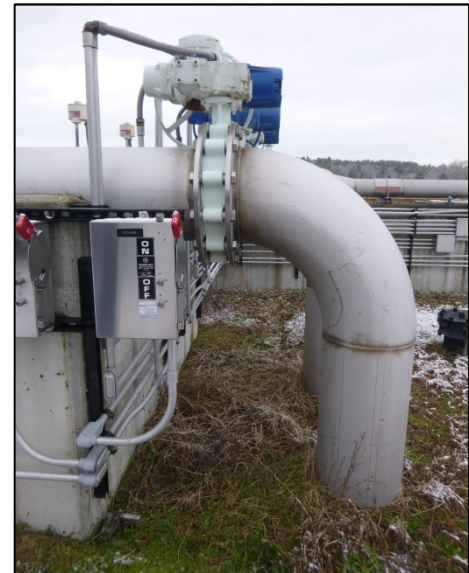
The WPCF staff has noted the concrete of the two older tanks is pitted and in need of repair. The uncertainty of the structural integrity of the walkways in Aeration Tank Nos. 1 and 2 is also a concern. During a site visit, it was noted that the process piping aeration valves should be downsized for better process air control.

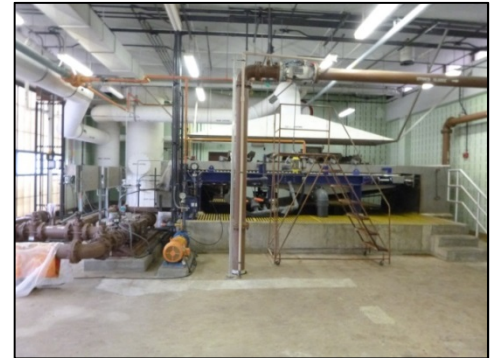
The Sludge Dewatering Building was originally constructed in the 1970s and modified during the 2005 upgrade project. The majority of the equipment in the building was installed during the 2005 upgrade project. The building's structural and architectural features have approximately 10% remaining life until they reach their minimum design life of 50 years, resulting in a high LoF rating. Once the building is 50 years old, it is recommended a condition evaluation be conducted to determine its expected remaining life.

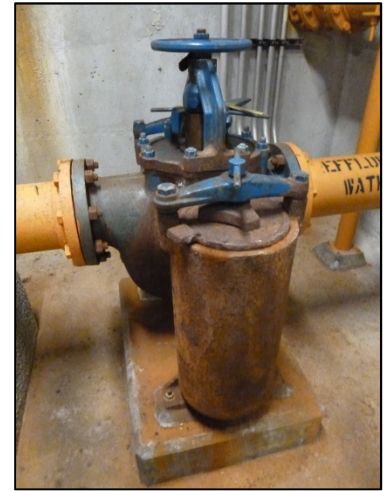
During a site walk-through, rust was observed on equipment. The operators noted several performance issues with equipment at the Filter/Blower Building:

1. The roof HVAC unit has failed and is need of replacement
2. Roof repairs are needed.
3. The denitrification filters plug frequently.
4. The plant water system is potentially undersized for the needs of the facility and frequently experiences low water pressure.

Based on the operators' comments, the performance ranking was increased for the items noted above, resulting in an elevated LoF.

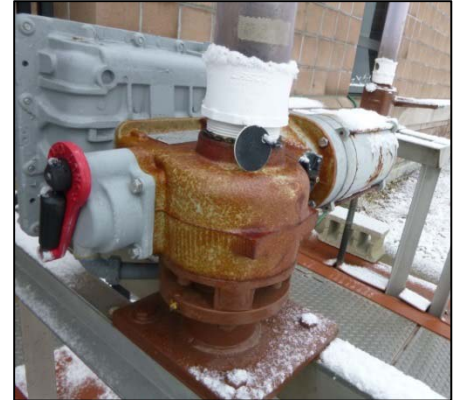
During the site walk-through, rust and peeling paint were observed on equipment. No other issues were noted by the WPCF staff.
