This article details the considerations and collaborative efforts which led to the selection and use of epoxy cured in place (CIPP) liners in these projects: the rehabilitation and repair of the deteriorating 8-inch AC gravity main at Swifts Beach, and the repair of the 21-inch RCP interceptor sewer along Viking Drive near Wareham Middle School.

CIPP CONSTRUCTION: 8-INCH AC PIPE SWIFTS BEACH

Viking Drive 21-inch RCP: Wareham Middle School

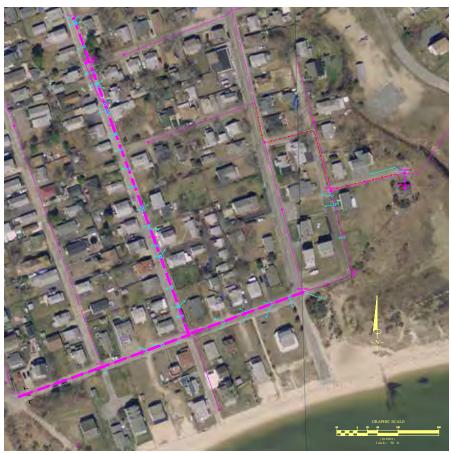
8-inch AC Pipe at Swifts Beach is permanently under water table at 17 feet depth

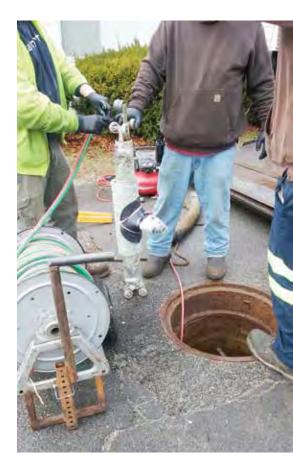
Tee Liner with inflatable packer assembled and ready for insertion

After the laterals were reinstated, the lateral/main connections located below the water table were repaired by installing a tee liner connection using an inflatable packer. Any concerns the neighborhood residents had regarding disruption, inability to get around, and prevention of access of emergency vehicles did not materialize. In 2013, the 20 feet of 8-inch AC gravity main that was dug up and replaced disrupted the neighborhood for 3 weeks. The CIPP project lining

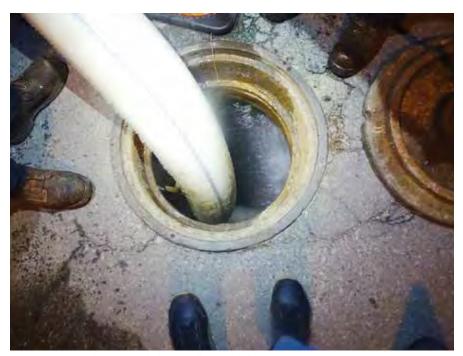
Liner inversion and curing worked very well at pipe deflection

The liner inversion and curing process worked very well at the pipe deflection location. Although it was not possible to pass the sewer camera though the 2-3 inch deflection it was possible to visualize the transition from both sides. Based on visual and flow observation we determined that the sewer hydraulic condition was adequate for the projected flows and that the sewer could be cleaned in the future by approaching the deflection from upstream and downstream ends.

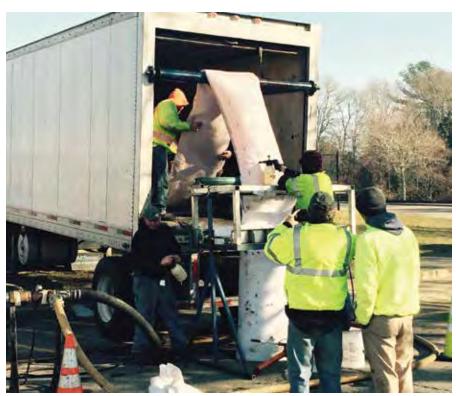
Liner Installation 21-inch RCP at Viking Drive near Wareham Middle School

The reline work on the 315 foot segment of the Viking Drive sewer between 2 manholes under the tennis courts at Wareham Middle School was a great learning opportunity for students in the engineering program, who were invited along with their instructor, to take part
