# Wareham Historical Society Historic Building Survey

October 21, 2013

Great Neck Union Chapel  
Old District School No. 6  
Old Methodist Meeting House  
Fearing Tavern Museum  
Captain Kendrick House

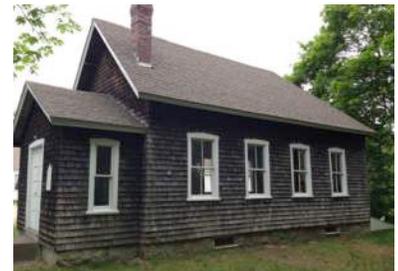
UC-2 South side of Chapel

Built in 1880, the Union Chapel is a charming example of the Shingle Style which was popular around the end of the nineteenth century and a particular favorite among resort and seaside communities of New England where it developed. The style is characterized by a focus on material textures like wood shingles and granite foundation blocks, as well as simple massing that spreads low against the ground. Large overhangs and hipped roofs are also quite common (UC-1). The detail tends not to be complicated and windows are generally regular and organized in horizontal bands (UC-2).

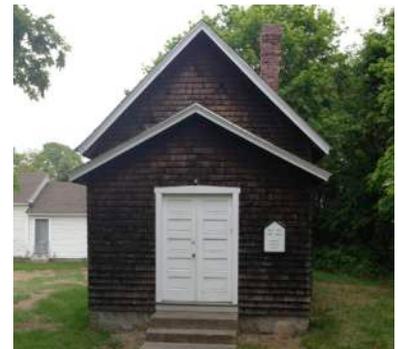
UC-3 Chapel entrance

The site abuts the old town green and it is not difficult to imagine the area as the old town center. It is flat with only a slight pitch down from the west to the east. Most of the lot is covered with grass and a few immature trees. The center of the lot is covered with gravel and serves as a makeshift parking lot. The western edge of the lot is bound by a concrete sidewalk with a single curb cut into it. The Chapel is oriented east/west with its gable end and entry vestibule facing Main Street. (UC-3).

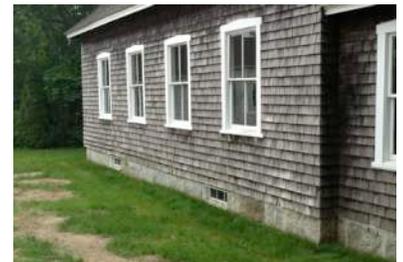
when the building was moved. The doors and interior steps are in very poor and even dangerous condition (UC-6). They should be repaired or replaced very soon. At the minimum, the opening should be protected with heavy plywood immediately to prevent injury. The deterioration of the stairs and bulkhead door appear to be caused by high levels of moisture. This could be a result of roof runoff falling on the doors or storm runoff finding its way into the basement, where it becomes trapped and supports mold growth and rot. Installing a dehumidifier in the basement would help remove this trapped moisture. Positively pitching the grade away from the building or installing a perimeter drainage system are two other ways of managing storm water runoff (UC-7).

UC-7 Pitch grade away from foundation

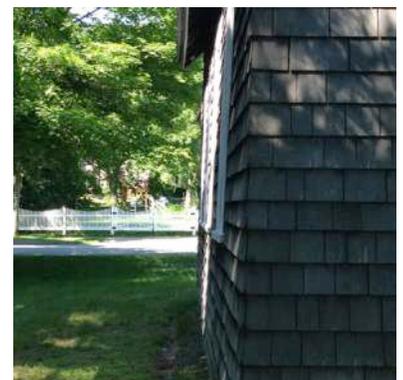
UC-9 Wall racking

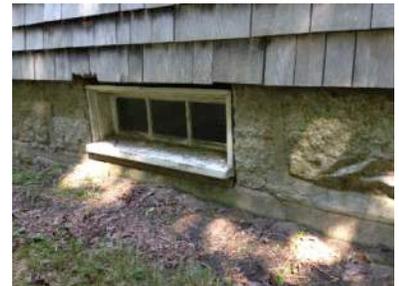
UC-10 Existing wash area for roof run-off

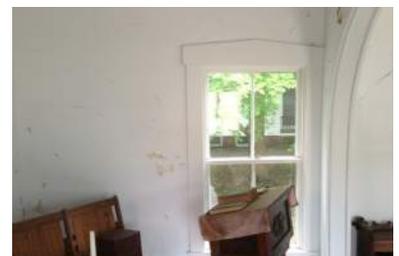
UC-13 Typical interior plaster cracks

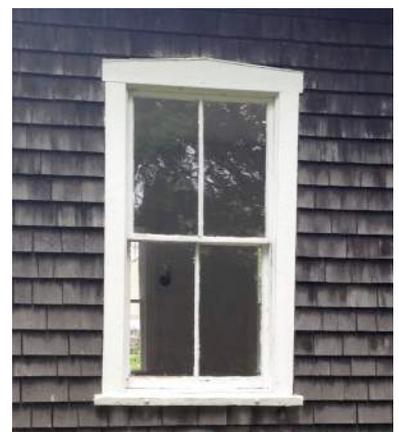
The windows are typically two-over-two wood double-hung units with two one-over-one units either side of the vestibule (UC-14). All of them are in fair condition but the glazing is typically failing. All of the double-hung window sash should be carefully removed, the glass completely re-set, the windows reglazed and the sash repainted and reinstalled. The two leaded-glass windows at the back of the chancel are in generally good condition, but the sash should be repainted and the wire mesh protective screens replaced with bronze or stainless steel to prevent staining (UC-15). All of the exterior window casings should also be repainted.

UC-14 Typical wood window

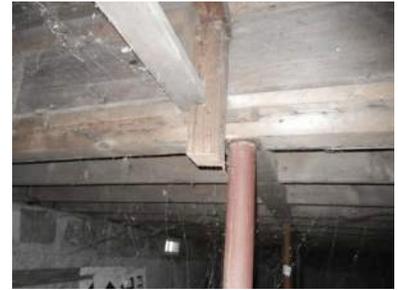
UC-16 Center beam supported by columns

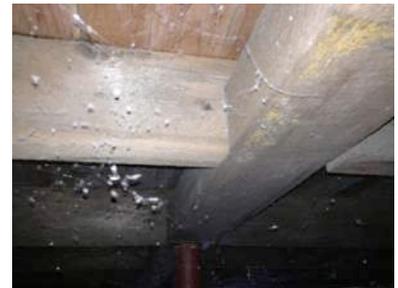
UC-17 Joists notched into beam

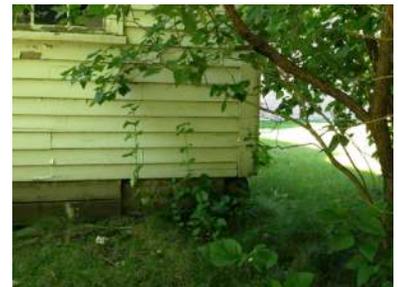
DS-2 Overgrown plantings at north end

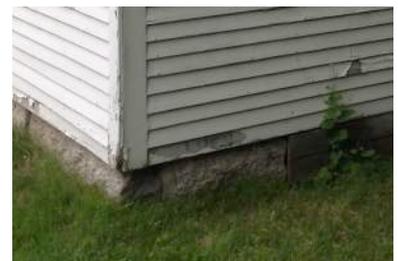
DS-3 Masonry veneer wraps SW corner

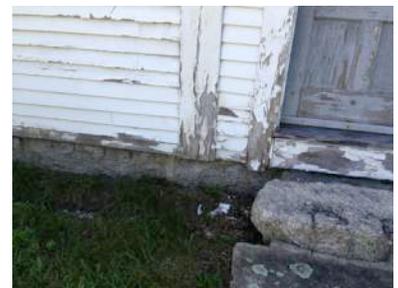
DS-4 Missing masonry joint at storage addition

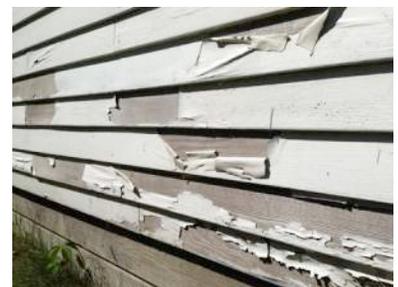
DS-5 Failing paint at east side

of them should be carefully repaired and the trim scraped, sanded, primed and repainted (DS-6).

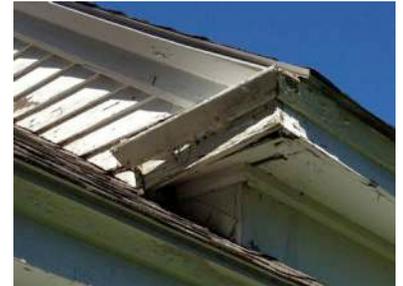
DS-6 Damaged & missing trim at eave

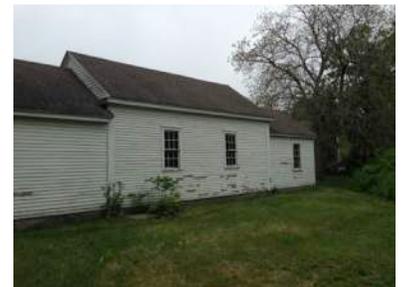
The roof is covered with asphalt shingles that appear to be in good condition (DS-7). There are no gutters or down spouts to control the roof runoff. An aluminum drip edge is visible along the eaves of the roof. For future roof work other more traditional drips should be used, like wood shingles.

DS-7 Existing asphalt shingle roof

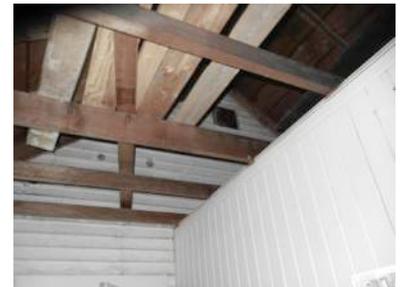
DS-8 Roof framing at storage addition

*The gable roof structure of the original school house and the two additions appears to have been conventionally framed with rafters and ties at the eave elevation (DS-8). The roofs, walls and ceilings do not appear to have any obvious signs of structural distress. Therefore, I don't anticipate the need for new structural reinforcements.*

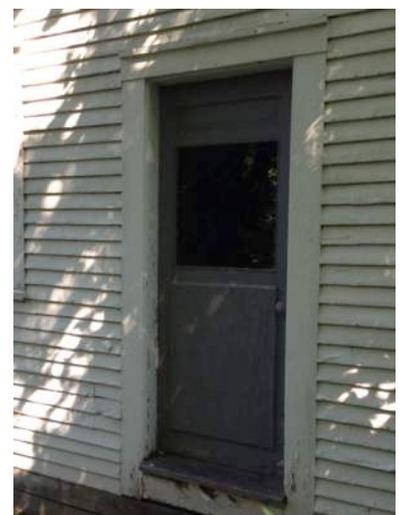
There are three exterior wood doors – two four-panel doors on the west side (one on the kitchen wing and one on the storage wing) and one glazed, two-panel door on the south side of the storage wing. The two four-panel doors appear to be in fair condition, but require repainting. The glazed two-panel door on the storage wing is in poor condition and should be entirely rebuilt or replaced (DS-9).

DS-9 South end exterior door

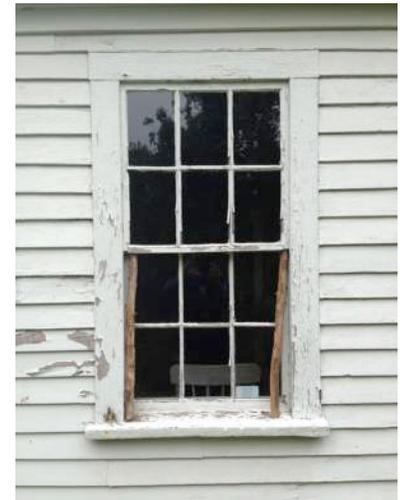
The windows are typically six-over-six wood double-hung units. The sash themselves are generally in fair condition, but the glazing and paint have failed completely (DS-10). All of the windows should have the glazing removed, the sash scraped, sanded, and primed. The glass should be reset and the windows entirely reglazed and repainted. Old blown or salvaged glass should be used to replace any broken or missing panes. Full height stops screwed into the frame provide a clean method for fixing the upper sash in place.

DS-10 Existing 6/6 wood double-hung window

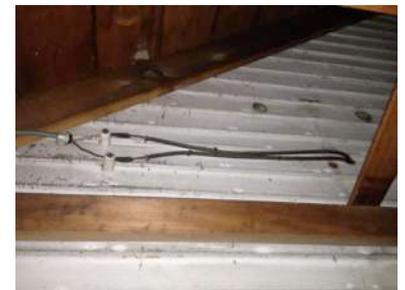
There is some old knob and tube wiring visible in the storage wing against the old exterior wall of the school (DS-11). This type of wiring is

DS-11 Knob & tube wiring

unreliable and sometimes can be quite dangerous. All knob and tube wiring should be removed completely, whether active or not. The wiring is very easily shorted and is frequently the cause of fires in old buildings.

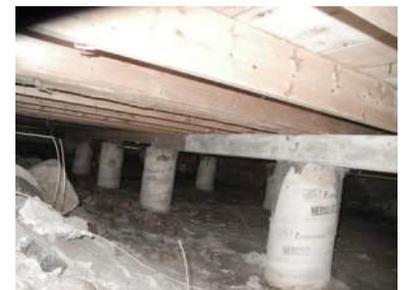
*The first floor is framed over a crawl space. The wood joists are supported by perimeter and interior wood beams that are supported by a series of concrete piers (DS-12). Access to the floor framing was not accessible, however, from an access hole to one location of the perimeter skit board (DS-13), the framing appeared to be free of decay or rot and the concrete piers appeared to have been located in some organized fashion. Due to limited access, a general analysis and close inspection of the existing floor framing was not possible.*

DS-12 New floor framing

*However, the floors appeared to be relatively sound with no obvious soft areas and relatively level; however, it appears to my limited perspective that some of the floor joists were not bearing on the wood beams. I suggest all of the joists be inspected and shims added to ensure the joists are bearing solid on the intermediate wood beams.*

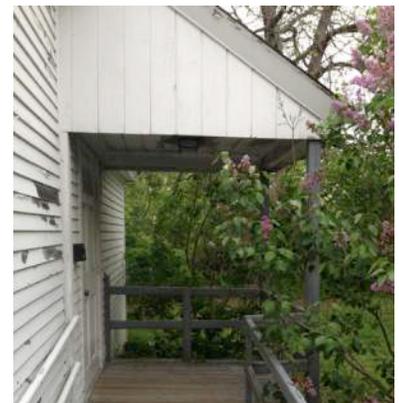
MH-2 Existing accessible entrance & cover

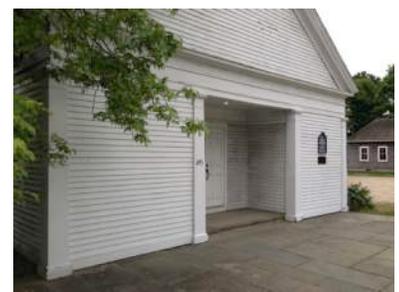
There is a large bluestone patio outside the main entrance on the western face of the main hall that extends virtually all the way to Main Street (MH-4). This is complimented by a blue stone landing just outside of the main entrance doors inside the "portico".

MH-4 Bluestone paving at main entrance

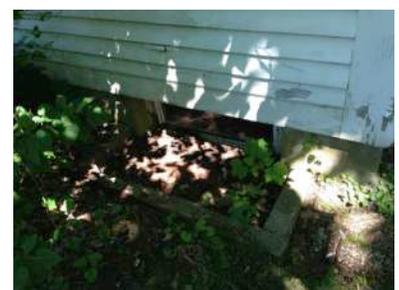
MH-5 Leaking basement window

The site is relatively flat with a gentle slope down from west to east just like the Chapel and School. Because the building is substantially longer west to east, the total grade change is significantly more (approximately 18") than either of the other two buildings on the lot. The fieldstone foundation under the older section of the building is barely visible at the west end (MH-3). This should be regraded to provide a minimum of six to eight niches of exposure. The field stone should be carefully repointed to minimize rodent access. The foundation under the kitchen addition is poured concrete and appears to be in good condition. However, the areaways at both basement windows should be cleaned out and drainage improved (MH-5).

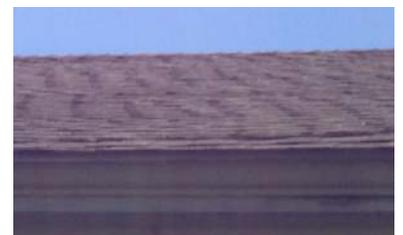
The roof is covered with asphalt shingles that appear to be in generally good condition (MH-8). There is, however, an area on the north side of the main roof where the sheathing appears distressed, however, the exact cause is not known (MH-9). The framing appears intact but displaced in this area so some repair to the top plate/girt may be required. The roof shingles and possible eave and soffit trim in this area should be carefully removed and the sheathing and framing repaired as required.

MH-8 Damaged roof area

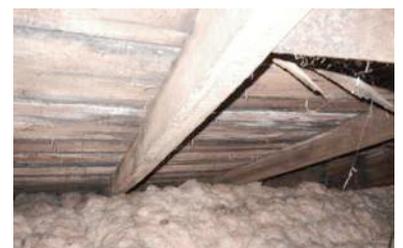
MH-9 Broken roof sheathing

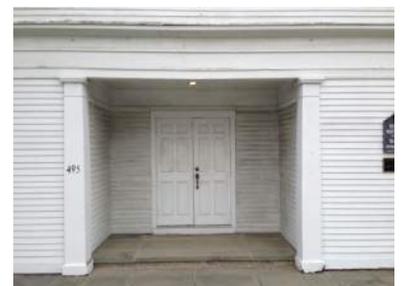
MM-10 Existing front door

There is a pair of six-panel exterior wood doors tucked inside a rectangular recess between the center two pilasters that serves as the main entrance to the meeting house (MH-10). These are in good condition but would benefit from a careful scraping, sanding and repainting. The hardware has a pull with a thumb latch, a single leaf is less than 34 inches wide, and there is a small step up to the landing from the patio, all of which makes the main entry somewhat inaccessible.

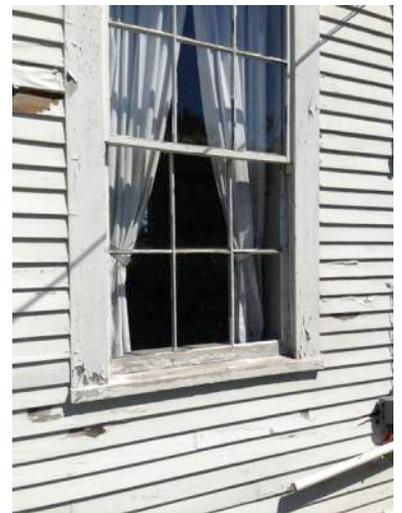
The windows are typically six-over-six wood double-hung units. The sash themselves are generally in fair condition, but the glazing and paint have failed nearly completely (MH-12). All of the windows should have the glazing removed, the sash scraped, sanded, and primed. The glass should be reset and the windows entirely reglazed and repainted. New or salvaged blown glass should be used to replace any broken or missing panes. Be sure to match the color and optics for the best fit. Full height stops screwed into the frame provide a clean method for fixing the upper sash in place.

MH-12 Existing window

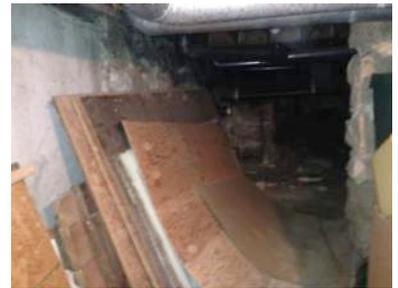
*The foundation wall of the original building appears to be a stone wall while the rear addition has a cast in place concrete wall (MH-13). There were no obvious signs of cracking of the foundation or the interior wall finishes that would be indicative of ongoing foundation settlements. Therefore, it appears that the foundation is adequately serving its current use.*

MH-13 Existing basement (conc foundation @ left with fieldstone foundation @right & beyond

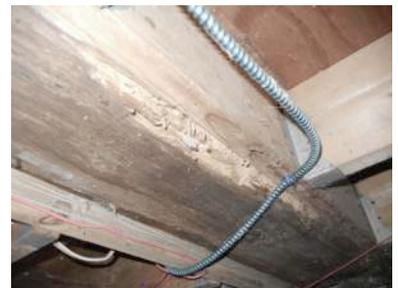
- *The attachment of the new ledger to the original wood beam.*
- *The extent of damage to the original wood beams.*

MH-14 Existing first floor framing repairs

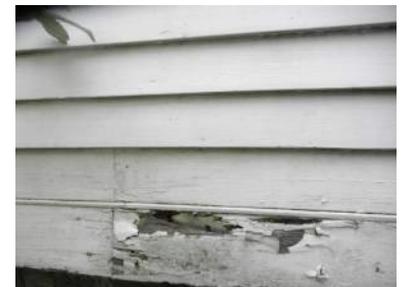
MH-19 Insect damage

*structure. The current extent of damage cannot be determined without further investigation and selective demolition*

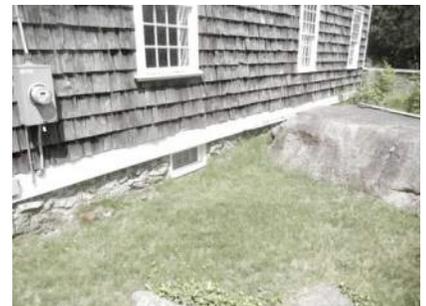
FT-3 East wall bulge behind granite boulder

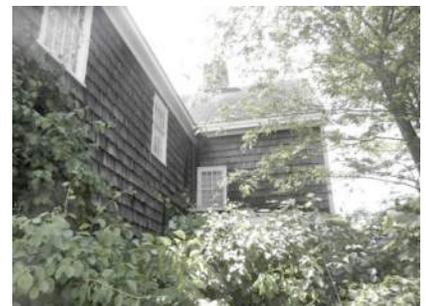
FT-4 Overgrown northwest corner

completely overgrown. This surely contributes to the moisture in the basement and this condition should be corrected.

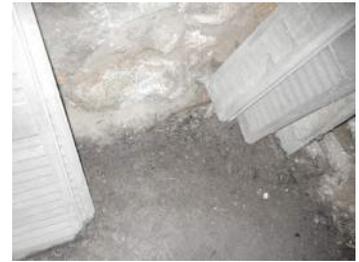
The cellar is quite damp, and while access to the crawl space was not possible, it is likely that surface runoff is also entering that space. Without sounding like a broken record, stopping moisture from entering the building is the most important goal for preserving historic buildings. Regrading the perimeter or even installing a perimeter drainage system would help manage the surface water. Gutters and downspouts, if maintained properly, do a wonderful job of this. There is a wooden bulkhead door at the front of the west side that is in good condition.

FT-5 Corner of partial cellar

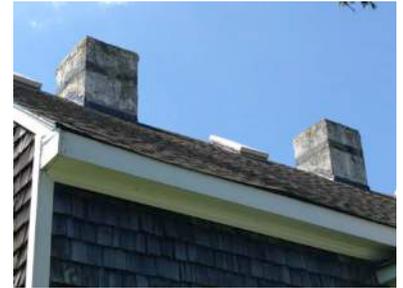
Both the roof on the main house and the ell are covered with asphalt shingles that appear to be in good to fair condition. Currently there are no gutters or down spouts. There are three roof hatches located near the ridge of the north side of the roof. There are two large masonry chimneys located on the ridge of the main roof and one located along the ridge of the ell roof. All three of the chimneys have been painted white with black bands (sometimes referred to as Tory Chimneys), but the paint has worn away.

FT-8 Painted brick chimneys

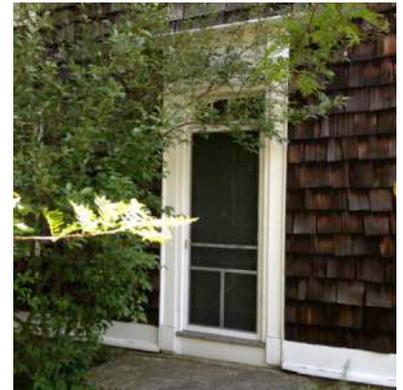
There are three entrances to the Fearing Tavern. The most important is the south entrance with its elaborate split pediment and sidelights. This entrance leads to an elegant central stair hall. There are also two additional entrances, one on each side of the ell. The entrance on the west appears to have been the tavern entrance, and the one on the east side appears more like a kitchen entrance located adjacent to the well and old herb garden. The sill of the kitchen entrance is badly rotten and requires replacement. The sill underneath should be inspected and repaired, if necessary, as part of this work.

FT-9 West entrance

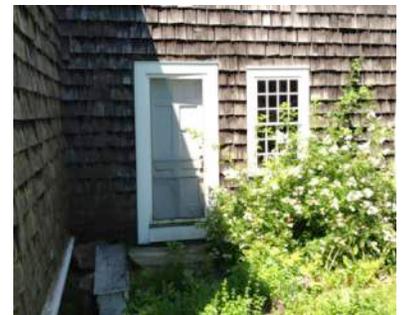
FT-10 Kitchen door

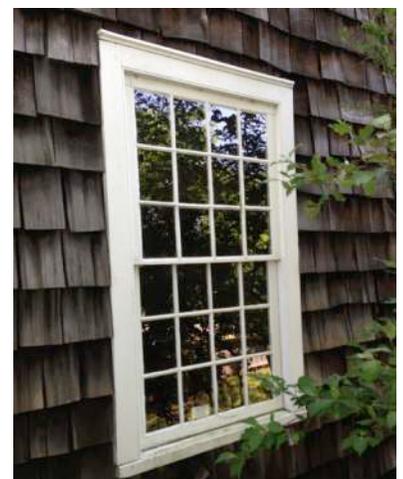
The windows on the main house are 12-over-12 double hung wood windows, a signature detail of Georgian houses. They are in generally good condition, but require at least some glazing repair and repainting. There are several pintles (pieces of earlier hinges), still visible at some of the windows, evidence that shutters were once installed, though no shutters are currently in use. Consideration should be given to reinstalling these wonderfully efficient elements of historic climate control.

FT-11 Typical 12-over-12 window

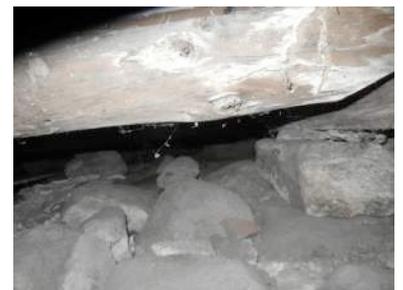
*The basement is limited to a small area in the front of the building (FT-16). The basement was damp and the wood framing had signs of insect infestation and decay due to moisture, the framing noted in the basement has undergone various reinforcements and changes (FT-14&15).*

FT-14 Floor framing at crawl space access

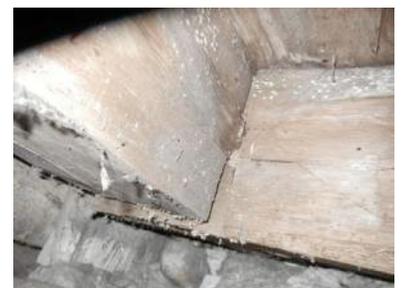
FT-15 Floor framing connection

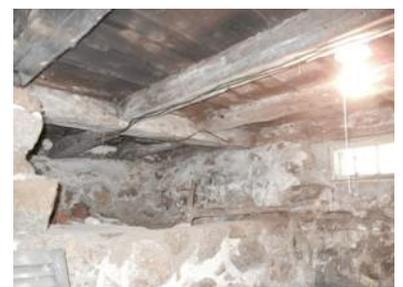
FT-16 First floor framing

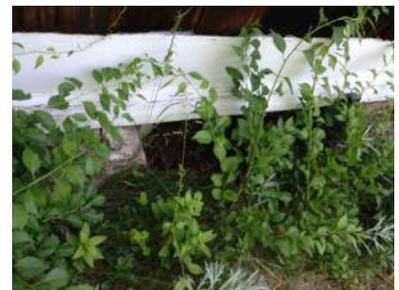
FT-19 Overgrown cellar window

- *All overgrown plantings be cut down to expose the exterior to reduce the possibility of future decay due to moisture and insect infestation (FT-19).*
- *The gutters appear to have been taken off the house. I suggest a drainage bed and possibly a perforated pipe be installed around the perimeter to collect and dispose of surface and roof rainwater off site.*
- *A basement drainage system with a sump and ventilation system be considered in the basement to reduce the moisture levels and reduce the possibility of future rot and decay due to water and insect infestation.*
- *An exterminator inspect and treat the property periodically to inhibit insect and rodent infestation.*
- *I suggest the sag in the 2nd floor be investigated further by a qualified Contractor who can selectively remove and replace interior historic finishes and determine the cause of the sag and possible repairs.*

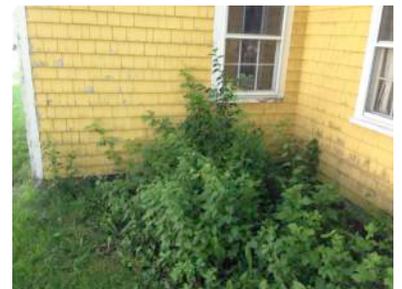
KH-2 Overgrown foundation plantings

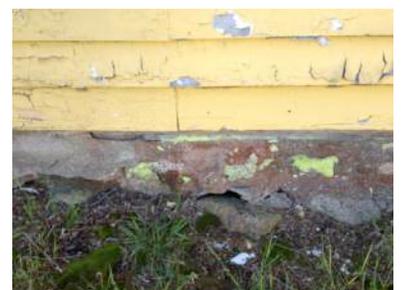
The foundation of the rear ell is fieldstone and requires some repointing and gap filling (KH-5). This should be checked regularly to prevent rodents from getting inside the house. There is a plywood bulkhead door on the southwest side of the main house. While the location may be quite old the material choice, plywood, does not integrate well with the rest of the

KH-5 Fieldstone foundation needs selective repointing

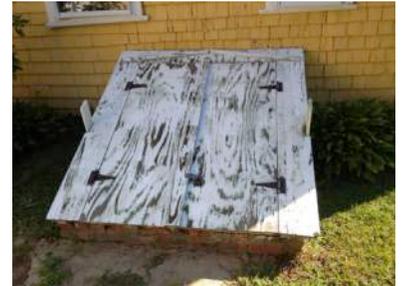
KH-6 Existing bulkhead door

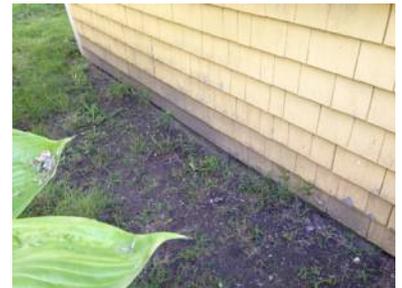
The grade along much of the ell is only a few inches below the siding and even more of the foundation is overgrown with vegetation (KH-7). This condition is not good for the framing and certainly contributes to water infiltration into the cellar and basement.

KH-7 Low clearance between grade & siding

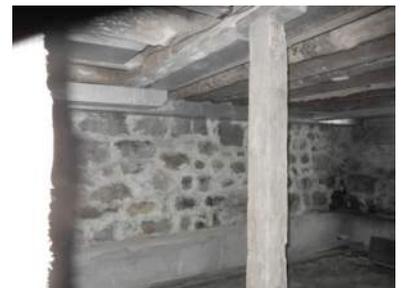
The basement is quite damp and there were pools of standing water visible (KH-8). The dirt floor is covered with small pieces of polyethylene covered with Homosote panels that are completely saturated with water. This should all be removed and replaced with large sheets of heavy, 10 mil poly covered by a few inches of pea stone or  $\frac{3}{8}$ " river rock.

KH-8 Existing basement

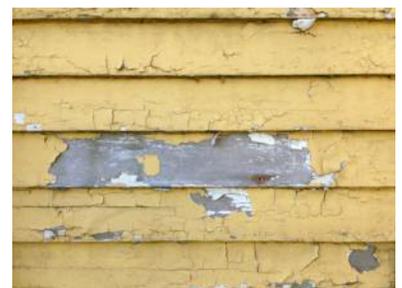
The walls of the main house (except for the rear, or west side) as well as the north and east sides of the ell are covered in clapboards and painted. The remaining faces are covered with painted wood shingles. The paint on most of the siding is in very poor condition. There are several locations where the paint is peeling off in large flakes. While in fair condition, most of the wood trim is also generally in need of repainting (KH-9).

KH-9 Failed exterior paint – typical

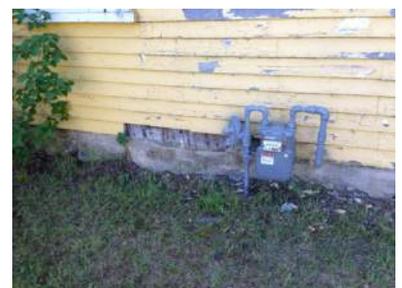
There is a small area on the north side of the main house where part of a clapboard has broken away and the sheathing is now exposed to the weather (KH-10). There are also areas where the nails have failed or the sheathing is no longer able to hold fasteners. The siding should be carefully checked and repaired as appropriate. All of these conditions should be repaired to prevent further water infiltration. There is also a newer patch on the south side of the ell where the shingles have been replaced (KH-11). There were apparently some framing repairs performed in this area in 2007 after a portion of the wall failed.

KH-10 Missing clapboard

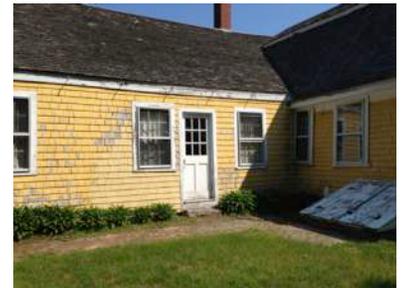
KH-11 Siding patch on ell

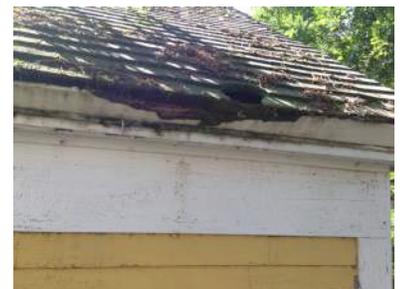
There are several instances where the existing trim is missing, broken or damaged. In a few of these locations, it appears that rodents have made the most of it by making themselves at home in the eaves, attic and walls

(KH-12). These areas should be repaired and an exterminator consulted to prevent future investigations.

KH-12 Rodent damage at rotten trim

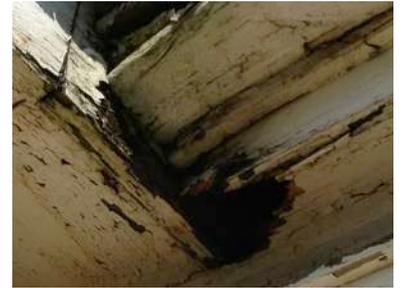
There is a small entry vestibule on the east side of the main house approximately four feet deep and eight feet wide with one four-over-four wood double-hung window on each side. It is covered with a finely proportioned pediment and gable roof. Some of the trim is in very bad condition – rotten and victimized by rodents (KH-16). All of the damaged trim should be repaired or replaced.

KH-16 Rodent & water damage

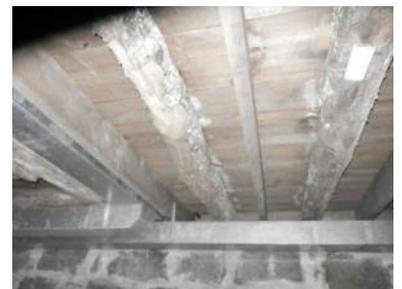
*The main house perimeter foundation wall and the center chimney/ floor support structure have been reinforced with new cast in place concrete (KH-18). I suspect that water infiltration damaged the original building foundations, creating an unstable condition and a need for new reinforcements. Also, the basement was very damp, mold was evident and there were signs of past insect infestation and damage to the existing wood framing (KH-19). I suspect that replacement of foundation sill plates, wall framing, and other decayed framing was required and performed during the foundation reinforcements, most likely these conditions were the primary cause of noticeable settlements.*

KH-18 Existing framing with reinforcements

*Assuming the cause for the settlements has been addressed and repaired, I suggest the basement carpet/flooring be removed, an under slab drainage system with a sump and a ventilation/dehumidification system be installed to reduce the high level of humidity and moisture in the basement. Also, the floors, roof, ceilings, and walls should be inspected periodically for signs of ongoing movement, e.g. cracking finishes, poorly*

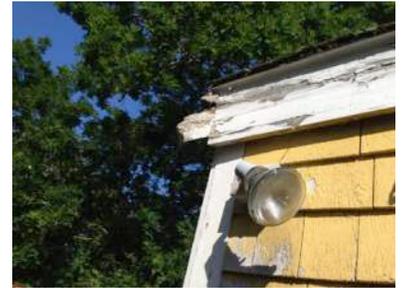
KH-20 Rodent damage at trim

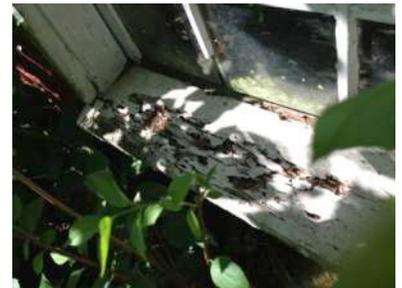
KH-21 Insect damage at basement window sill

*I suggest a qualified exterminator inspect the property on a periodic basis for signs of active insect infestation and treat the property as required reducing the possibility of infestation. Also, I suggest a qualified contractor/carpenter review the as-built framing to make specific recommendations for permanent supports to replace the as-built temporary members.*

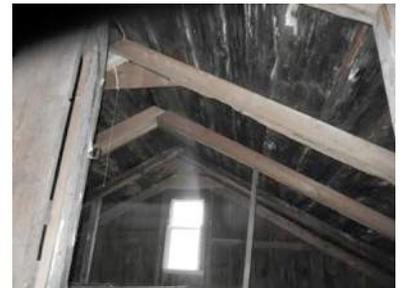
*I noted several original roof rafters have been reinforced with new rafters sistered along side the existing decayed members (KH-22). The existing*

KH-22 Existing roof framing

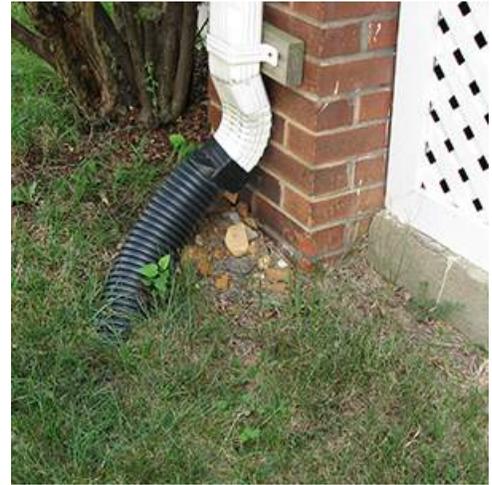
**Figure 17.** Extending downspouts at their base is one of the basic steps to reduce dampness in basements, crawl spaces and around foundations. Extensions should be buried, if possible, for aesthetics, ease of lawn care, and to avoid creating a tripping hazard. Photo: NPS files.

- Reset splash blocks at the end of downspouts or add extender tubes to the end of downspouts as necessary (Figure 17).
- Lubricate operable foundation vent grilles to facilitate seasonal use; paint as needed.
