Conditions Assessment & Feasibility Study

Tremont Nail Factory

Wareham, Massachusetts

June, 2009

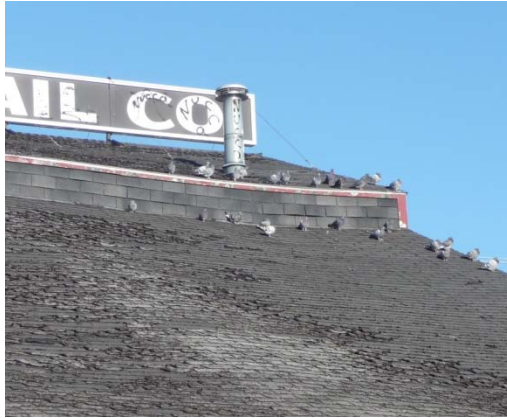
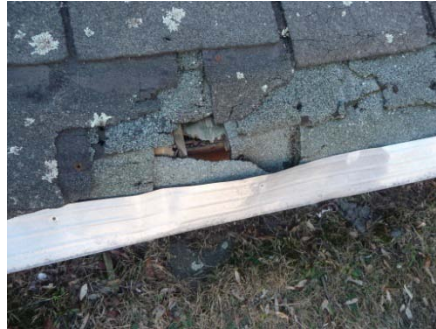
The gable roofs are covered in three-tab asphalt shingles in *poor* to *fair* condition. Roof sagging is seen on the north elevation of the main building, where the shingles are in *poor* condition with the exception of those in the repaired sections, which are in *fair* condition. The south elevation of the main building exhibits similar shingle conditions and an undulating profile. Shingles on the west ell are in *poor* condition; exposed flashing is seen in several locations. Shingle condition ranges from *poor* to *fair* on the south ell. The rubber roof on the east ell exhibits areas of repair and is in *good* condition.

The cupola on the ridge of the main building gable, which has rotated and leans to the right, appears to be in *fair* condition. There are two shed dormers on the south roof elevation. The roof signs and lettering ("T and N") on the west elevation are in *good* condition. The chimney on the west ell is in *poor* condition; it should be rebuilt and repointed at the top. The timber supporting the roof overhang at the doors facing Elm

Street is in *poor* condition and should be removed or replaced. The wavy roof line on the east side of the south ell suggests a framing inadequacy.

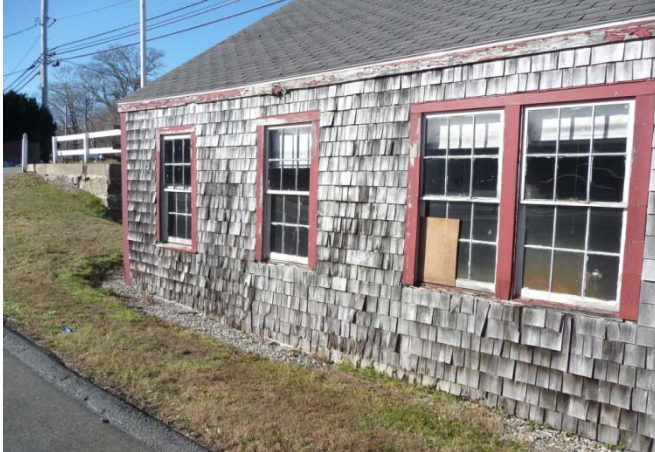
Exterior walls of the building are cedar shingles left to weather. As would be expected, the lower courses are subject to maximum wear and tear and water infiltration and are generally in worse condition than the upper courses. On the north elevation of the main building, the shingles are in *good* condition at the top and *fair* condition nearer the bottom. Shingles on the south elevation of the main building are in generally *poor* condition, with advanced deterioration due to run-off at wall intersections with the south ell. The east and west elevations of the main building have shingles in *poor* to *fair* condition.

Shingles on the east ell are in *fair* to *good* condition, with the most damaged shingles near the damp northeast corner at the bank. Shingles on the west and south ells are in *poor* condition.

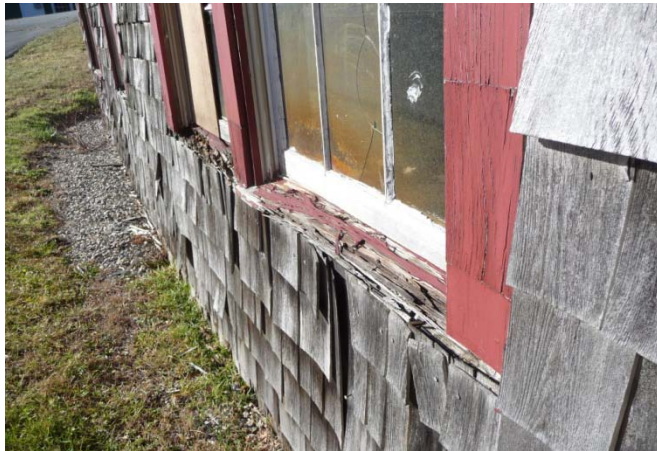
The wood trim on the Nail Factory Building ranges from *poor* to *fair* condition, with the exception of spot trim repairs and the trim on the north elevation of the main building, which has been replaced and is in *good* condition. There is significant wood rot in many locations, particularly at sills. All the trim should be repaired, or replaced if necessary, and repainted.

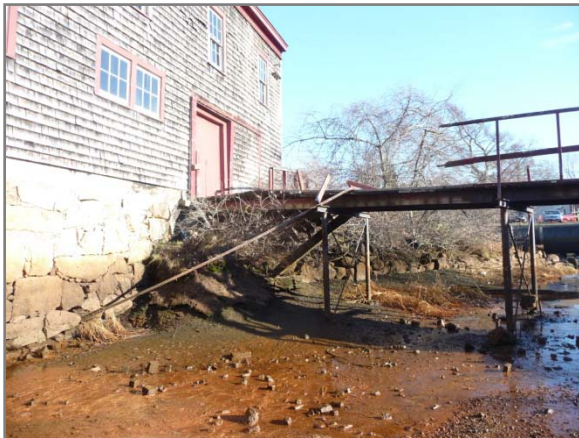
The building's foundation is not generally exposed on the building's exterior. An eight-foot rubble foundation rises from the runoff pool on the east side of the main building's south elevation. A cracked slab foundation is seen at the southwest intersection of the main building and south ell. The foundation visible from the exterior is in *fair* condition.

A trench for water diversion runs around the south and southwest sides of the building along the foundation wall. Two bridges – one concrete, the other wooden – cross water culverts to connect the factory building to the land surrounding the Pickling Building. Both bridges are in *poor* condition and should be removed.

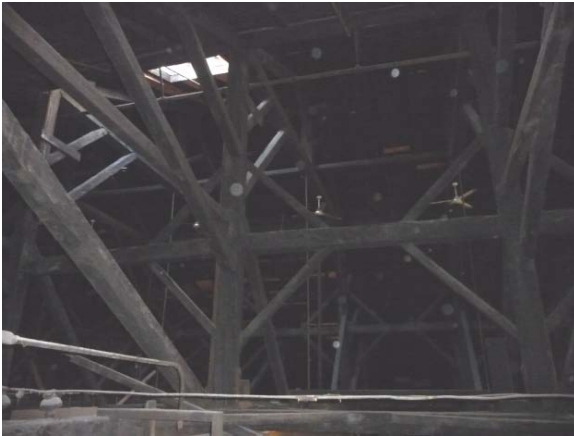
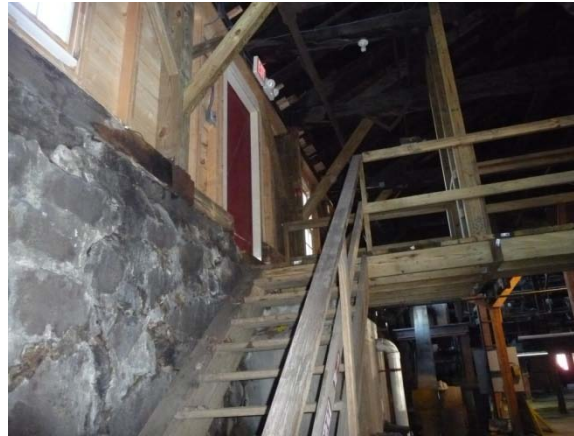
The main factory space is a large, high, open mass with heavy timber post and beam framing; all framing is exposed. Rows of timber columns line the room. Some trusses have been reinforced with steel beams; trusses on existing posts at the exterior wall are only partially bearing and should be replaced or reinforced. Wall sheathing is 1x plank, which is not individually adequate to provide lateral stability for conventional structures. The heavy timber and steel framing of the Nail Factory structure would need to be studied further to determine whether the plank sheathing should be augmented with plywood sheathing. Sheathing on the south wall is damp and shows mold. Roof sheathing is 1x plank in *poor* to *fair* condition; damaged portions should be replaced in kind so the historic appearance of sheathing is visible from inside and below.

Wooden catwalks and open tread stairs that provide access to nail-making equipment are in *poor* condition; the catwalks should be removed or reinforced and the access stairs removed. An open stairwell linked to the catwalks exits at the Elm Street roadway. The sill, with the exception of the portion over the culvert area on the south side, does not appear to have been properly attached to the foundation. In-fill walls and sills appear to be in *good* condition.

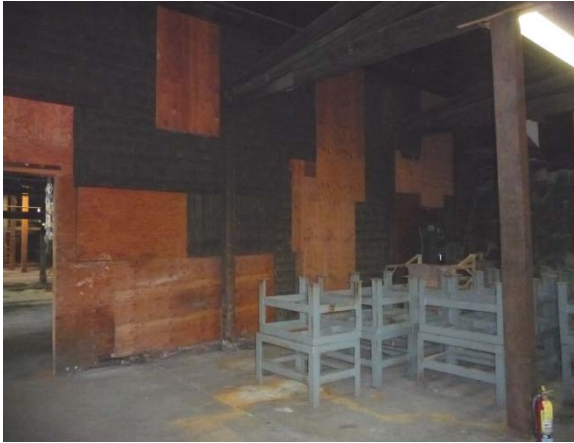
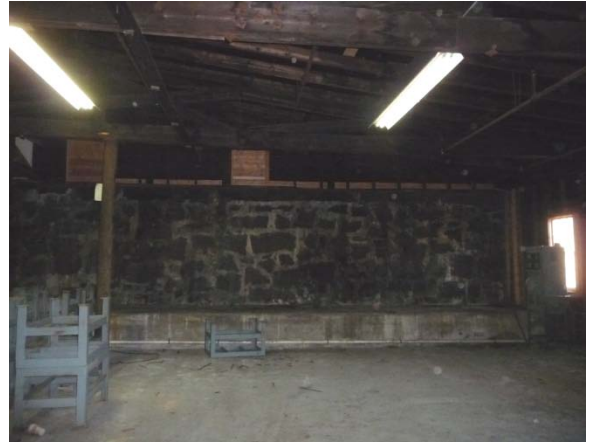
The shed-roofed addition at the east side of the building has 2x6 rafters and 2x4 stud walls. Posts and headers supporting the roof framing are inadequate and should be replaced with appropriately sized members. There is a row of three columns down the center of the room. The sill is in *poor* condition and does not appear to be connected to the foundation wall. Wall sheathing is 1x board

planking and beadboard; roof sheathing is 1x board planking. The original shingled exterior load-bearing wall separating the room from the main factory room is in **poor** condition and should be stabilized and then reinforced.

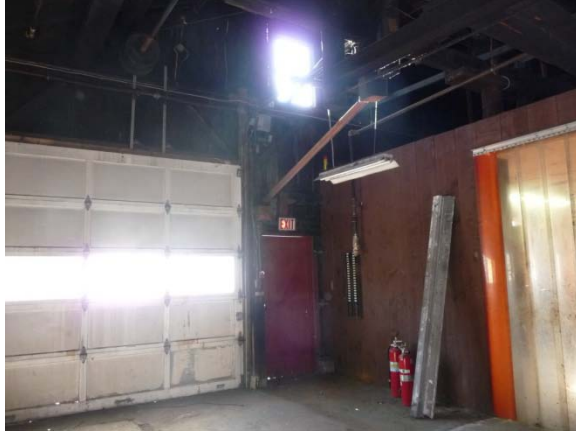
Room 104

This space, part of the original gable-roofed ell, comprises a hall joining the main factory area with the exterior through a garage door. The west wall is in *poor* condition. The slab concrete floor is in *poor* condition, with cracks and portions missing.

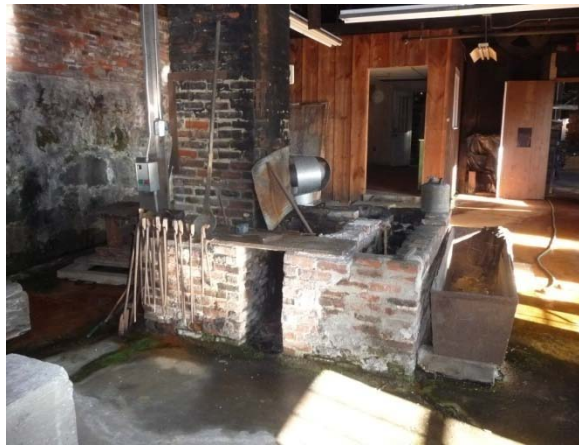
Room 107

This room comprises the west ell, which joins the main factory room at its northwest corner. The bank built north wall has roughly 15 courses of brick over granite rubble. A water trough along the north and west walls is continuous with the trough in the main factory room. The west wall is post framed with horizontal beadboard; the south wall and ceiling are tongue and groove planks. A blacksmith forge and chimney occupy the center of the room.

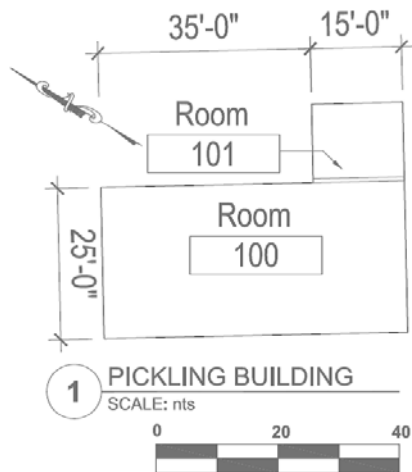
PICKLING BUILDING (SHEARING SHED), PRE-1896

The Pickling Building is a one-story, gable-roofed rectangular building measuring roughly 1,450 square feet in area with a monitor on the ridge at the south end. A small shed-roofed rectangular concrete block addition on the southeast corner measures roughly 15' x 13'. The building rests on a concrete block (CMU) foundation wall. The building has a concrete slab floor. The interior is largely open with exposed wall and ceiling framing.

The building has a weathered exterior but a relatively watertight interior.

End any uses of the building for storage and supplement existing structure with rough framing and diagonal bracing. Make necessary envelope repairs and repair windows and trim. Maintain envelope until time suitable for Step 2.

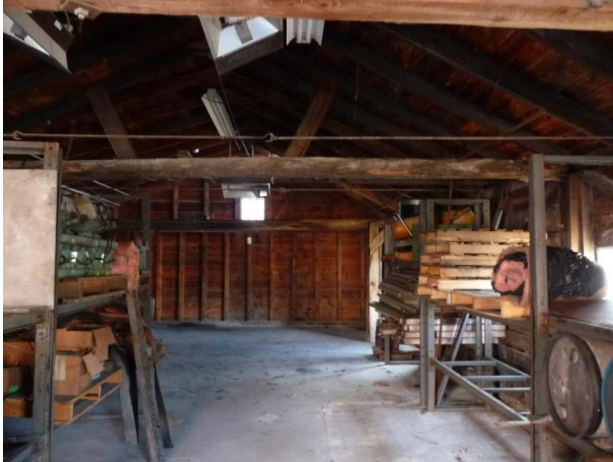
Room 100

This room contains machinery, storage furniture, manufacturing supplies, and control boxes. The open-framed room shows no visible leaks.

The room is stick 4"x 4" framing with diagonal bracing, 3" x 6" rafters, and tongue and groove roof sheathing. The condition of the framing is generally *poor*. Please see the Coastal Engineering structural report for a more detailed description of condition.

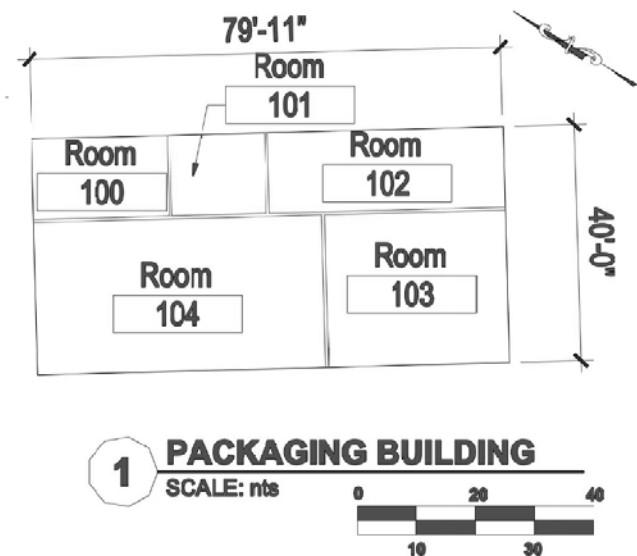
PACKAGING BUILDING (C. 1957)

The Packaging Building is a one-story, gable-roofed rectangular building measuring roughly 3,200 square feet in area. The building rests on a concrete block foundation wall with up to three courses of blocks exposed at the lowest grade. The building has a concrete slab floor on two levels with a transiting concrete slab. The interior is divided into five rooms.

The building exterior is in relatively good condition. The interior finishes are simple and show accumulated wear and tear reflecting the factory use, but are intact.

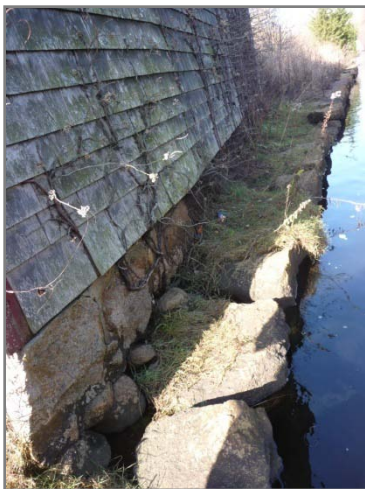
Along the river elevation the foundation is also the stone bulkhead along the Wankinco River and can be seen as a collection of massive, rough-faced granite blocks rising out of the water. The bulkhead continues north to the Factory building. The foundation is in **fair** condition with some reconstruction required at the stacked stone protecting the south toe of the bulkhead adjacent to the public river access. Some stones of the retaining wall have been displaced and no mortar is visible in the joints of the stone.

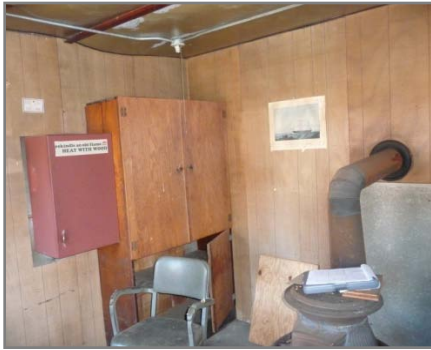
Room 100

This small room contains sprinkler valves, control boxes and a cast iron heating stove. It is a box within the larger open space of the Freight Building.

The room is stick framed with horizontal bead-board cladding on the exterior and a combination of press-board paneling and drywall on the interior and ceiling. The framing appears to be in *good* condition.

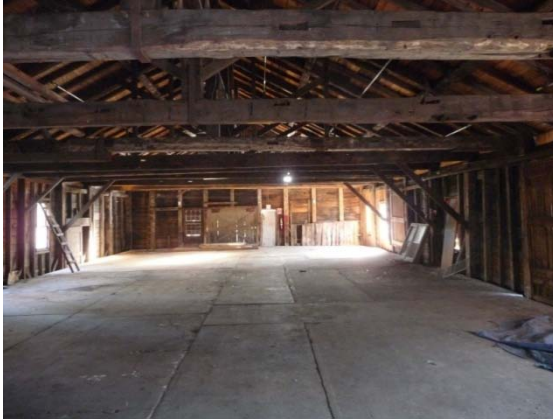
Room 101

This large, open space fills the remaining volume of the Freight Building from slab to wall and roof framing. A short demising wall stands at about a third the width of the intersection between the long and short bays. A slender brick chimney outside Room 100 vents the cast iron heating stove.

Both sections of the Freight Building are heavy timber framed with stud and rafter infill between the timber bents. Purlins span between the timber trusses at both sections of roof. Some posts are rough tree trunks. See structural section for comment on conditions.

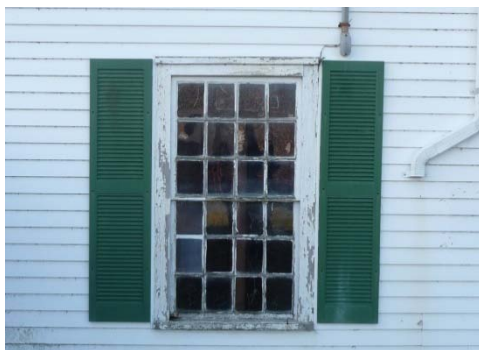
There are 12 window openings in the main block, including five twelve over twelve and five six over six windows. These windows, some apparently original to the building, are in **poor** condition and require sash repair, glazing and painting. The ell has 13 modern windows in **fair** condition with a variety of lite configurations. All windows are fitted with metal storms. Metal basement windows at the ell are in **fair** condition and are rusted and require paint.

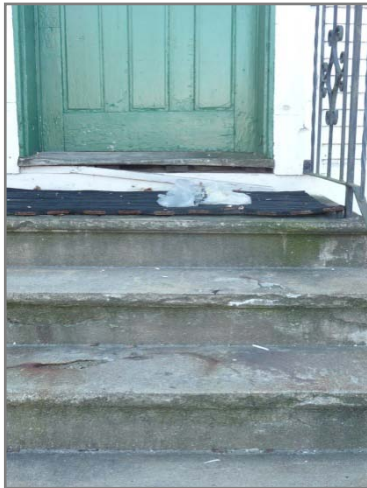
The concrete steps at the main entrance are cracked. Those at the north entrance to the ell have separated from the building. Both are in *poor* condition.

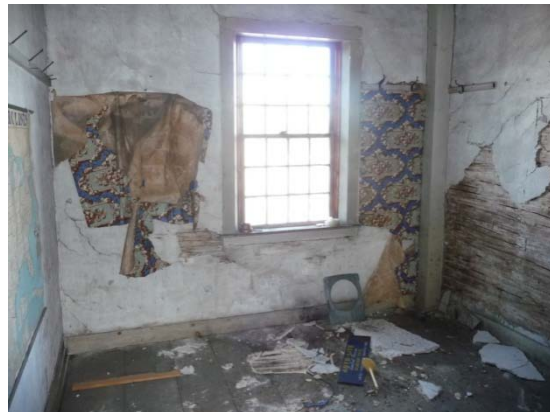
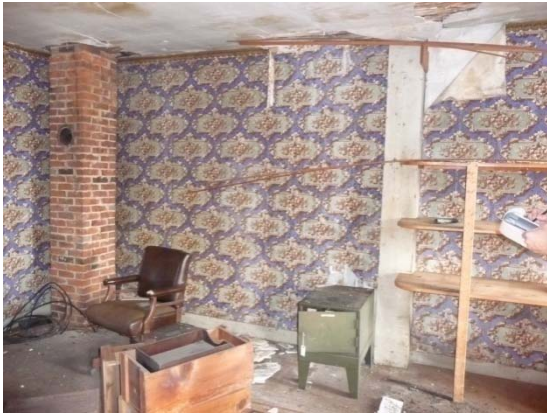
The unpainted wood floors are in BI condition. The plaster is in *poor* condition; approximately one-half of the wall and ceiling plaster throughout has fallen

off, revealing the lathe and cluttering the floor. Nineteenth century wallpaper, in *poor* to *worn* condition, covers much of the remaining plaster.

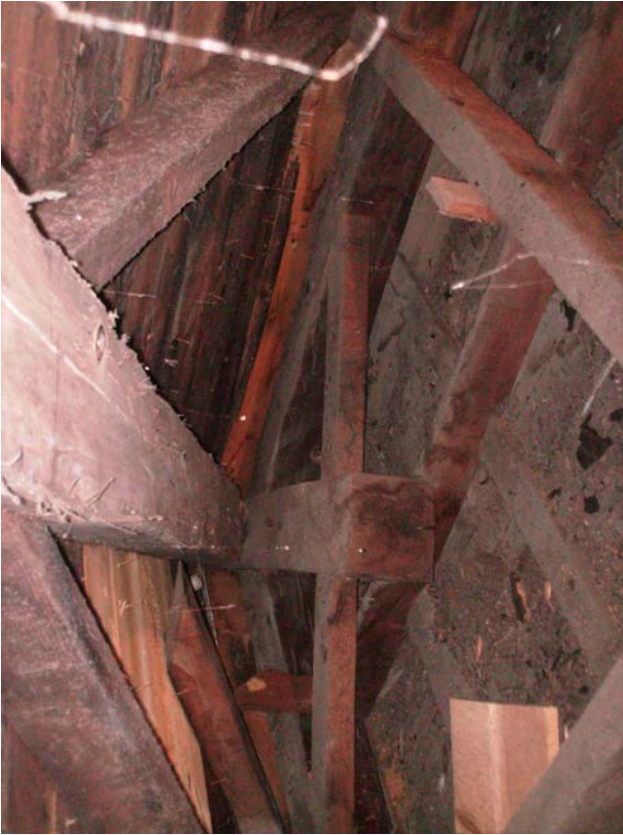
#1) Hip beam bearing on exterior wall (Note: Not all rafters attached to hip beam, proper connections should be provided.) (Office "A")

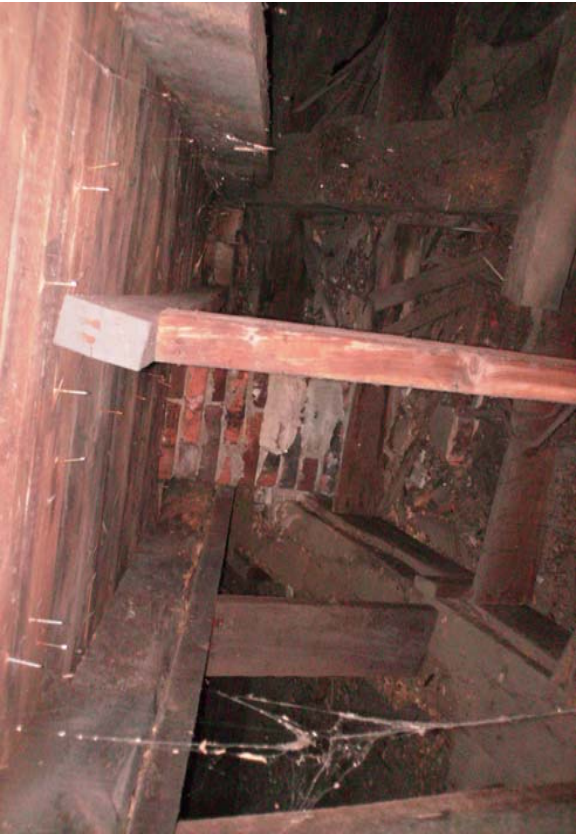
#3) An additional 2x rafter placed next to the chimney and supported with a post bearing on the ceiling joist (Office "A")

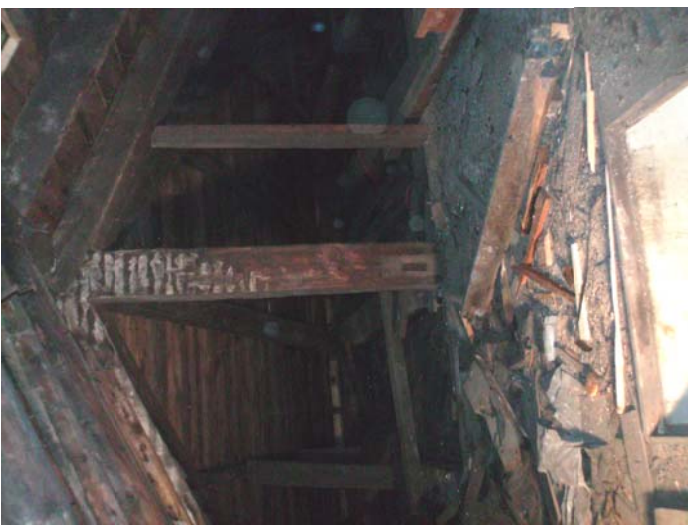
#2) Typical post support for the roof hip beam (Note the debris in the attic, which should be removed.) (Office "A")

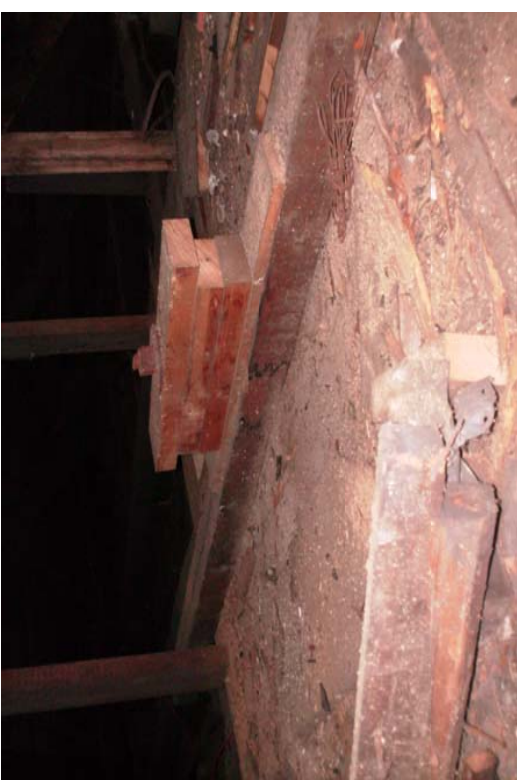
#4) 1x board w/(3) 2x4 blocking atop ceiling joist, centered in blocking is the steel rod that extends through the second floor. (Office "A")

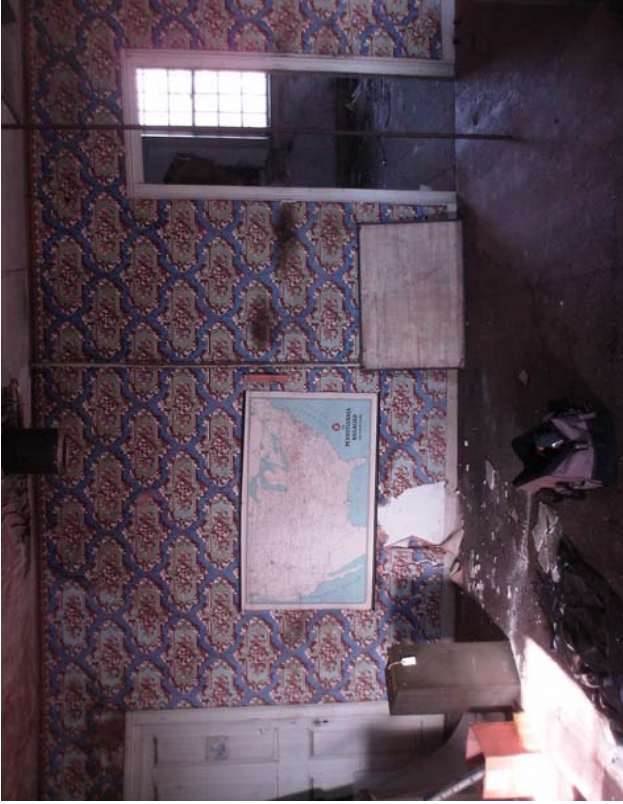
#5) Note the significant deflection of the second floor walls, with the low point at the intersection of all 3 partition walls. (Office "A")

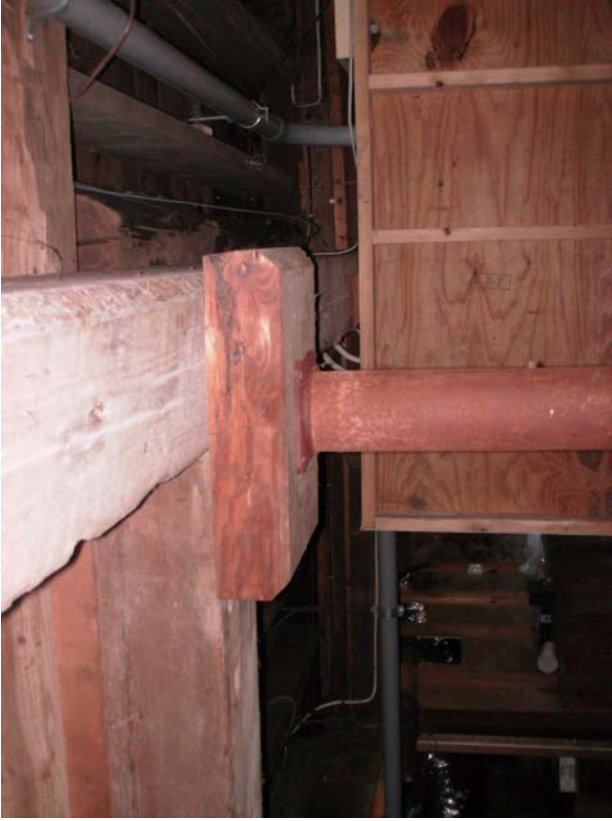
#9) Wood column "Capital" view atop steel lolly column. Note that the wood column cap is not mechanically fastened to the beams. (Office "A")

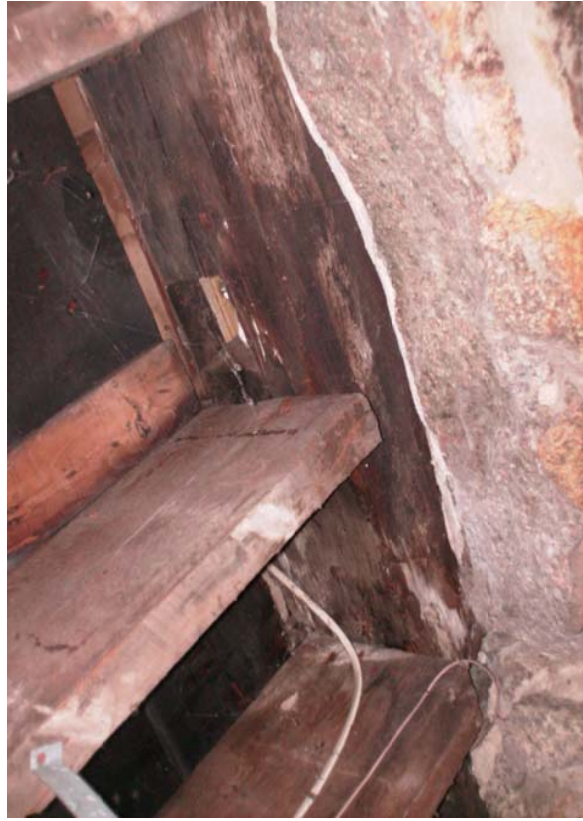
#11) Floor joist mortise and tenon into sill. Properly sized joist hangers to secure joists to sill should be used. (Office "A")

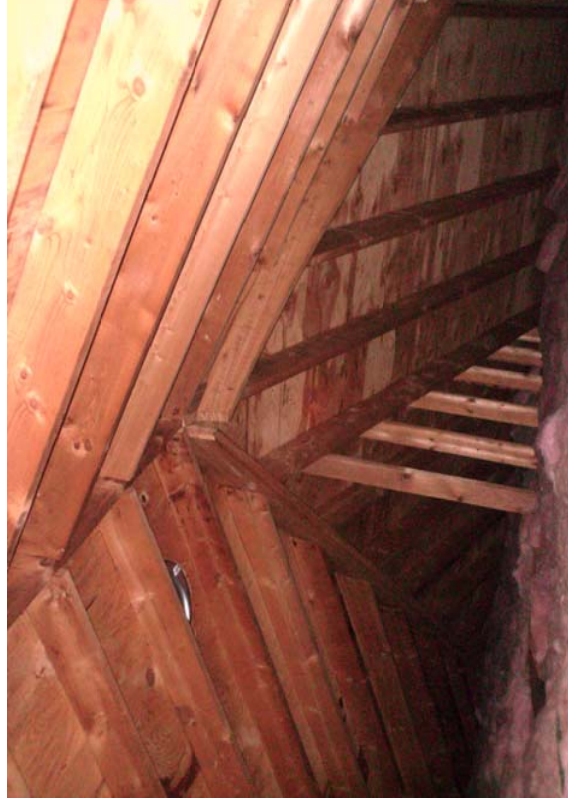
#12) Hip roof framing, using a hip board design and plywood roof sheathing. (Office "B")

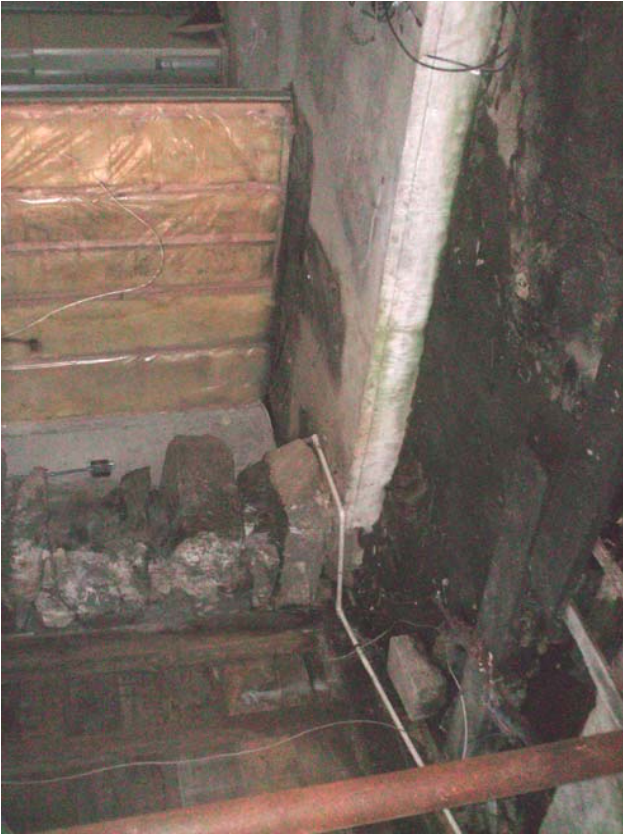
#13) Step in slab at transition between the new and original portion of the building. (Note the new portion has the higher slab elevation.) (Office "B")

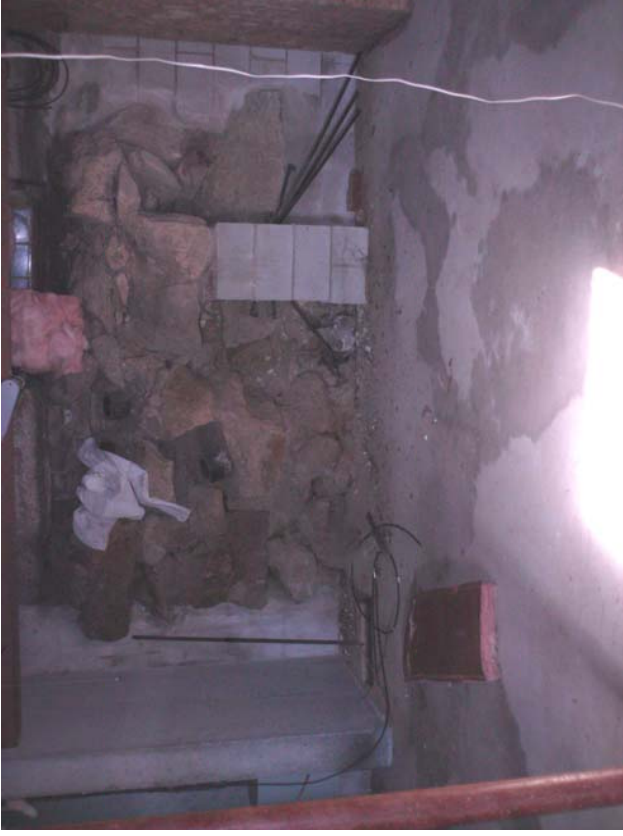
#14) Stone foundation from the original building protruding into the new building foundation. (Office "B")

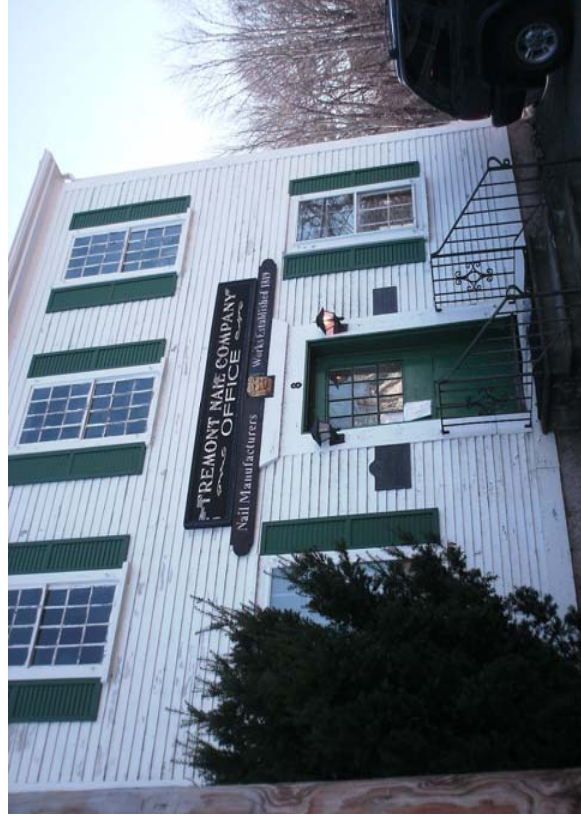
#16) Front of the original portion, the second floor wall at this level is leaning inward. (Office "A")

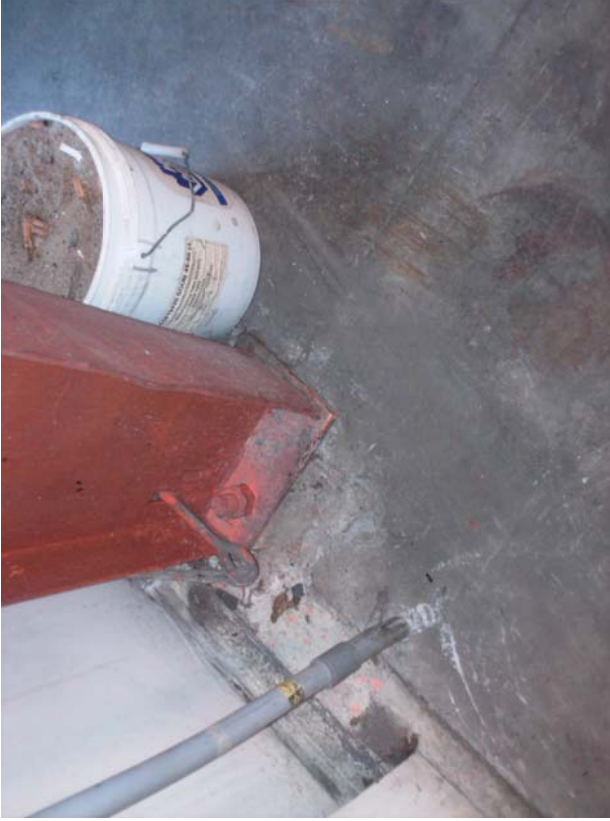
#17) Column bearing on pilaster and slab-on-grade with no leveling grout. Monitoring of pilasters should be implemented and grout placed under the columns. Also note that the cross bracing cable has been cut. (Steel Bldg.)

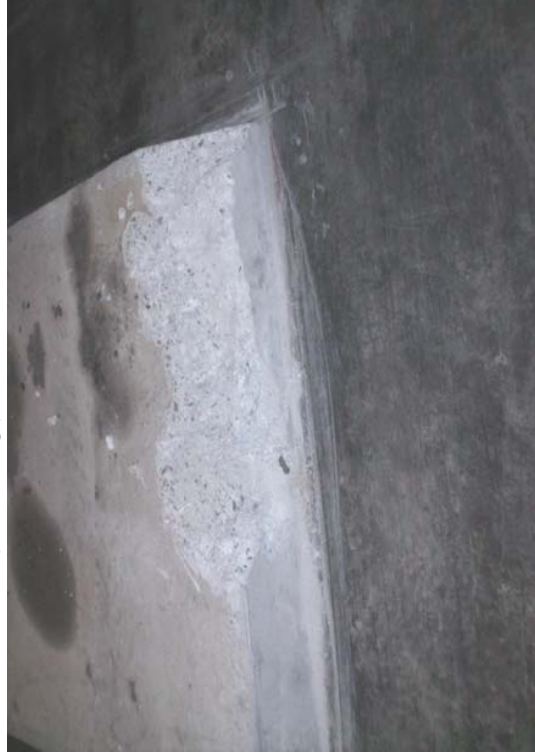
#19) Abandon housekeeping pad, appears to have been attempted to be removed. The pad should be removed as it is a potential tripping hazard. (Steel Bldg.)

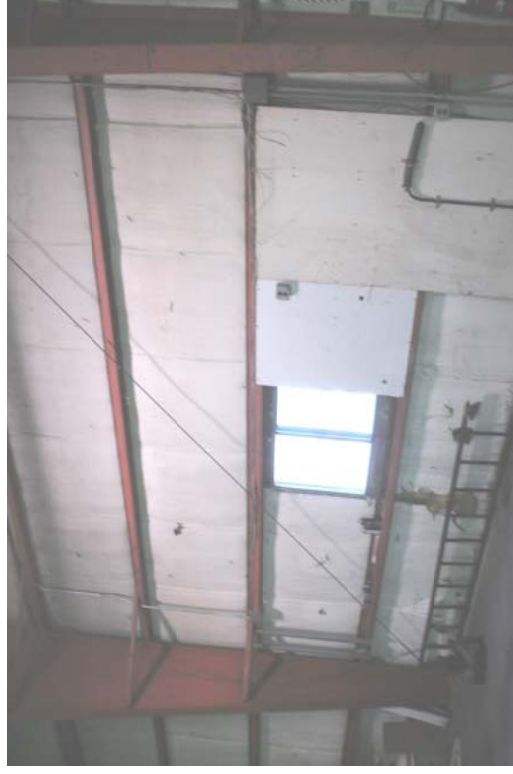
#20) Cross bracing in one direction is missing and should be replaced immediately . (Steel Bldg.)

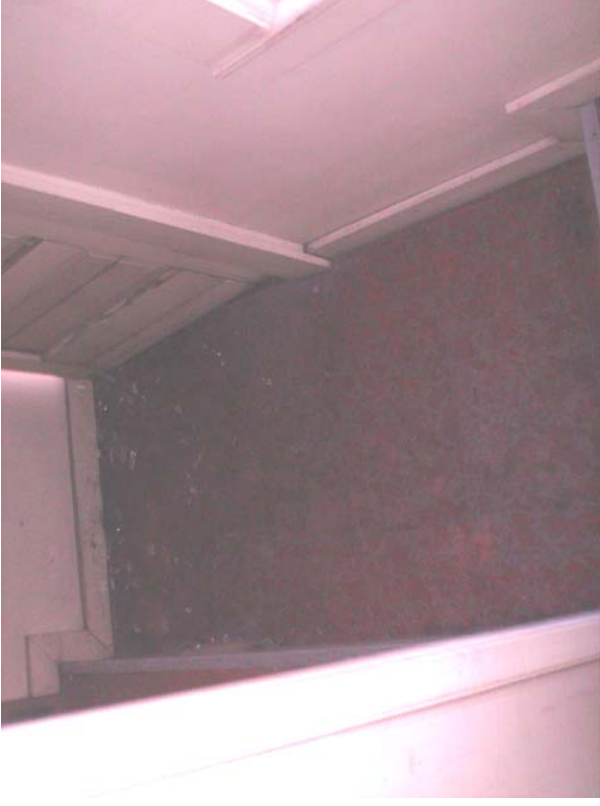
#22) Wood floor in the ladies restroom likely due to being placed after the building was constructed. (Restroom)

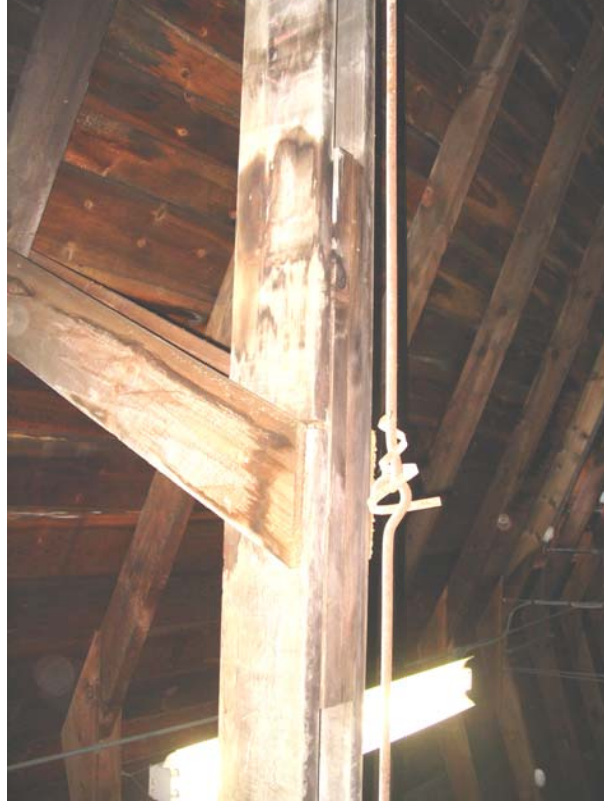
#27) Connection of steel tie elements (Note if tension seizes the ties would sag.) (Pickling)

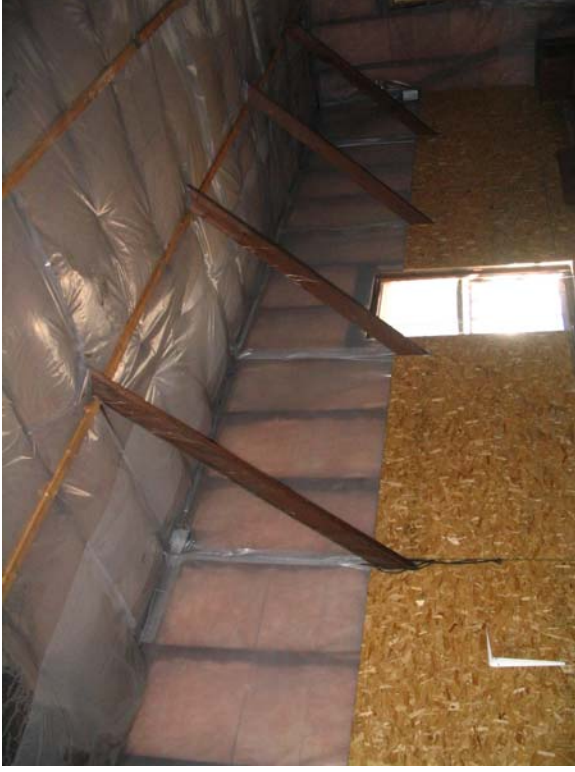
#30) 2x diagonal uplift tie to secure truss to wall. (Packaging)

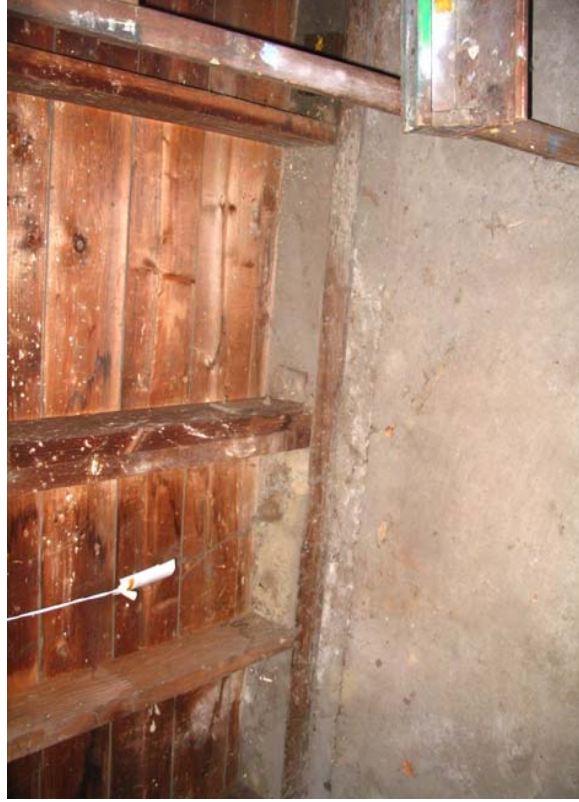
#31) Stud attached to sill w/steel angle. Sill appears to be in good condition w/little deterioration. (Packaging)

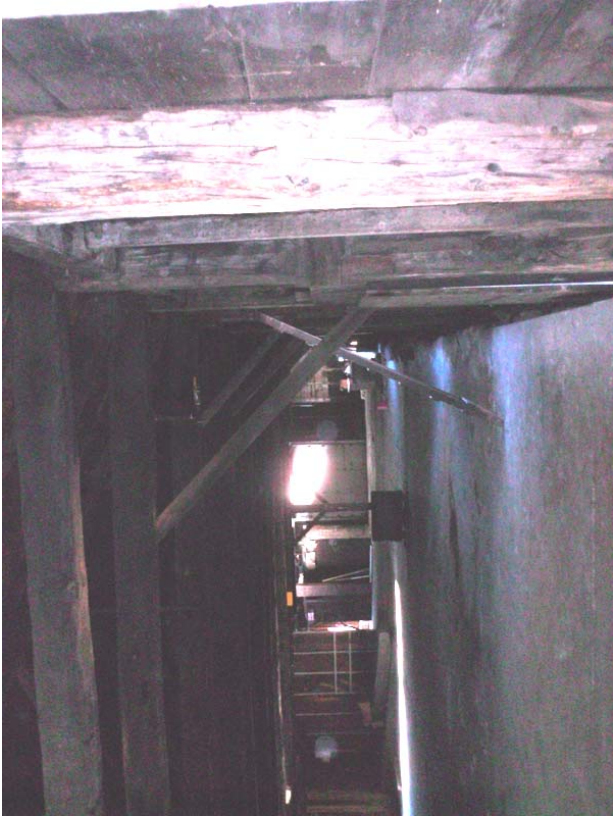
#37) Diagonal uplift ties at most trusses, Note that at some trusses these have been removed. (Freight "A")

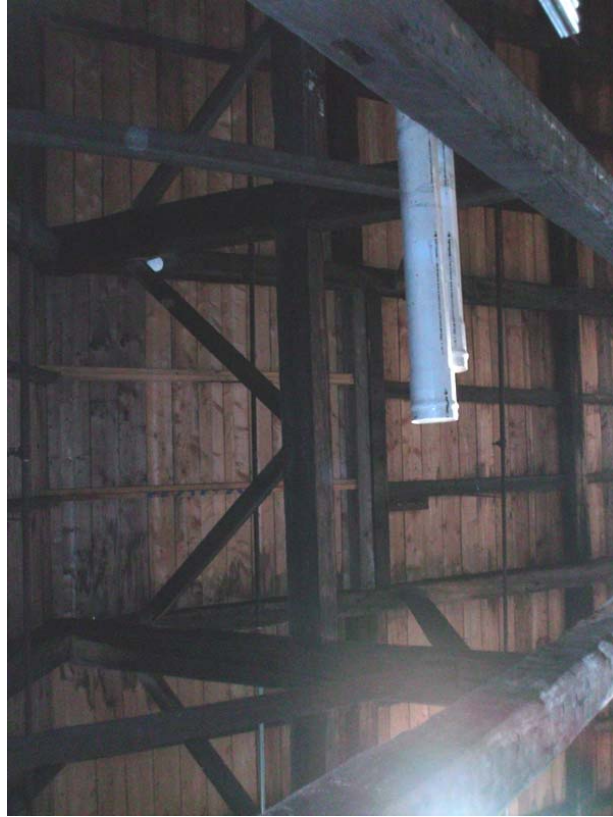
#39) Lateral bracing of the truss king post (Freight "A")

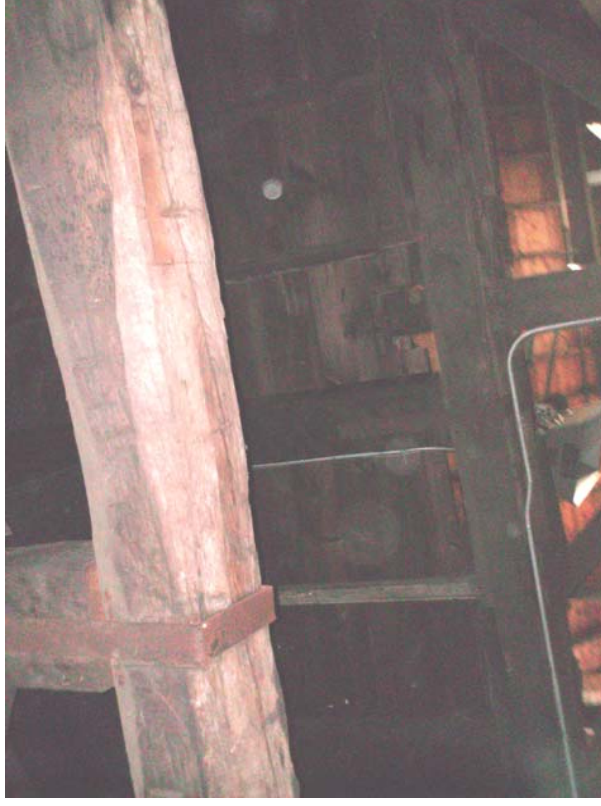
#44) Metal connector used to connect the king post to the bottom chord. (Freight "A")

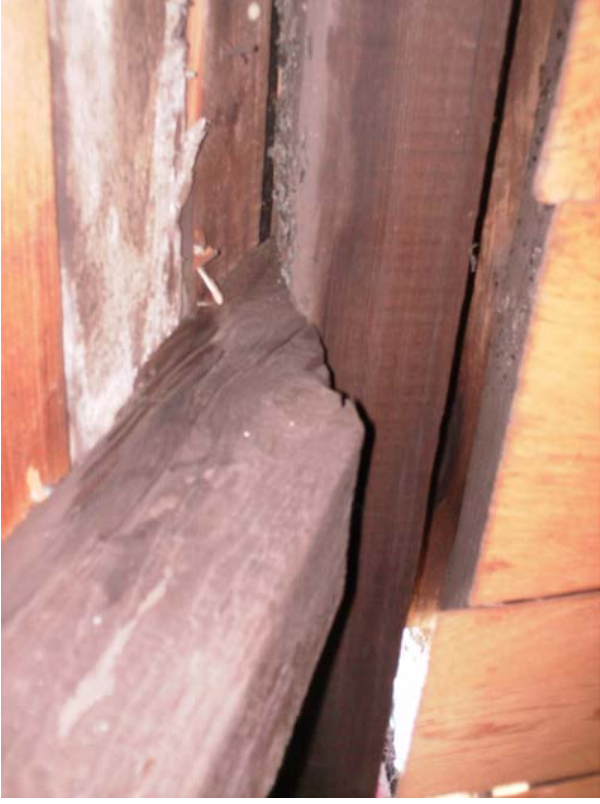
#46) The rafters bear on a 3"x5" beam spanning between trusses and provide limited bearing area for the rafters. (Freight "A")

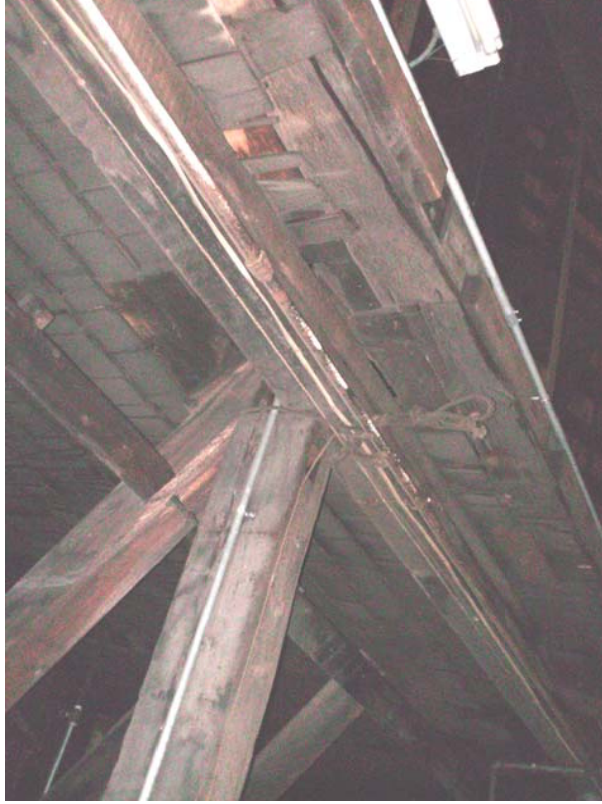
#47) The Timber frame roof support bearing on the bottom chord of the gable end truss of the original building. (Freight "B")

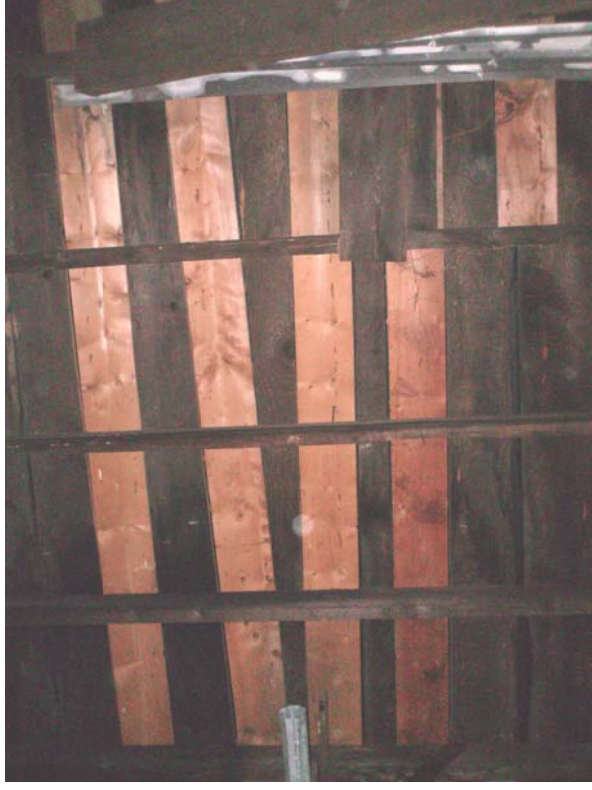
#48) Exterior building sheathing replaced in an odd pattern, for unknown reasons. (Freight "B")

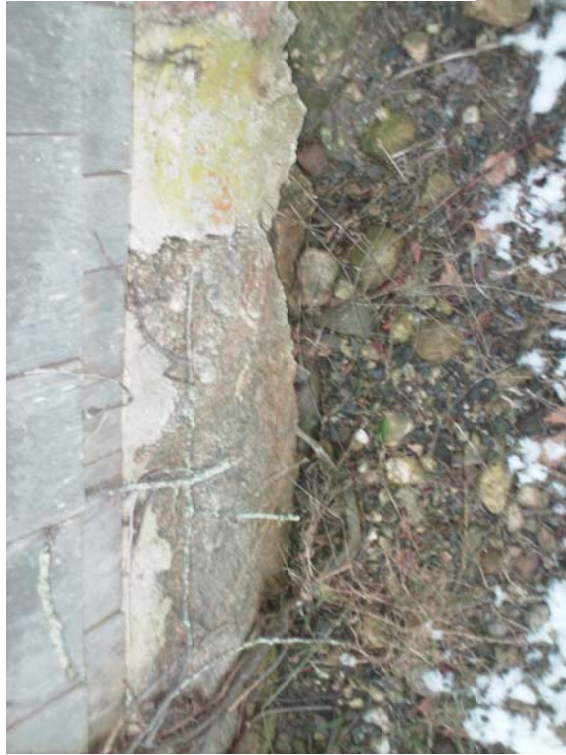
#52) Stone rubble foundation appears to be in good condition with some voids between boulders. (Freight "A & B")

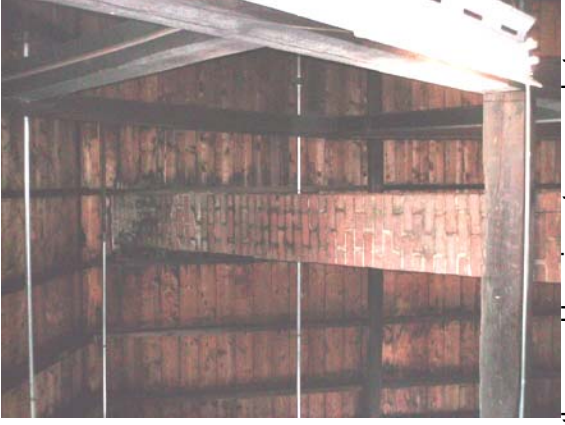
#51) The chimney for the wood burning stove needs to be repointed at the upper third. The bottom appears to be in good condition. (Freight "B")

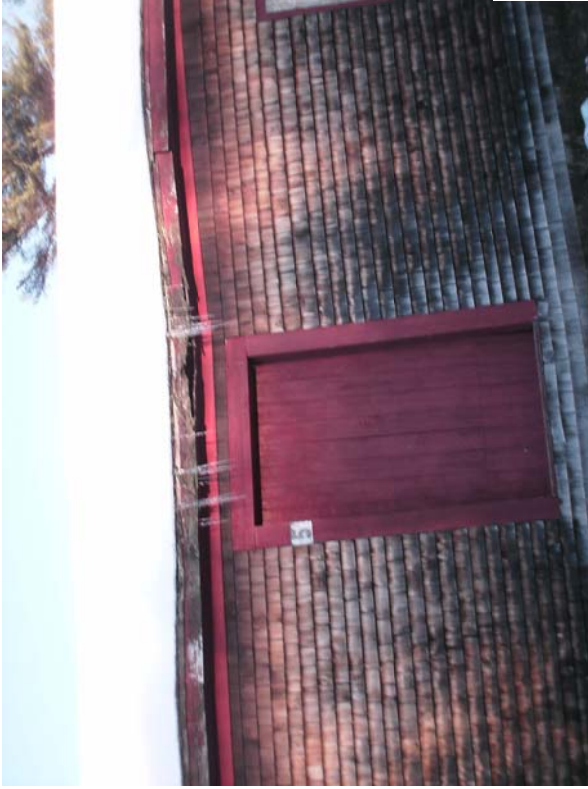
#54) Dip in roof at truck door #5, likely due to the deflection of the roof rafters and purlins (Freight "A")

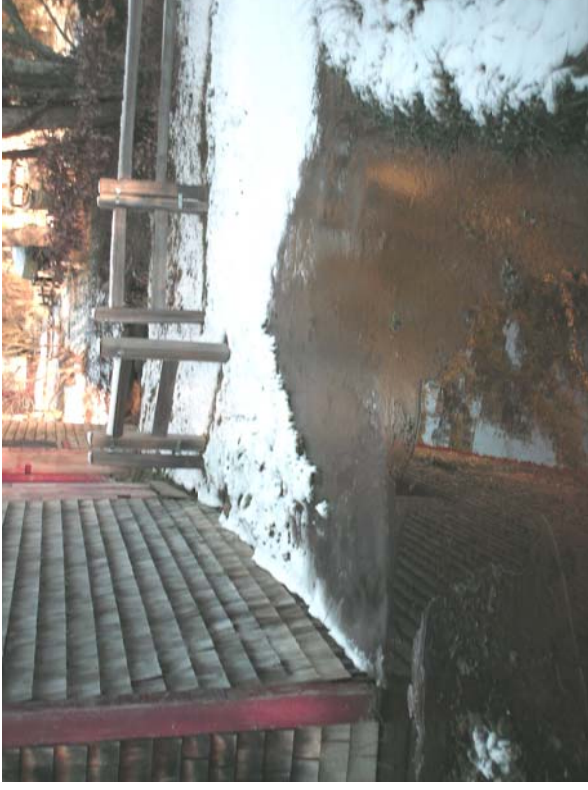
#55) Ice and water build-up against the sill. Site water management should be planned to shed water away from all buildings. (Freight "A")

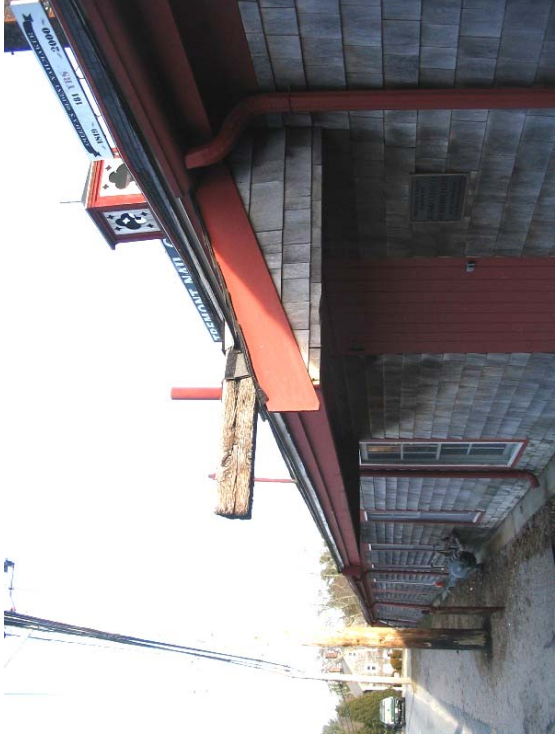
- At one of the doors facing to Elm Street there is a roof overhang supported by a heavy timber protruding from the factory. This timber is in poor shape and should be removed or replaced (#59) (C).

#59) Timber beam supporting roof; Note that the front wall leans in at the end. (Factory "D")

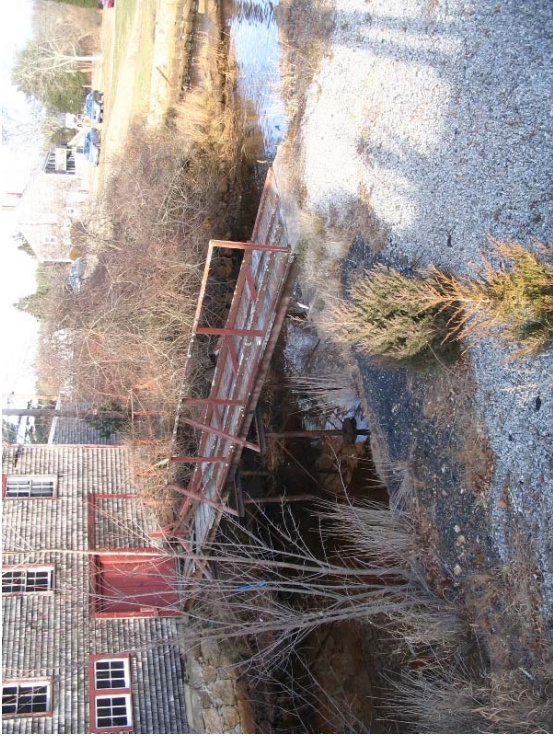
#63) Wooden foot bridge has deteriorated to the point where it should be removed or replaced. Note that one of the railings has fallen off. (Factory "ALL")

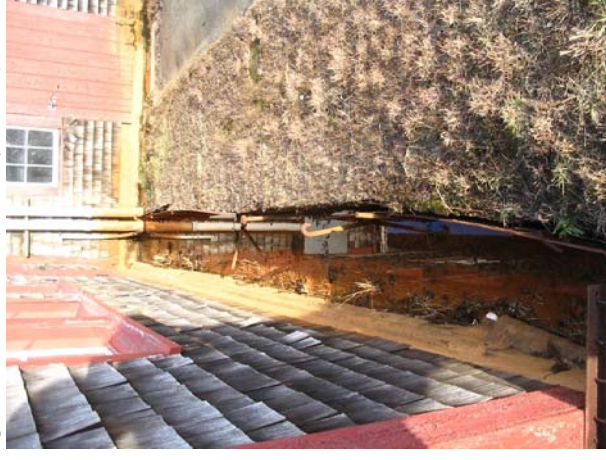
#65) Trench around the majority of the building for water diversion. This should be considered with a site water management plan. (Factory "ALL")
