Conditions Assessment & Feasibility Study

Tremont Nail Factory

Wareham, Massachusetts

June, 2009

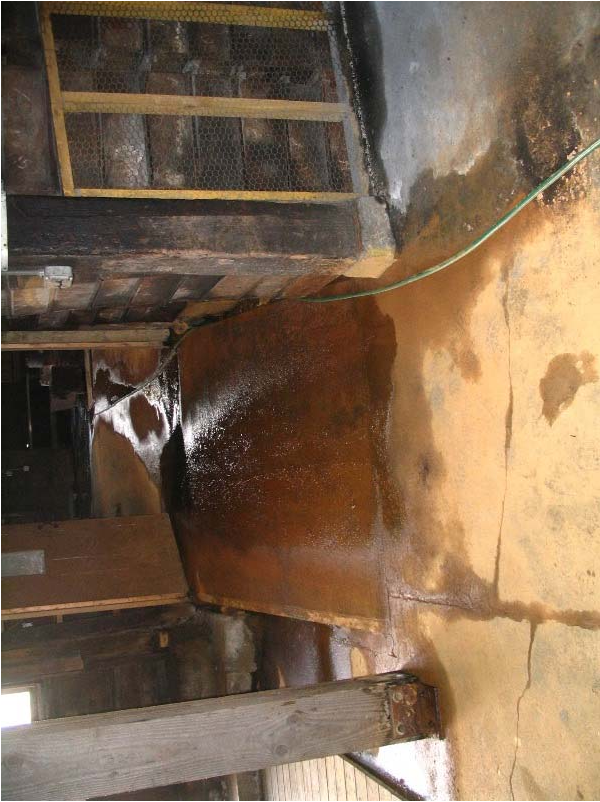
#66) Concrete cast-in-place ramp connects the main Factory "D" to the Forge "A." Note that the ramp is covered with water. (Factory "A")

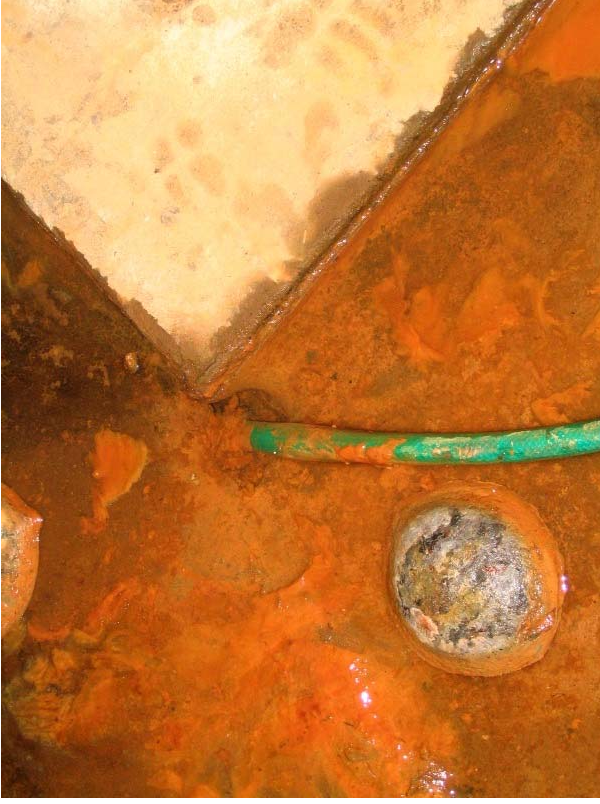
#67) Hole in concrete slab on grade filled with water. Note that the hose extends 4"-5" into the hole, due to undermining of the slab. (Factory "A")

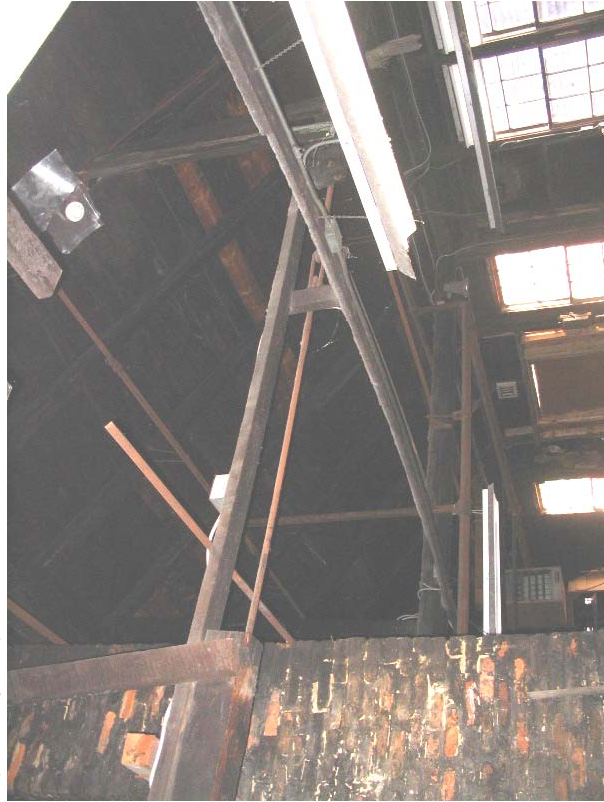
#68) Roof tie at top wall plate cut at mid span, and no longer ties the roof together. (Factory "A")

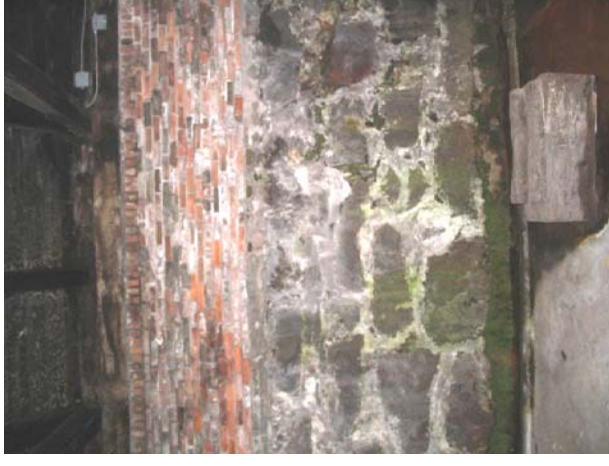
#69) Foundation Wall at high grade, 5'-7" stone rubble, 5" cement, 2'-1" clay masonry. (Factory "A")

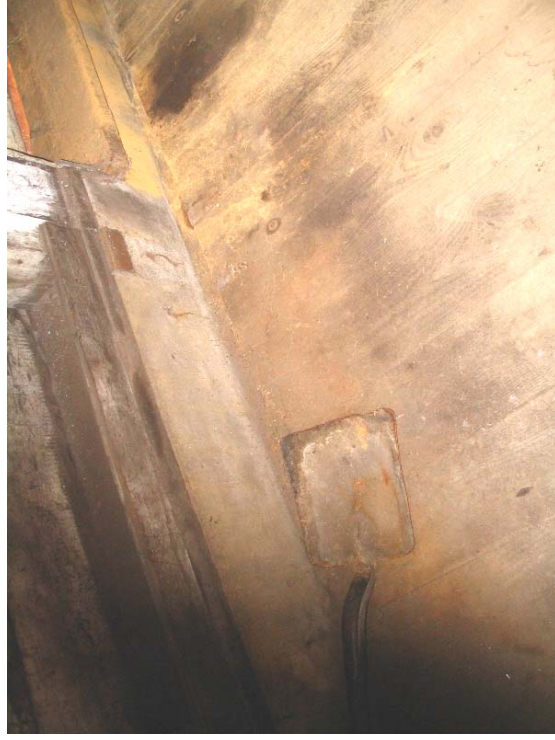
#73) 2x sill bearing atop concrete foundation wall with no fastening to the foundation observed. (Factory "B")

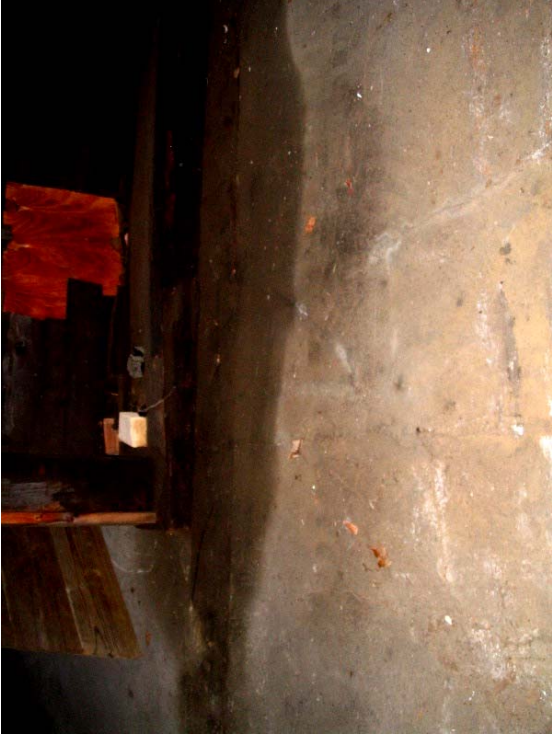
#75) Deterioration of sill between additions in area "B." This sill should be replaced with a new pressure treated sill fastened to the foundation. (Factory "B")

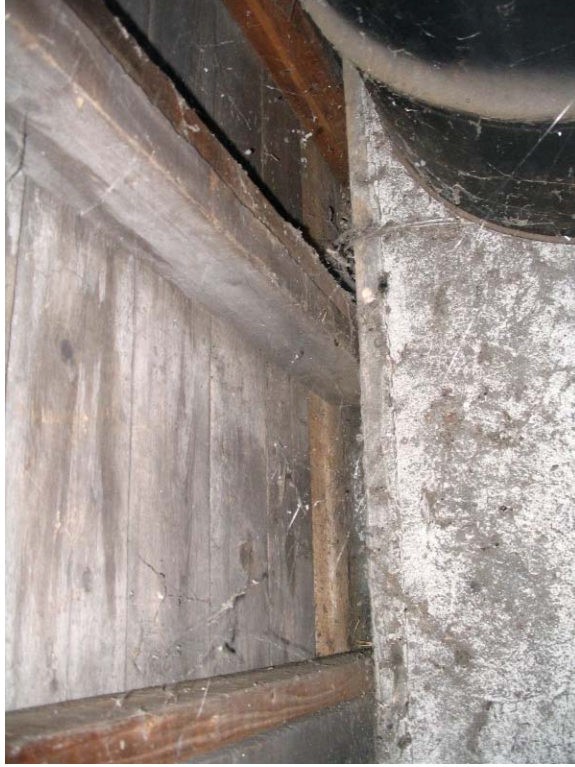
#76) Raised slab in storage room similar to the raised slab in the freight building. (Factory "B")

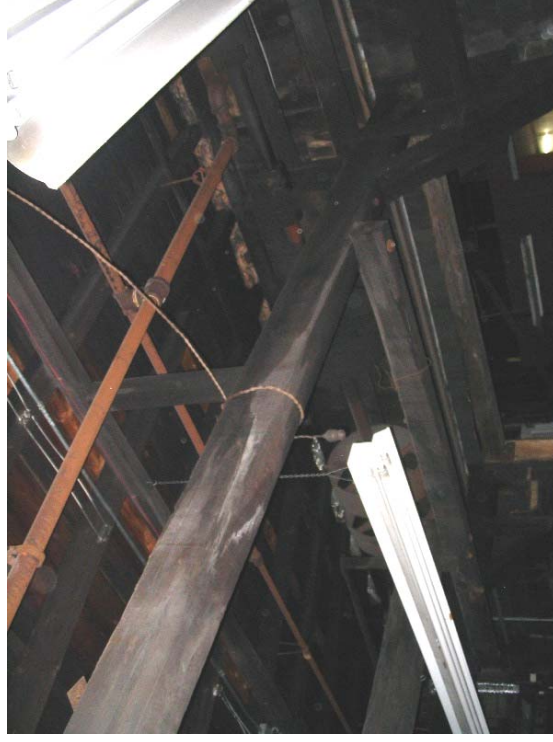
#77) Post and beam which supports the roof beam at the mid span of the rafters. (Factory "B")

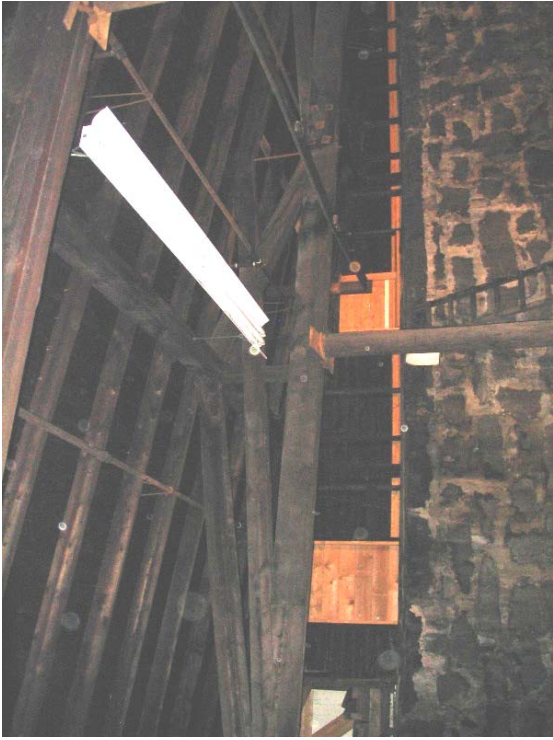
#78) Post and Beam which supports the roof beam at the mid span of the rafters. (Factory "C")

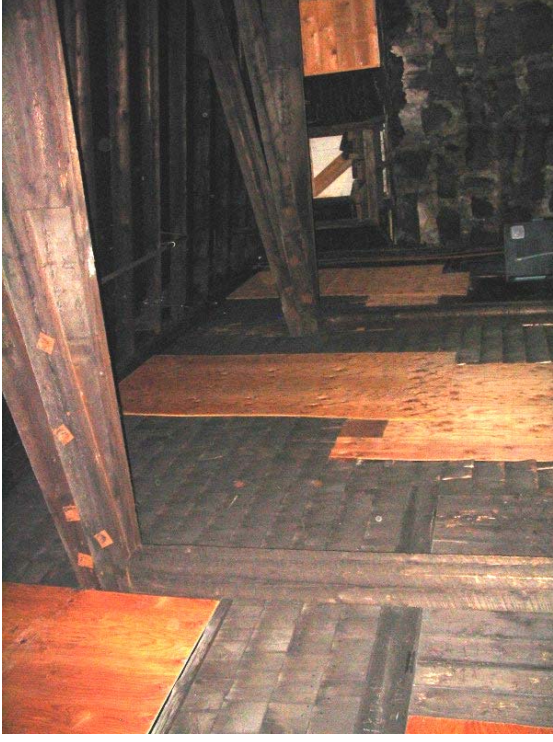
#79) Support of semi-truss on post at the original exterior wall. (Factory "C")

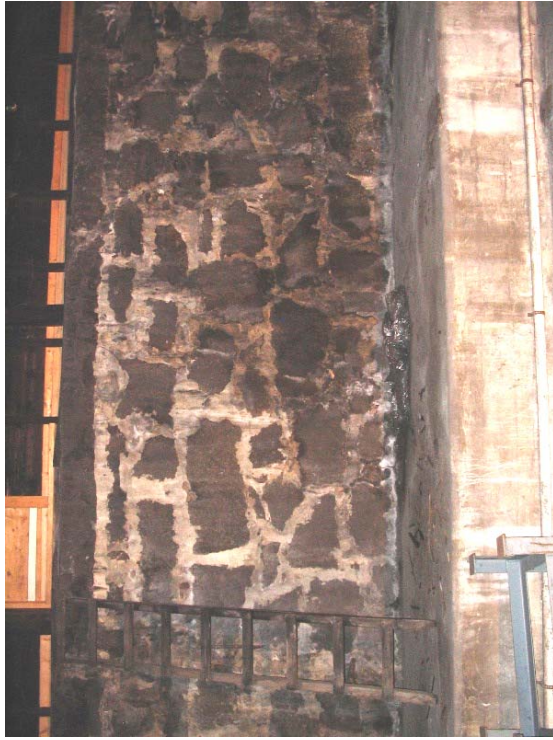
#80) Stone rubble foundation wall with concrete slab inset, and wood frame wall on top. (Factory "C")

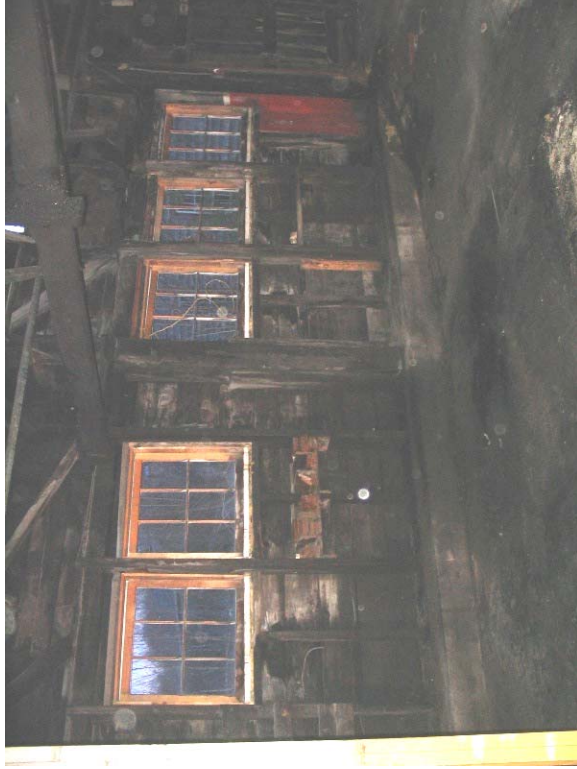
#84) Overview of northeast exterior wall (Factory "C")

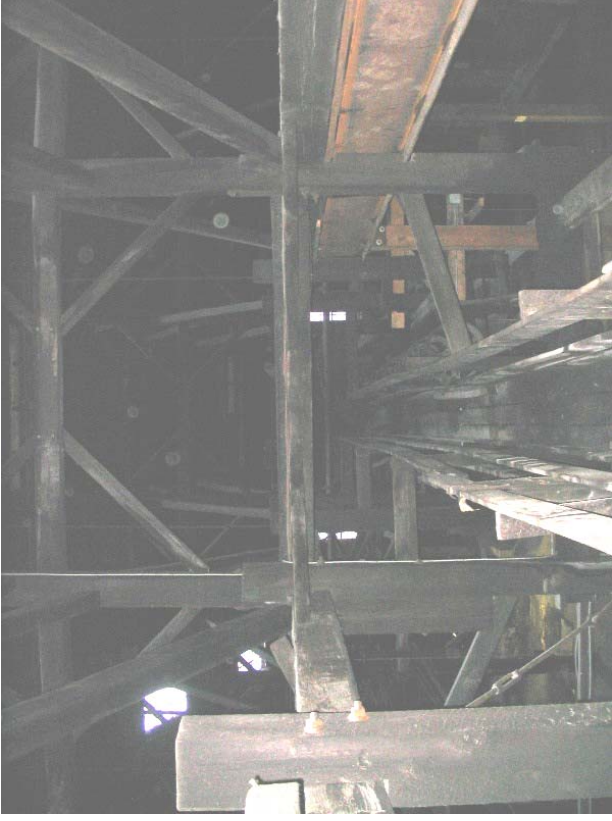
#87) Lateral cross bracing of the truss (typical) (Factory "D")

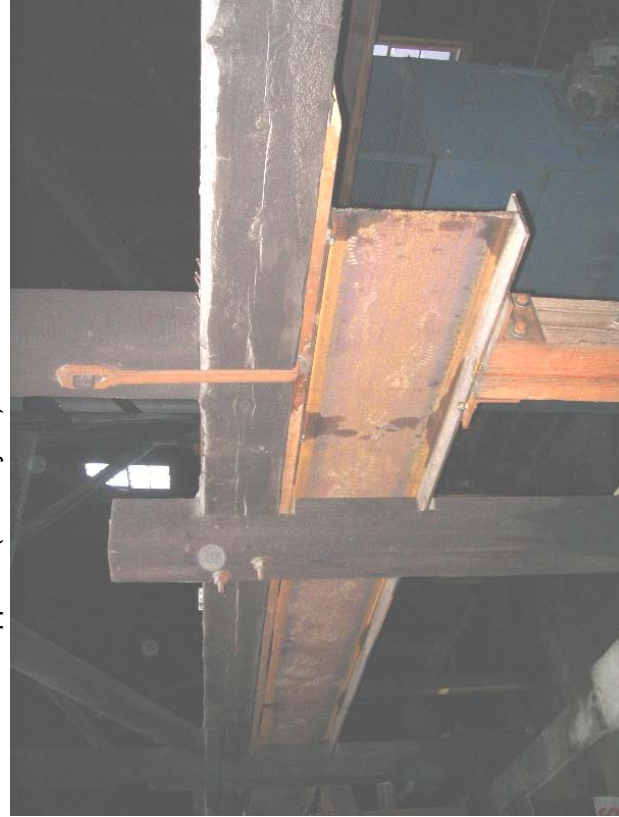
#88) Steel beam supporting the main trusses. Note that the steel beam is supported on 8x8 wood posts. (Factory "D")

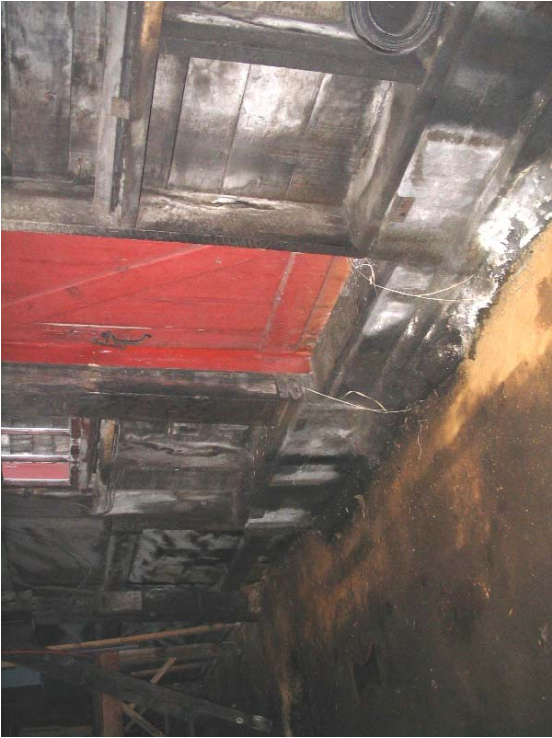
#90) 2x6 stud in fill wall with no connection of the sill to the concrete foundation wall. (Factory "D")

- There did not appear to be any mechanical connection of the sill to the foundation. Adequately sized adhesive or mechanical anchors should be placed to resist the lateral shear load in the building.
- Most trusses did not show any signs of distress or failure, however a structural load analysis would need to be completed in order to determine the adequacy of the trusses and their connections.
- The bottom chord of one was cut out at the location where the ceiling is raised into the attic area. A single 2x6 rafter is not adequate for a roof rafter at that given location. This member must be replaced and truss reinforced to meet minimum load requirements.

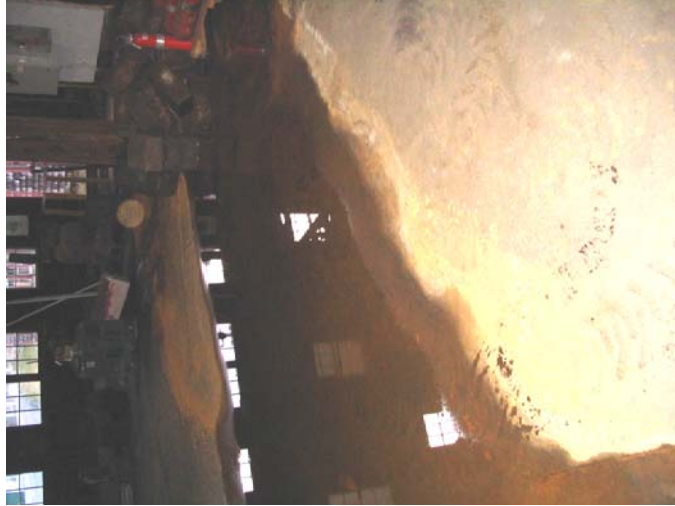
#92) Water 1" to 2" deep due to water infiltration through the foundation and unevenness of the slab. (Factory "D")

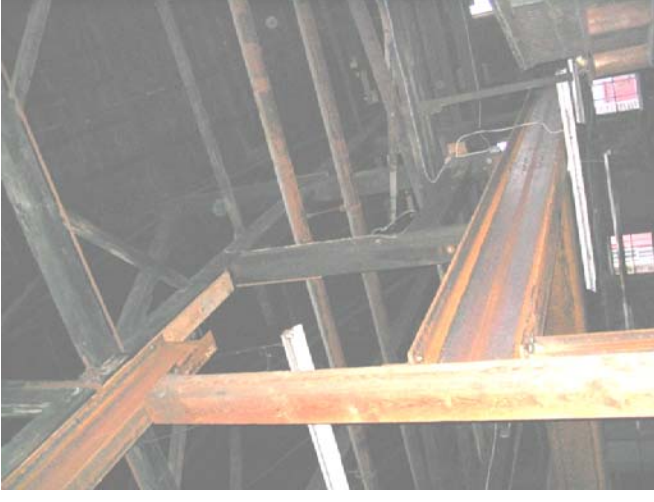
#91) Steel beams supporting the truss bottom chord and the original posts under the trusses (Factory "D")

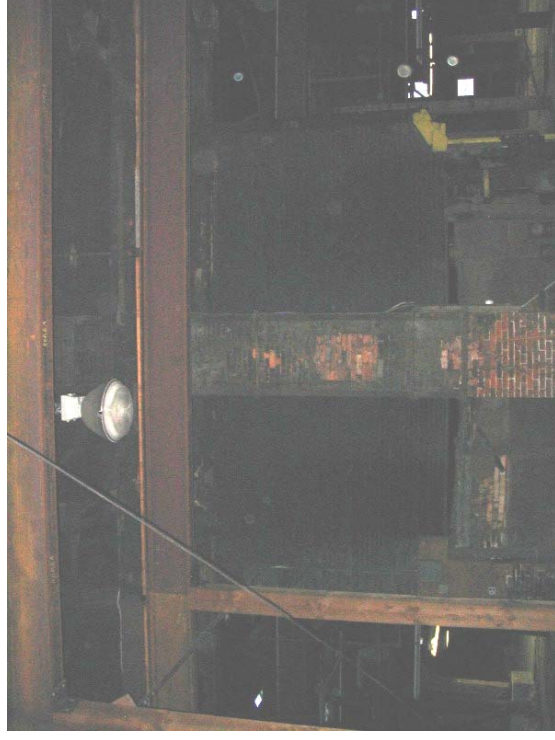
#93) Clay masonry wall at original heating unit and chimney. This wall supports the truss, through need to be replaced, as such the truss will need to be reinforced. (Factory "D")

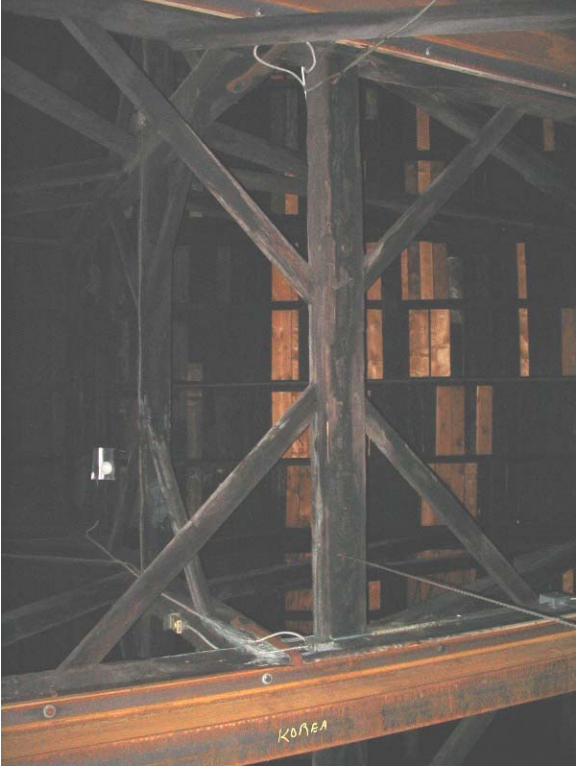
#94) Bottom chord bracing of truss, center bracing of truss (Typical) (Factory "D")

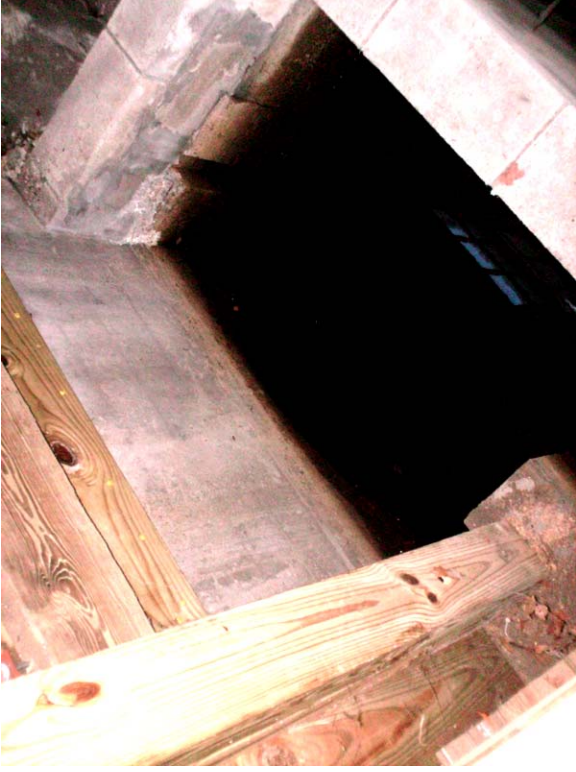
#95) Entrance of culvert into concrete "tub" in Main Factory. (Factory "D")

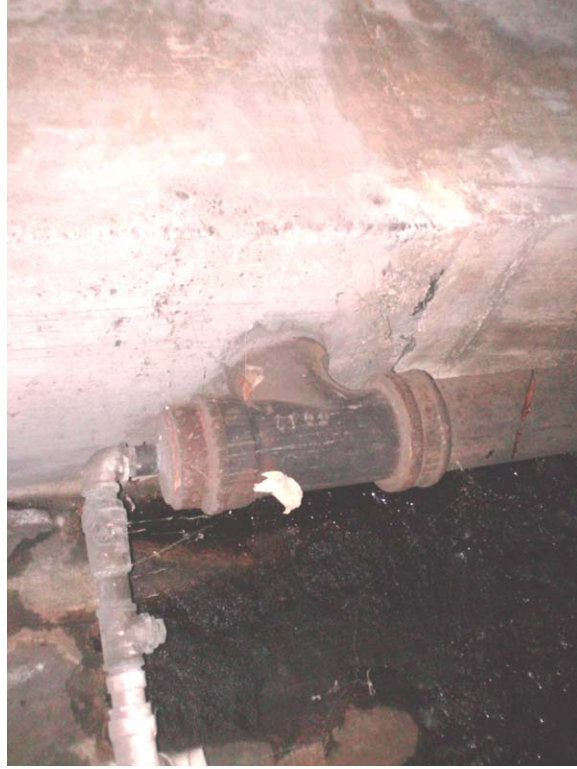
#96) Main exit pipe of culvert. Note: The bottom of the culvert and base concrete. (Factory "D")

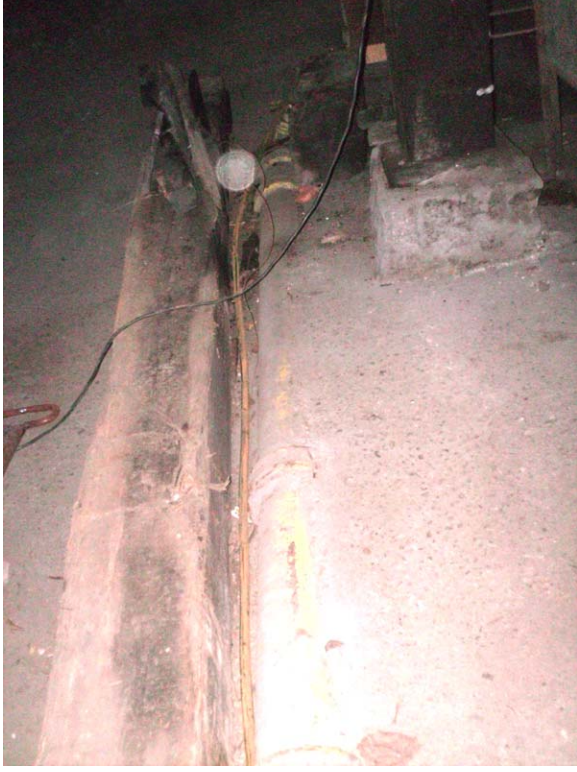
#97 Main exit pipe for culvert. Note that pipe is sloped and disappears under the slab. (Factory D")

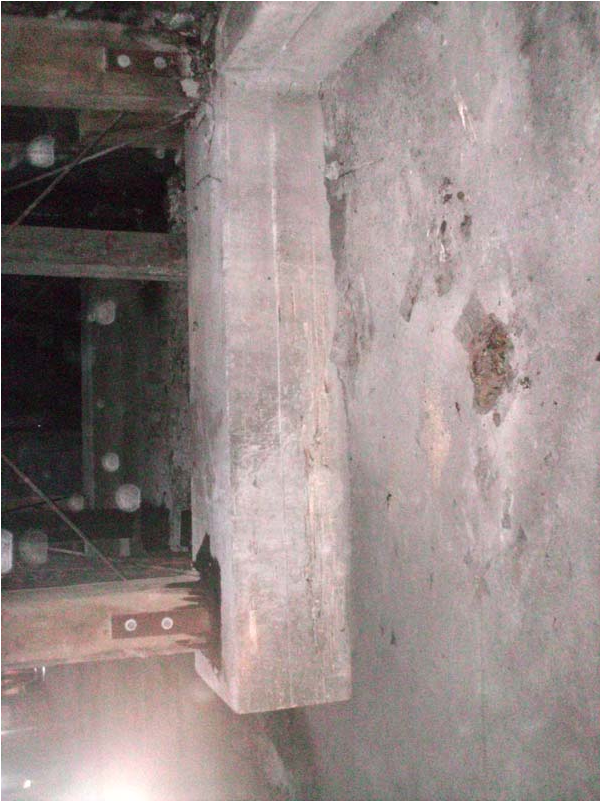
#102) Additional concrete footings were placed as needed for equipment support. (Factory "D")

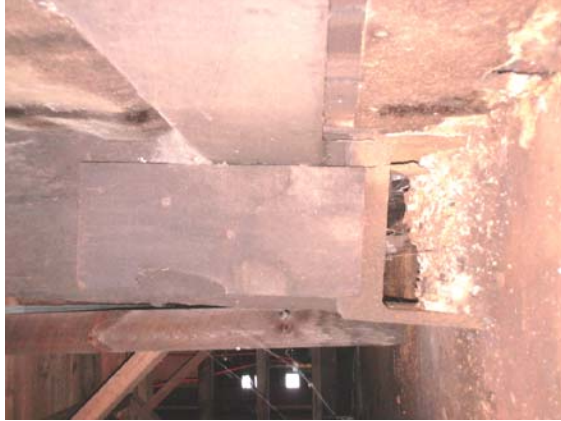
#104) Questionable support of post allows the southeast side of the building proper post base and connection shall be provided. (Factory "D")

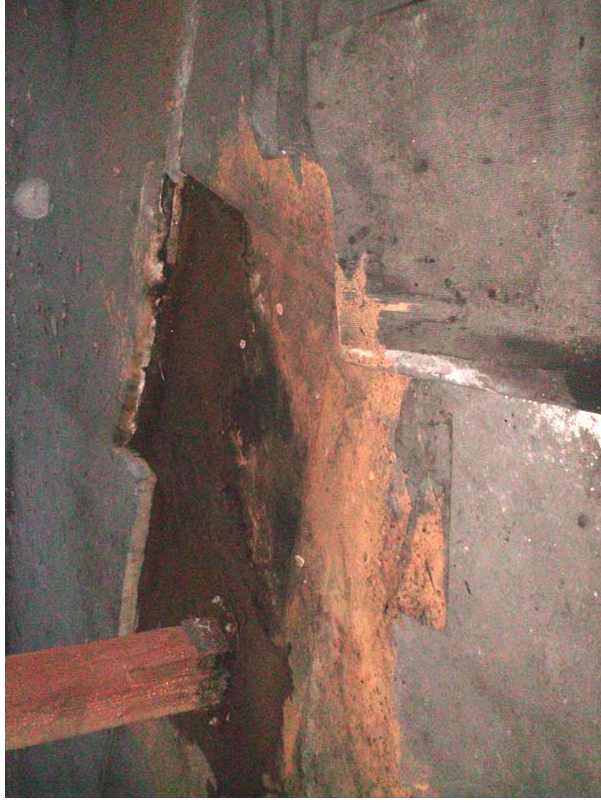
#105) Post bearing on slab and water. Note that the slab in this area has three different elevations. (Factory "D")

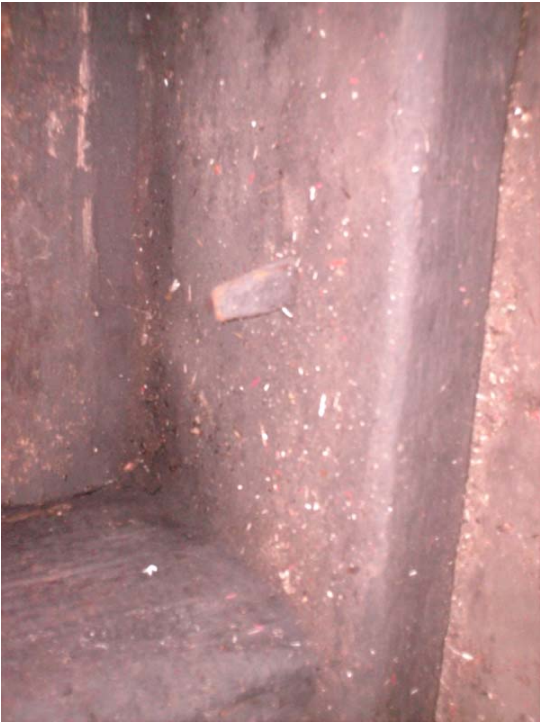
#106) Connection of sill to rubble foundation via steel wedge. (Factory "D")

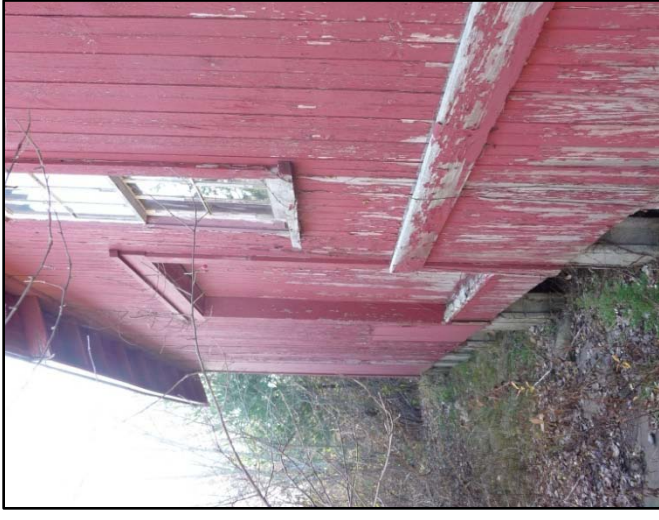
- Representative findings
 - Exterior envelope – fair to poor condition
 - Water, water, water
 - Preservation recommendations
 - Patch or repair roofs
 - Repair rotted wood
 - Character defining features
 - Building & roof forms
 - Board & shingle cladding
 - Window configurations

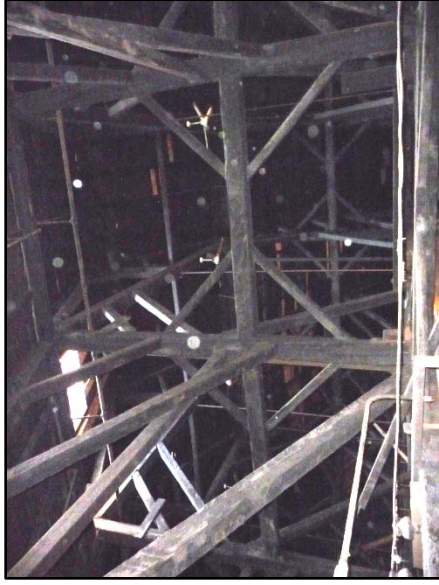
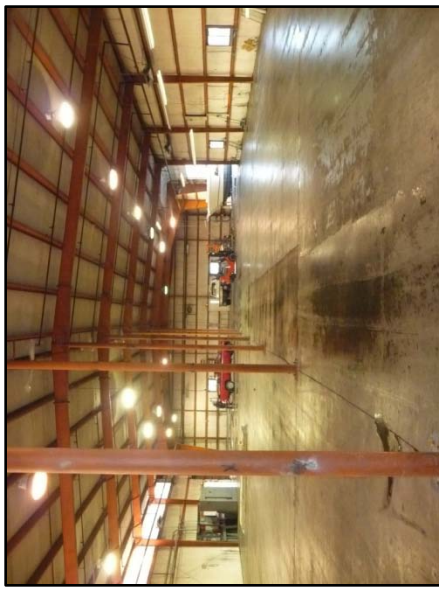
- Representative findings
 - Office building: framing appears unsound
 - Steel building: column placement has damaged foundation; lateral braces cut
 - Factory building: catwalks unsafe
 - Pickling building: worst overall condition
 - Mitigation recommendations
 - Additional evaluation
 - Reinforce rafters & connections

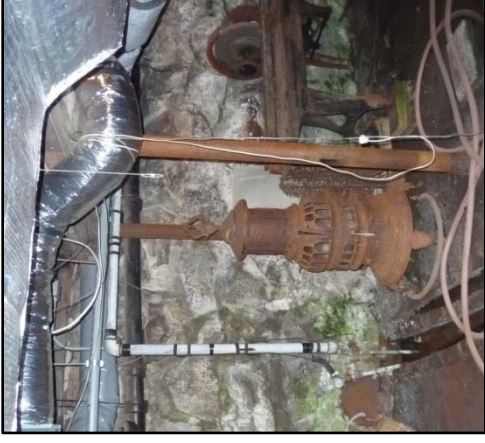
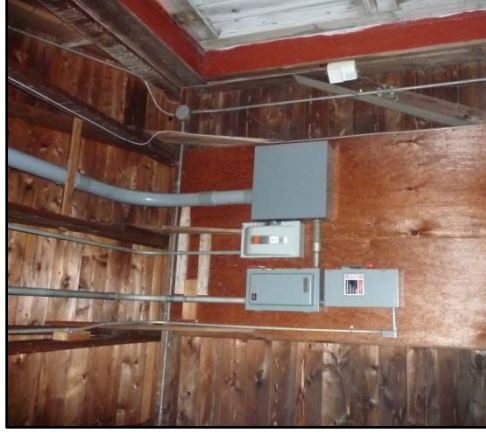
- Representative findings
 - Electrical & HVAC systems inadequate
 - Hazardous electrical conditions
 - Sprinkler piping system in relatively good condition

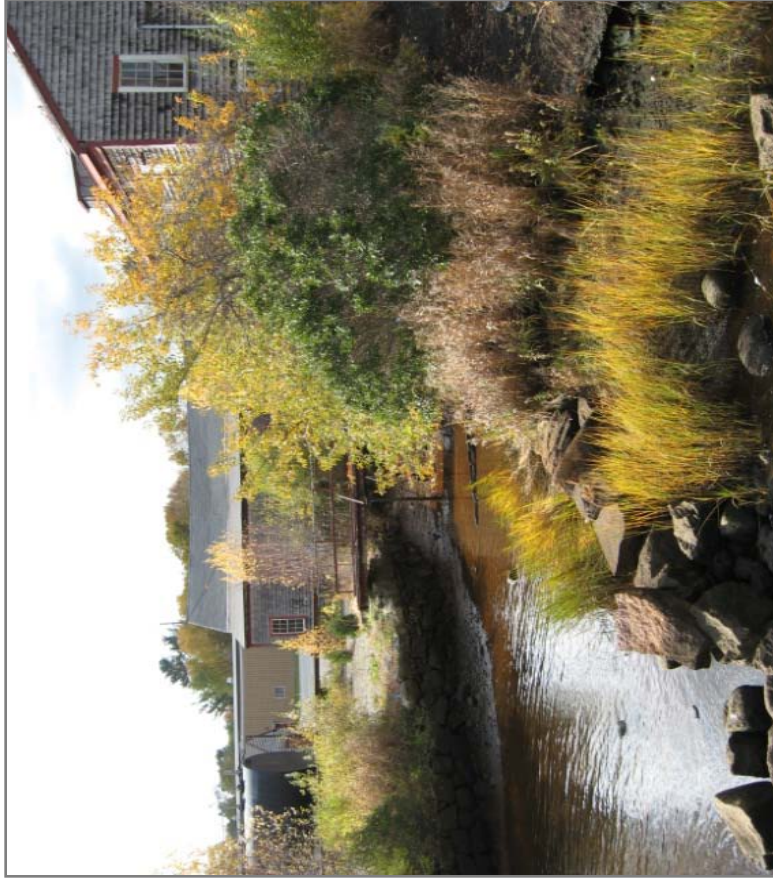
Existing Conditions: Nail Factory

- Characteristics
 - Circa 1846, wood frame, 19,225 SF
 - Exterior
 - Roof – asphalt shingles poor to fair; rubber good
 - Flashing, gutters & downspouts – worn to fair
 - Walls – wood shingles good at top, worn near bottom
 - Windows & doors – worn to fair
 - Foundation - fair

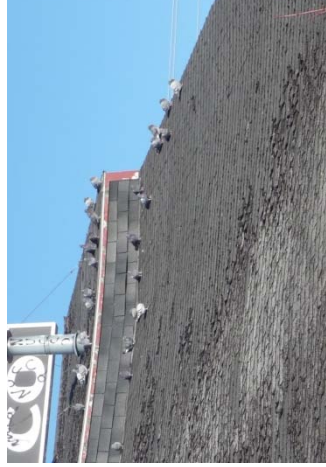
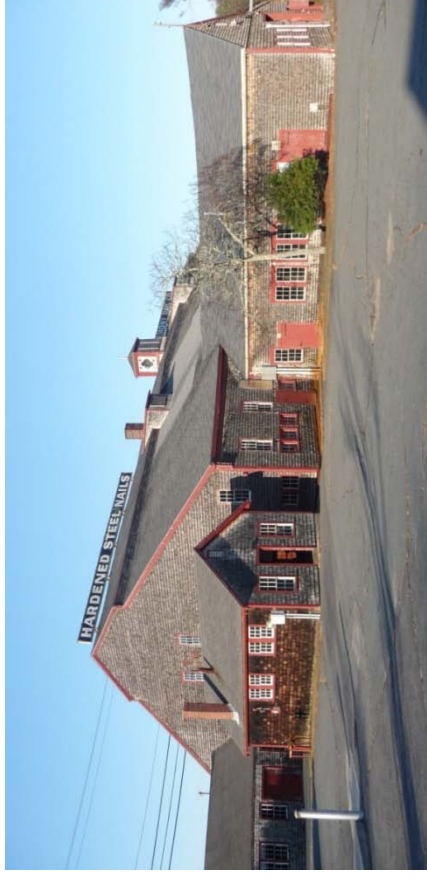
Existing Conditions: Nail Factory

- Interior

- Framing – timbers poor to fair; sheathing poor to fair; catwalks & stairs poor; infill good
- Foundation – water infiltrated, fair
- Floors – poor to fair
- Blacksmith shop chimney - poor

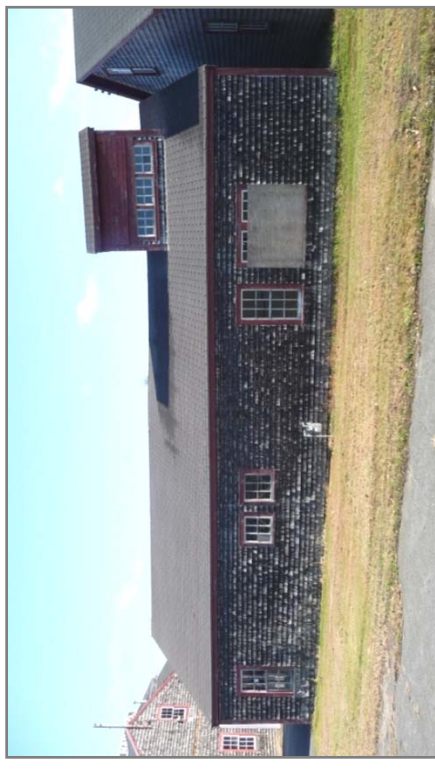
Existing Conditions: Pickling Building

- Interior
 - Framing – poor
 - Floor – fair
- Structural
 - Overall condition poor & unsuitable for active use; entire structure requires reinforcement
- Mechanical Systems
 - Detection adequate
 - Other systems Inadequate or non-existent, non-code compliant

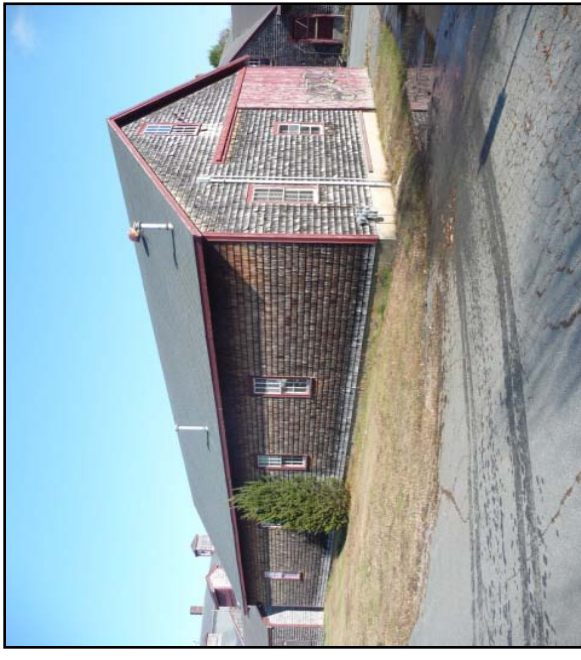
Existing Conditions: Packaging Building

- Interior
 - Framing – fair
 - Floor – fair
- Structural
 - Overall condition fair
- Mechanical Systems
 - Detection – adequate
 - Other systems – inadequate or non-existent, non-code compliant

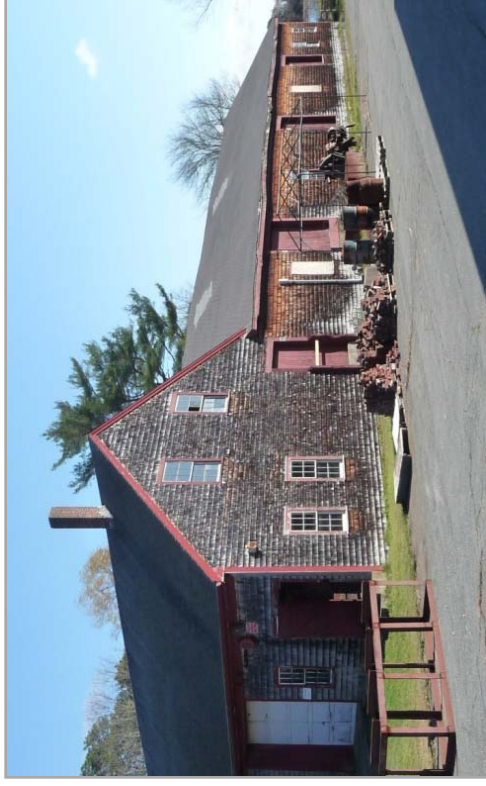
Existing Conditions: Freight Building

- Interior
 - Framing – good
 - Chimney - poor
- Structural
 - Overall condition fair; sill should be replaced & anchored; some posts require reinforcement or replacement
- Mechanical Systems
 - Detection – adequate
 - Other systems – inadequate or non-existent, non-code compliant

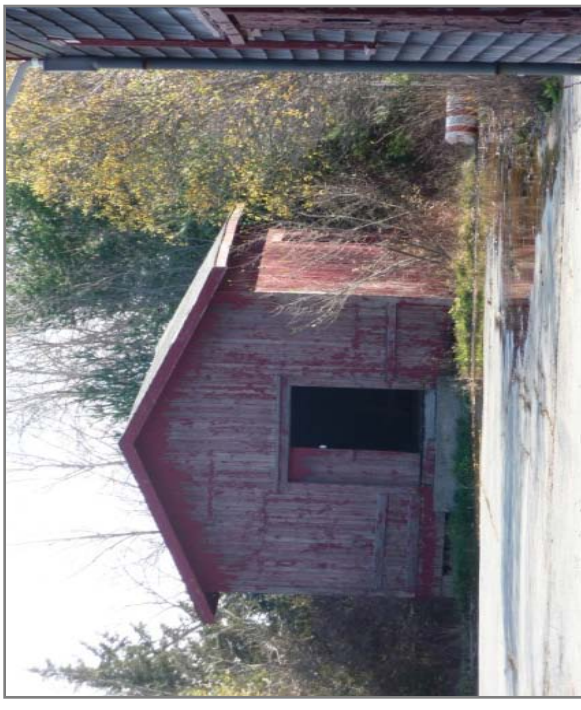
Existing Conditions: Freight Shed

- Interior
 - Framing – fair
- Structural
 - Overall condition worn; requires reinforcement
- Mechanical Systems
 - None

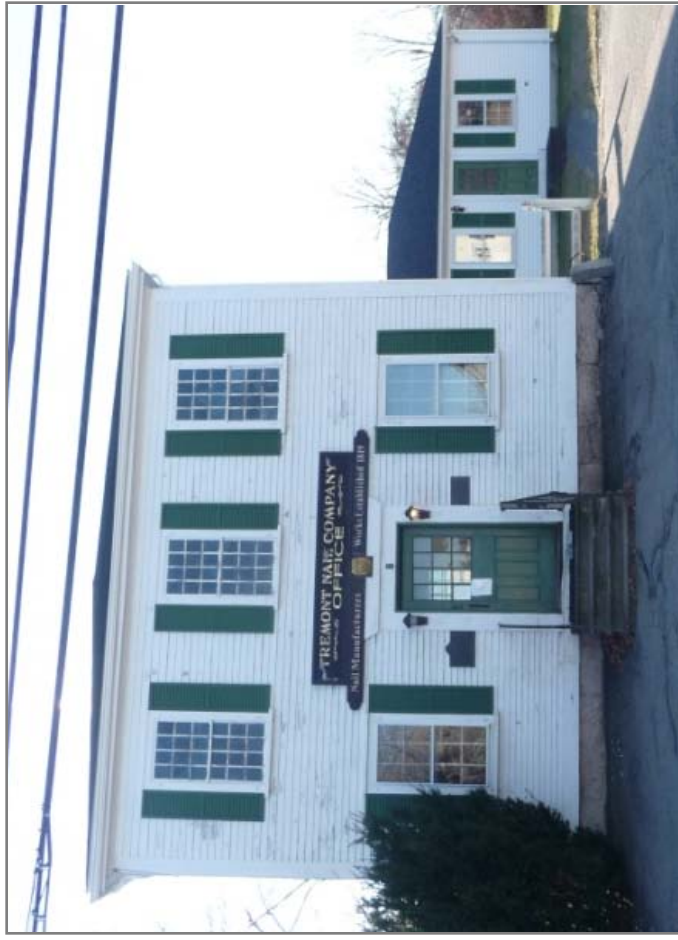
Existing Conditions: Office Building

- Interior
 - Basement – worn to fair
 - Framing – main building worn to fair; addition good
 - Stove chimney – worn to fair
 - Finishes – main building worn to fair; addition good
