**ARCHITECTURE
+ ACCESSIBILITY**

ACCESSIBILITY AUDITS

WAREHAM, MA

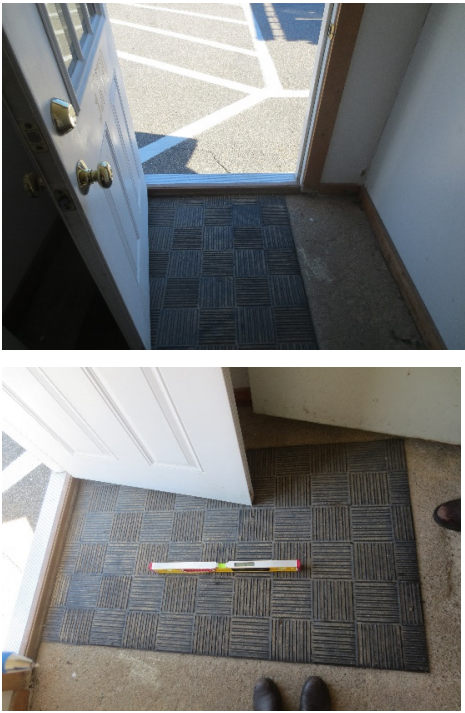
#	Issue	Mitigation	Photo	Cost
3.	Entry Vestibule <ul style="list-style-type: none"> Both doors of the entry vestibule lack the required min. 18" of maneuvering clearance on the latch pull side for a forward approach, @ 13 ½". There is <48" between the two vestibule doors in a series. The door maneuvering clearance has slopes >2%, @ up to 7.6%. The door thresholds are >1/2" AFF, @ up to 2 ½". The door hardware requires tight grasping, pinching, or twisting of the wrist to operate. 	Rebuild the entry vestibule. Unit Cost: \$15,000 Quantity: 1

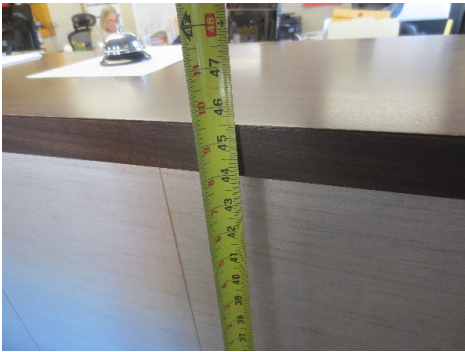
\$15,000
4.	Transaction Counter The transaction counter is > 36" AFF, @ 46 ½".	Provide lowered counter or shelf. Unit Cost: \$250 Quantity: 1

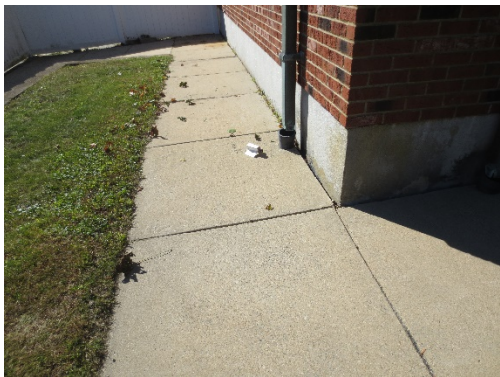
#	Issue	Mitigation	Photo	Cost
7.	Route from Curb Ramp to Entry Ramp <ul style="list-style-type: none"> The walkway has running slopes >5%, @ up to 6.5%. Portions of the walkway have cross slopes >2%, @ up to 6.9%. 	Re-grade the walkway. Unit Cost: \$75/sf Est. Quantity: 50 lf

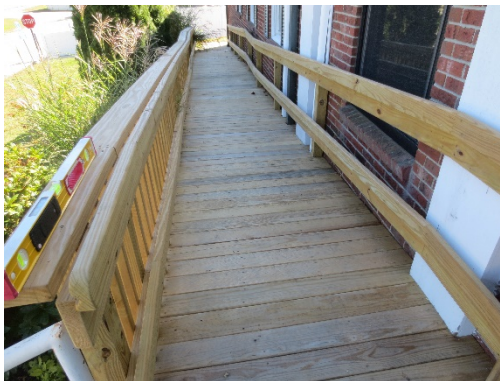
\$3,750
8.	Entry Ramp <ul style="list-style-type: none"> The entry ramp has running slopes >8.3%, @ up to 9%. The bottom landing of the entry ramp has slopes >2%, @ 3.6%. The handrails lack the required extensions at the top and bottom. 	Rebuild the ramp. Unit Cost: \$15,000 ea. Quantity: 1

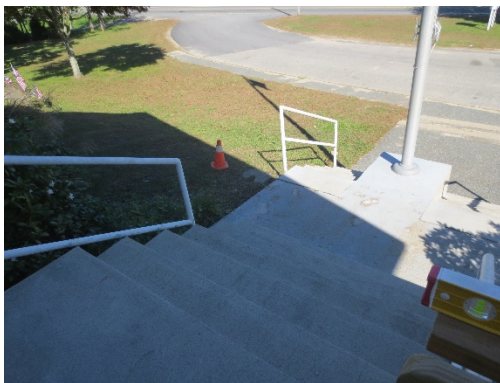
\$15,000
9.	Entry Stairs There are no handrail extensions on the top or bottom of the stairs.	Install compliant handrail extensions on both sides of the stairs. Unit Cost: \$50/lf Est. Quantity: 8 lf

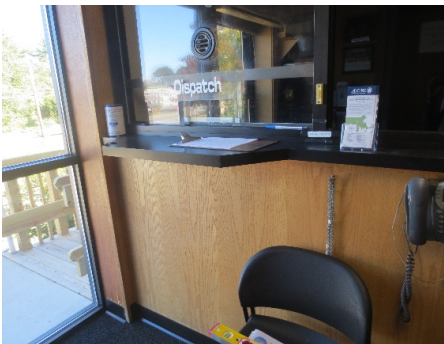
#	Issue	Mitigation	Photo	Cost
10.	Transaction Counter <ul style="list-style-type: none"> The transaction counter is > 36" AFF, @ 46 1/4". The transaction counter protrudes >4" into the circulation space. 	Provide lowered counter or shelf. Unit Cost: \$250 Quantity: 1

\$250
		Install a cane detectable object below the counter. Unit Cost: \$750 ea. Quantity: 1		\$750
11.	Bathrooms <ul style="list-style-type: none"> The public, employee, women's, bathroom lacks the required footprint for an accessible bathroom. The women's single user toilet room is not located on a min. 36" wide accessible route, @ 35". 	Further design study required. Unit Cost: \$15,000 Quantity: 1

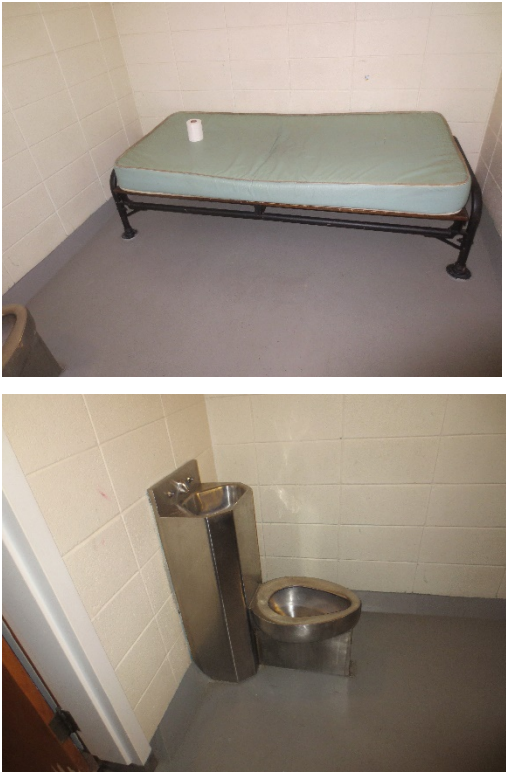
#	Issue	Mitigation	Photo	Cost
15.	Women's and Juvenile Holding Cells <ul style="list-style-type: none"> • The toilet CL's measured >18" from the adjacent sidewall, @ 19"-19 ½". • The toilet seats measures <17"-19" AFF, @ 15". • The sink lacks the required knee space for a forward approach, it is obstructed by the toilet. • The toilet lacks the required grab bars. • The telephone controls are located >48" AFF, @ 56". • The door viewing panel is >43" AFF to the bottom of the opening, @ 56". • The juvenile cell lacks the required min. 60" turning space and door maneuvering clearance due to the location of the bolted down bed. • The doors to the cells lack the required min. 54" deep maneuvering clearance for a latch side approach, @ 46". 	<p>Further design study required.</p> <p>Unit Cost: \$20,000</p> <p>Quantity: 1</p>

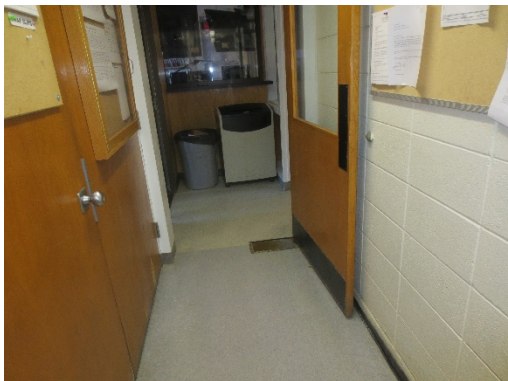
#	Issue	Mitigation	Photo	Cost
16.	Route to Offices The door to the offices lacks the required min. 18" of maneuvering clearance on the latch pull side for a forward approach.	Install an automatic door opener. Unit cost: \$2,500 ea. Quantity: 1

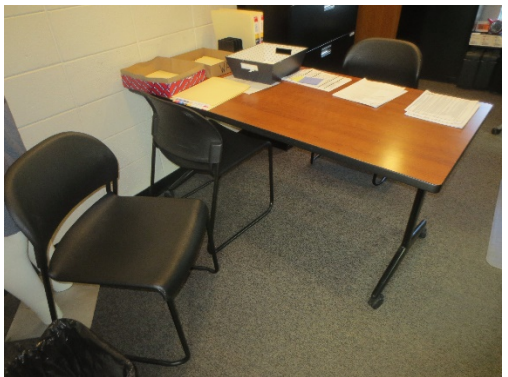
\$2,500
17.	Interrogation Room The interrogation room is not located on an accessible route, it is located on the lower level which requires the use of stairs.	Install an elevator or Relocate program to an accessible location Unit cost: \$0 ea. Quantity: 1

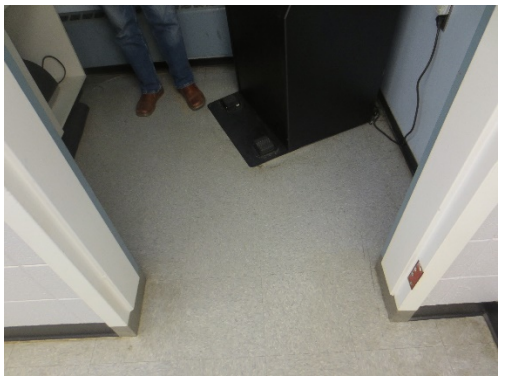
\$0
18.	Fingerprinting Room The fingerprinting machine lacks an adjacent 30"X48" clear floor space.	Relocate the fingerprinting machine. Unit Cost: \$250 Quantity: 1

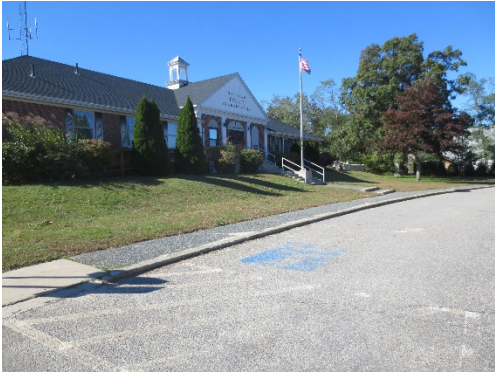
#	Issue	Mitigation	Photo	Cost
19.	Flag Pole The flag pole is not located on an accessible route, due to the stairs.	No action necessary if flag is raised/lowered by municipal employees. Town to confirm. Unit Cost: \$0 Quantity: 1

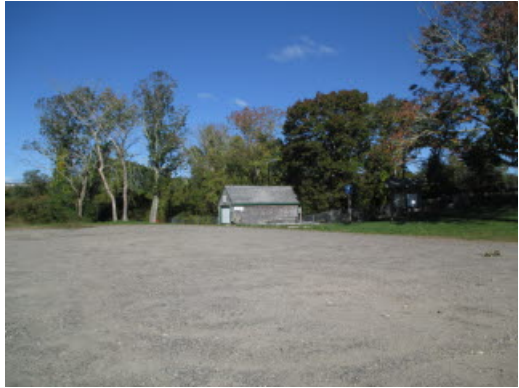
Herring Run				
1.	Accessible Parking No accessible parking spaces are provided.	Mark accessible spaces (including at least one van accessible space) and associated access aisles. Provide signage. Unit Cost: \$300 ea. Est. Quantity: 2 (1 space + 1 access aisle)

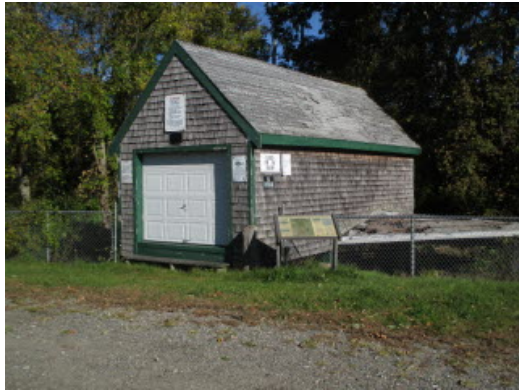
\$600
2.	Building No accessible route is provided into the facility.	Additional study required. Options include: <ul style="list-style-type: none"> • Information kiosk • Accessible viewing platform Unit Cost: \$2,000 Quantity: 1

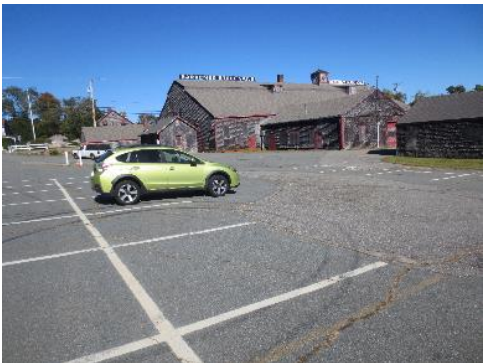
#	Issue	Mitigation	Photo	Cost
Tremont Nail Factory				
20.	Accessible Parking There no designated accessible parking spaces provided at the complex.	Further design study required. Unit Cost: \$1,000 Quantity: 1

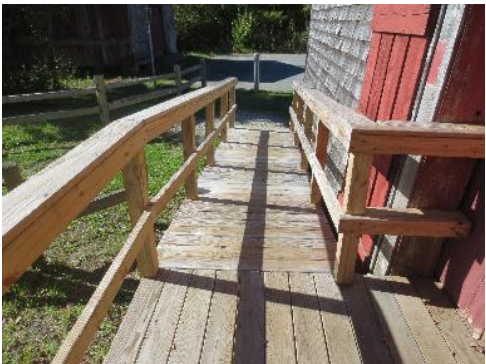
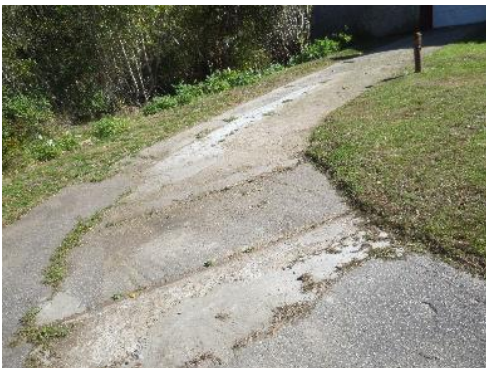
21.	Freight Building Entrances <ul style="list-style-type: none"> The wooden ramp is not located on an accessible route, due to the grass surface. Additionally, the ramp has running slopes >8.3%, @ up to 12.6%, and cross slopes >2%, @ up to 2.6%. The handrails are not rounded and lack the required extensions. One entrance is inaccessible due to the stairs. The paved sloped walkway entry has running slopes >5%, @ up to 5.9%. 	Rebuild the ramp. Unit Cost: \$15,000 ea. Quantity: 1 Install compliant handrails and handrail extensions on both sides of the stairs. Unit Cost: \$50/lf Est. Quantity: 10 lf Provide directional signage at the two (2) inaccessible entrances (stairs and sloped walkway). Unit Cost: \$100 ea. Quantity: 2

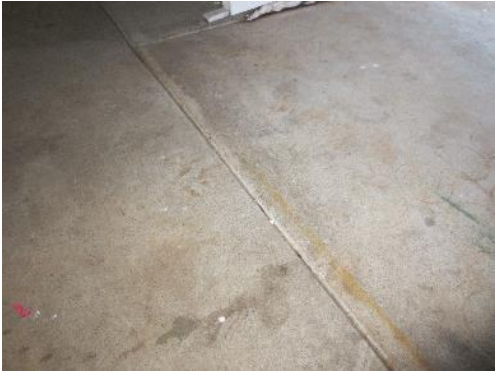
#	Issue	Mitigation	Photo	Cost
22.	Freight Building Flooring The flooring is uneven with vertical changes in level >1/4" at the control joints.	Re-grade the floor surface. Unit cost: \$30/sf Est. Quantity: 2,000

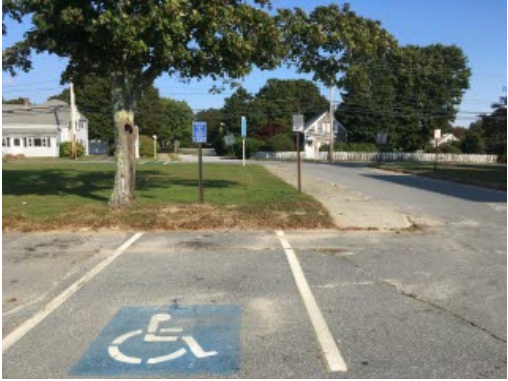
#	Issue	Mitigation	Photo	Cost
Multi-Service Building				
Exterior				
1.	Parking One of four designated accessible parking spaces lacks the required access aisle	Restripe a portion of the parking lot to add one (1) access aisle. Unit Cost: \$300 ea. Quantity: 1

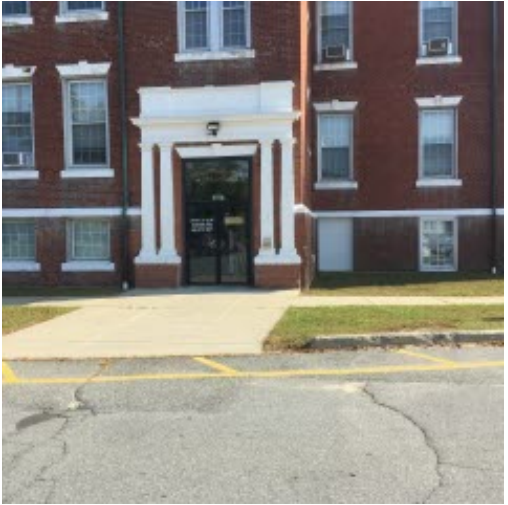
\$300
2.	Entrances The inaccessible entrance lacks directional signage to the accessible entrance.	Provide directional signage. Unit Cost: \$100 ea. Est. Quantity: 1

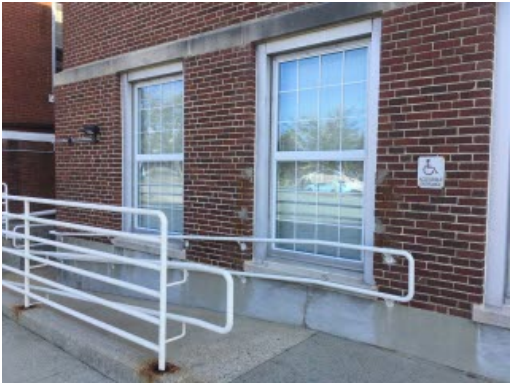
#	Issue	Mitigation	Photo	Cost
3.	Ramp The upper section of the ramp has running slopes > 8.33%, @ up to 9.8%	Rebuild the ramp. Unit Cost: \$15,000 ea. Quantity: 1

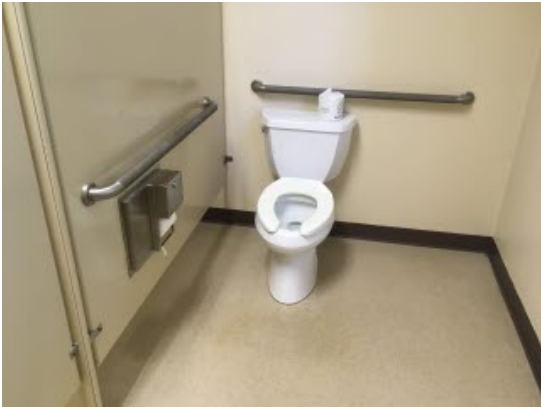
\$15,000
Level 1				
4.	Men's Toilet Room In the accessible stall, the toilet flush control is not located on the wide side of the toilet.	Reposition the flush valve or install an automatic flush control. Unit Cost: \$1,500 ea. Quantity: 1

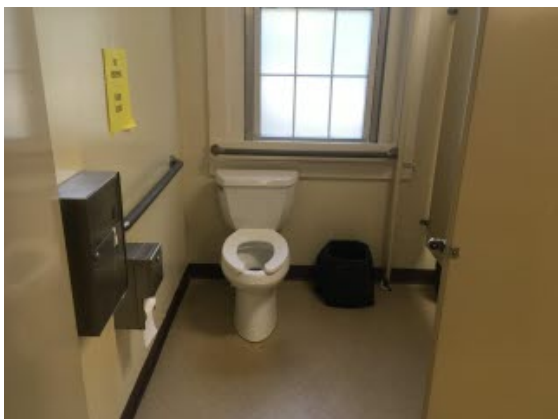
#	Issue	Mitigation	Photo	Cost
6.	<p>Accessible Stall in Women's Toilet Room.</p> <p>The stall door is not located opposite the toilet, it opens in front of toilet.</p>

<p>Figure 604.8.1.2 Wheelchair Accessible Toilet Compartment Doors</p>	<p>Replace front partition wall and relocate door.</p> <p>Unit Cost: \$1,000 ea.</p> <p>Quantity: 1</p>

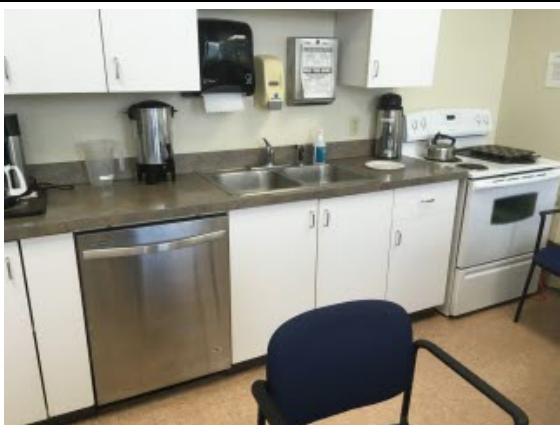
\$1,000
7.	<p>Café</p> <ul style="list-style-type: none"> The sink is > 34" AFF and lacks the required knee space below for a forward approach. The soap and paper towel dispensers are not located within an accessible reach range. 	<p>Modify counter and provide compliant sink.</p> <p>Unit Cost: \$1,000 ea.</p> <p>Quantity: 1</p> <p>Relocate the dispensers.</p> <p>Unit cost: \$150 ea.</p> <p>Quantity: 2</p>

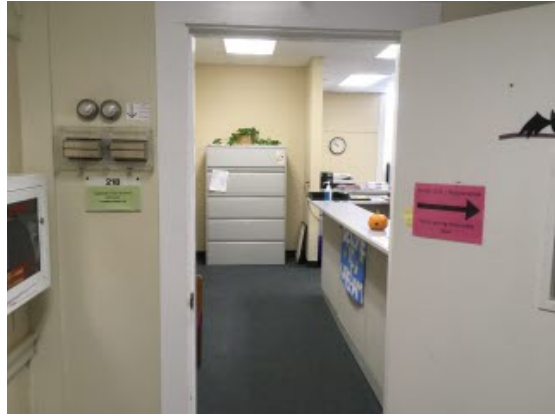
#	Issue	Mitigation	Photo	Cost
8.	Room 218 & 228 The transaction counters are > 36" AFF.	Provide lowered counter or shelf. Unit cost: \$250 ea. Quantity: 2

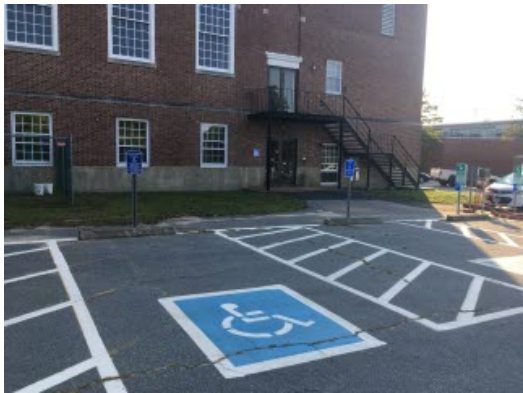
23.	Parking The van accessible parking space lacks signage indicating it is van accessible.	Install a van accessible parking sign. Unit cost: \$300 ea. Quantity: 1

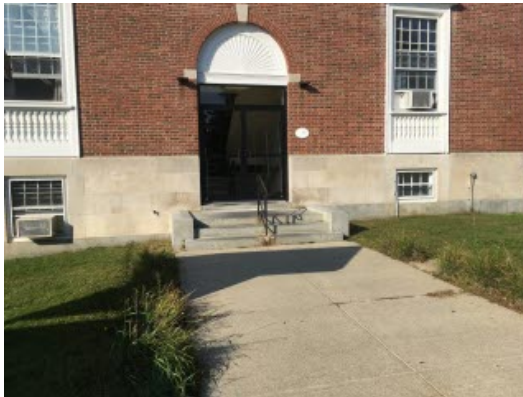
\$300
24.	Entrances Inaccessible entrances lack directional signage to the accessible entrance.	Provide directional signage. Unit Cost: \$100 ea. Quantity: 2

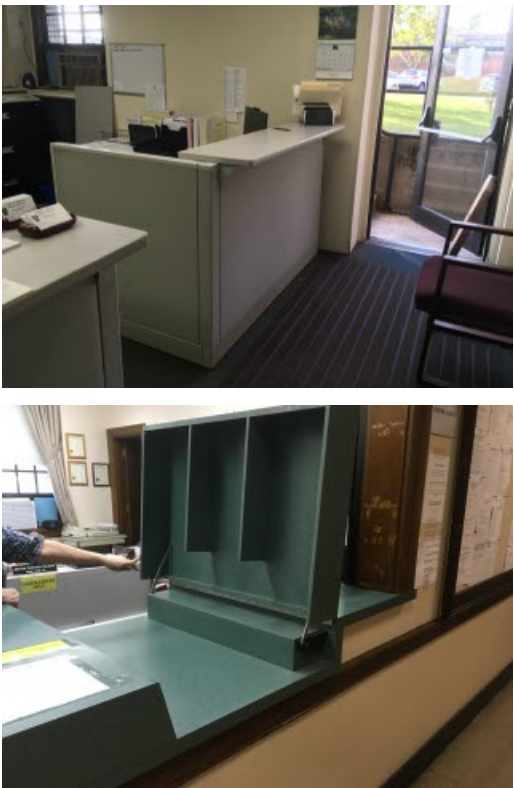
#	Issue	Mitigation	Photo	Cost
25.	Transaction Counters Transaction counters are > 36" AFF. Adapted counters are not used as they are very heavy and do not stay open.	Provide lowered counter or shelf. Unit Cost: \$250 Est. Quantity: 5

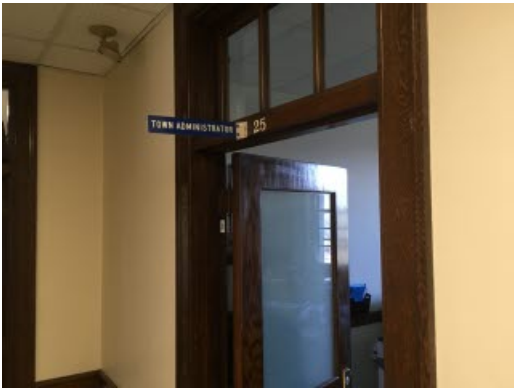
\$1,250
26.	Signage Permanent room sign is not mounted on the latch side of the door and lacks tactile/Braille elements.	Install tactile/Braille signage on the latch side of the door. Coordinate with location and height requirements. Unit Cost: \$100 ea. Est. Quantity: 18

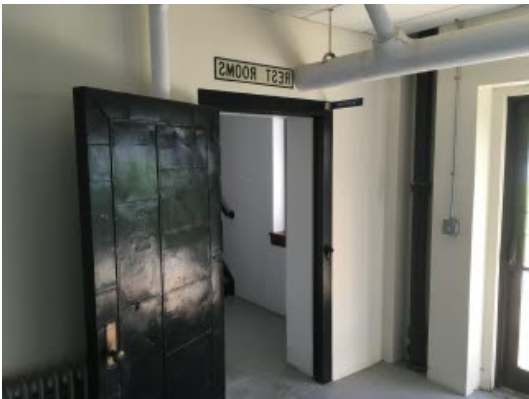
#	Issue	Mitigation	Photo	Cost
27.	Toilet Rooms The inaccessible Men's (1 st & 2 nd Fl) and Women's (1 st & 3 rd Fl) toilet rooms: <ul style="list-style-type: none"> lack visual alarms lack directional signage to accessible toilet rooms. 	Install a visual/audible alarm in each toilet room. Unit cost: \$750 ea. Quantity: 4 Install directional signs. Unit cost: \$100 ea. Quantity: 4

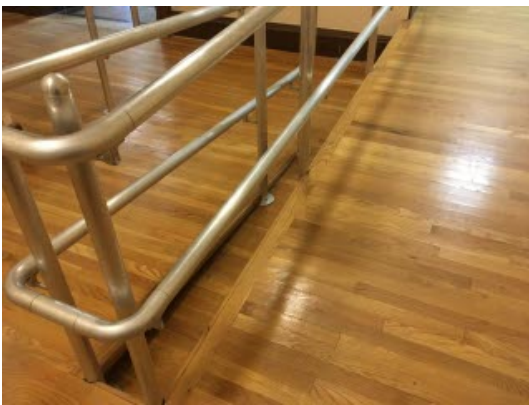
\$3,000 \$400
28.	Ramps (2) The ramps lack edge protection.	Install edge protection. Unit Cost: \$10/lf Est. Quantity: 40 lf

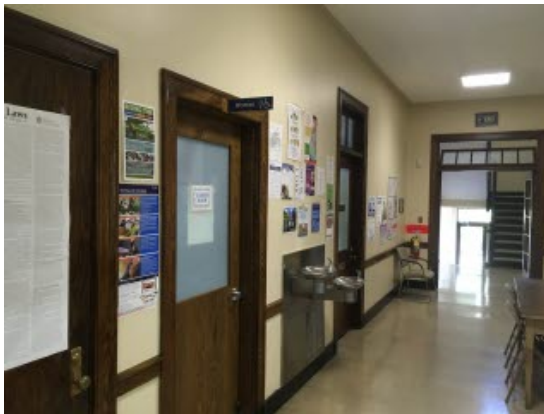
#	Issue	Mitigation	Photo	Cost
29.	Drinking Fountains The “high” water fountain protrudes >4” into the circulation route.	Install a cane detectable object below the water fountain. Unit Cost: \$250 ea. Quantity: 1

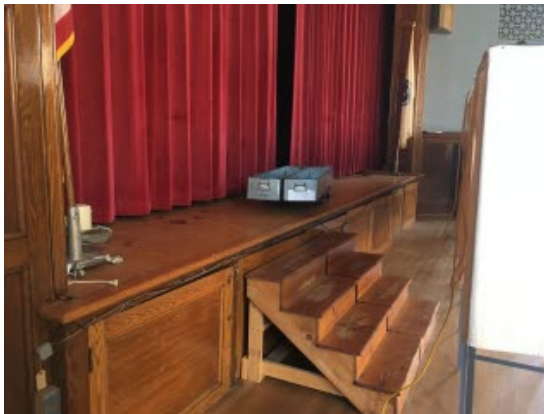
\$250
30.	Auditorium The auditorium lacks an accessible route to the stage.	If the stage is used for public programs, install a platform lift. Unit cost: \$15,000 ea. Quantity: 1

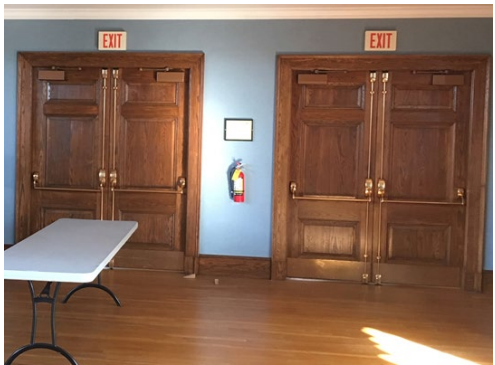
#	Issue	Mitigation	Photo	Cost
31.	Doors Doors require > 5lbs force to open.	Adjust door closers. Unit Cost: \$0 Est. Quantity: 2

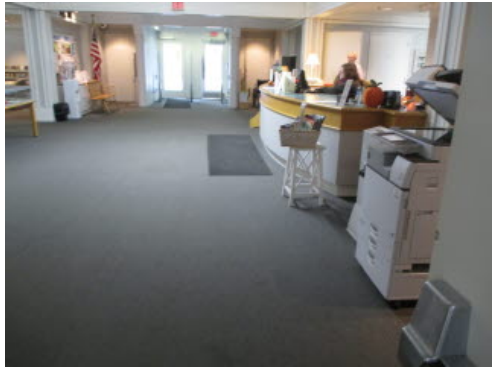
#	Issue	Mitigation	Photo	Cost
5.	Transaction Counter The transaction counter is >36" AFF.	Provide lowered counter or shelf. Unit Cost: \$250 Quantity: 1

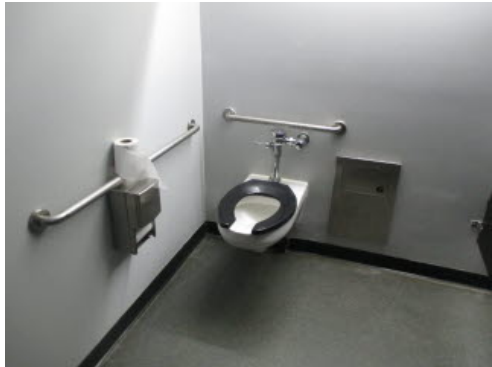
\$250
6.	Children's Toilet Room The toilet flush control is not located on the wide side of the toilet.	Reposition the flush valve or install an automatic flush control. Unit Cost: \$1,500 ea. Quantity: 1

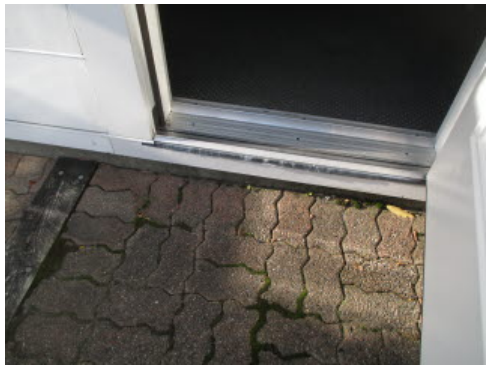
\$1,500
7.	Patio Doors All doors to the patio have changes in level > ½" AFF, @ 4"-7".	Provide an accessible route to the patio. Additional study required. Unit Cost: \$6,000 Quantity: 1

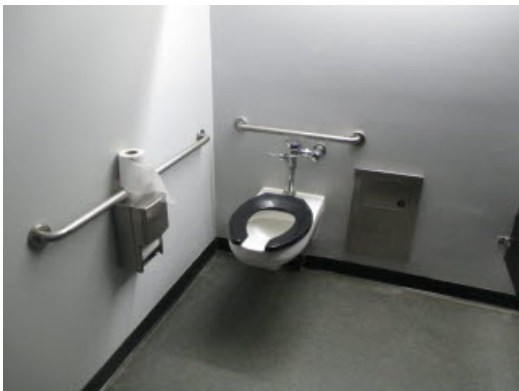
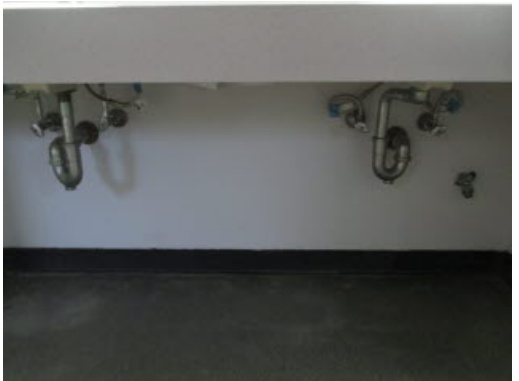
#	Issue	Mitigation	Photo	Cost
8.	Men's & Women's Room <ul style="list-style-type: none"> The grab bars are mounted <33"-36" AFF to the top of the gripping surface, @ 30". The rear grab bars are < 36" long, @ 24". The lavatory pipes are not insulated. 	<p>Re-position the side grab bars. Unit cost: \$150 ea. Quantity: 2</p> <p>Install a new 36" rear grab bar. Unit cost: \$150 ea. Quantity: 2</p> <p>Insulate the pipes. Unit cost. \$50 Quantity: 2</p>

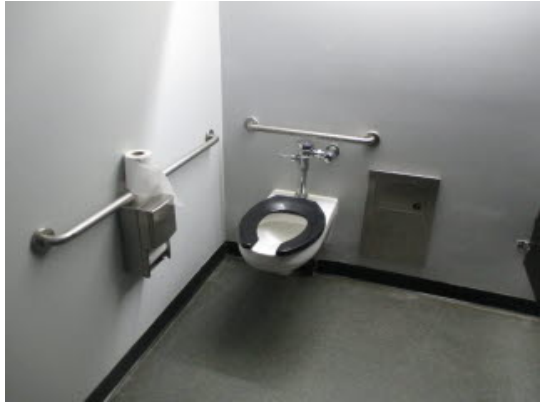
#	Issue	Mitigation	Photo	Cost
9.	Women's Toilet Room The toilet flush control is not located on the wide side of the toilet.	Reposition the flush valve or install an automatic flush control. Unit Cost: \$1,500 ea. Quantity: 1

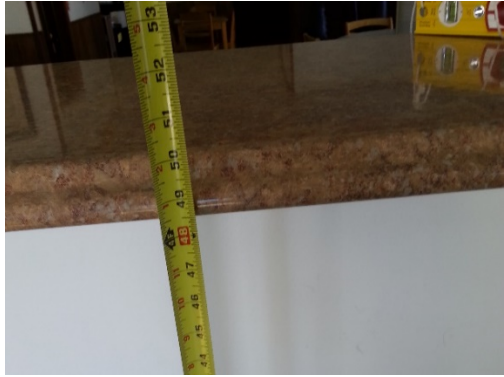
#	Issue	Mitigation	Photo	Cost
2.	Transaction Counter The counter height of the main service desk in the building is >36", @ 50" AFF.	Provide lowered counter or shelf. Unit Cost: \$250 Est. Quantity: 1

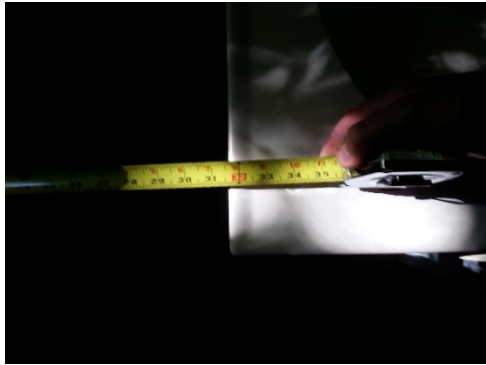
\$250
3.	Toilet Room The toilet room lacks the footprint and fixtures required for an accessible bathroom.	Build an accessible toilet room. Further design study required. Unit Cost: \$15,000 Quantity: 1

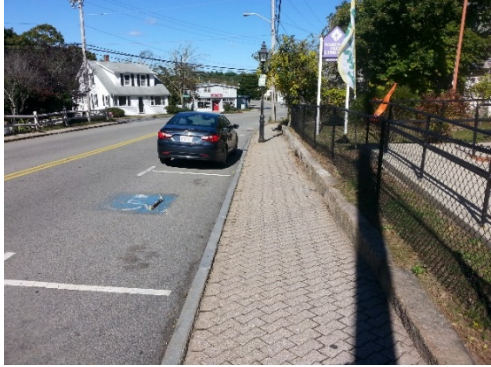
#	Issue	Mitigation	Photo	Cost
Spinney Library				
1.	Accessible Route There is no accessible route from the accessible parking space to the walkway accessing the building.	Install a curb ramp. Unit Cost: \$1,250 ea. Quantity: 1

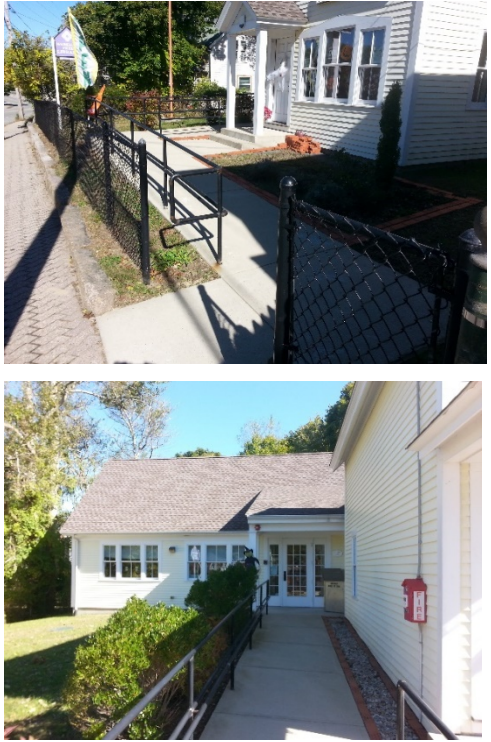
\$1,250
2.	Ramp The ramp lacks the required handrails on both sides.	Install compliant handrails and handrail extensions on both sides of the ramp. Unit Cost: \$50/lf Est. Quantity: 30 lf

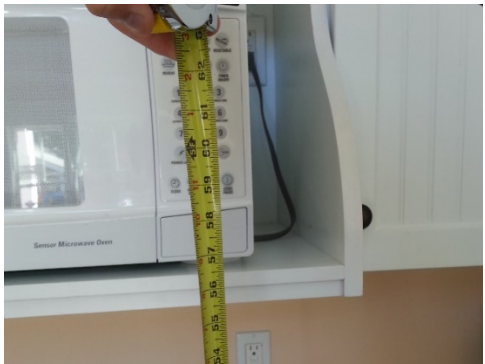
#	Issue	Mitigation	Photo	Cost
3.	Microwave The microwave controls in the common-use space are >48" AFF, @ 63".	Lower the microwave. Unit Cost: \$200 Quantity: 1

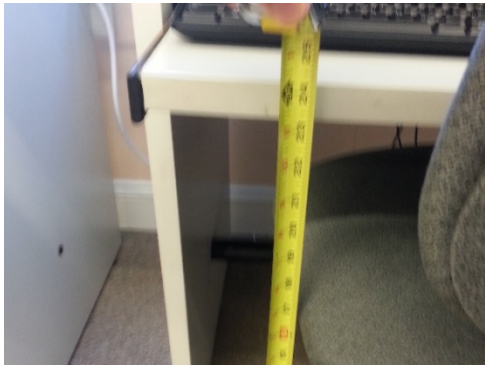
\$200
4.	Computer Stations The knee space at the computer stations is <27" AFF, @ 22".	Provide at least one table, and no less than 5% of the total number of tables, that provides compliant knee and toe clearance. Unit cost: \$250 ea. Est. Quantity: 1

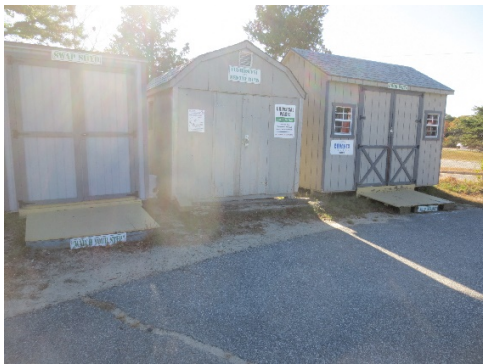
#	Issue	Mitigation	Photo	Cost
34.	Buildings The book barn, fluorescent/mercury, swap shed, and surplus paint buildings are not on an accessible route, due to the steps.	Install ramps. or develop/implement operational protocols and staff training to provide assistance. Unit Cost: \$0 Quantity: 1

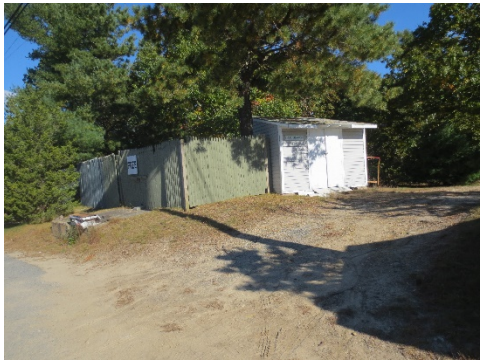
\$0
35.	Electronics/ Free Areas The electronics/free areas are not located on an accessible route, due to change in elevation and surface materials.	Install a walkway. or develop/implement operational protocols and staff training to provide assistance. Unit Cost: \$0 Quantity: 1

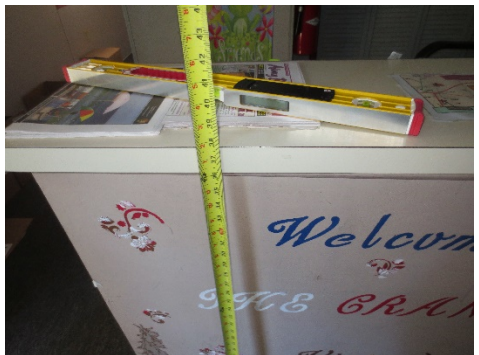
#	Issue	Mitigation	Photo	Cost
3.	Transaction Counter The counter height is >36", @ 37 ¾" AFF.	Provide lowered counter or shelf. Unit Cost: \$250 Est. Quantity: 1

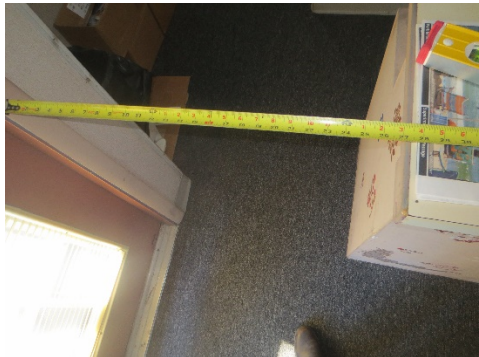
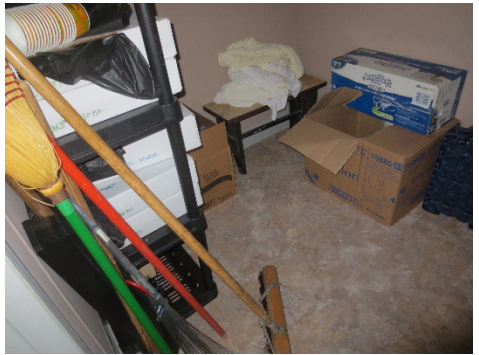
\$250
4.	Baby Changing Room <ul style="list-style-type: none"> The baby changing room is not located on a min. 32" wide accessible route, @ 27" wide between the transaction counter and the opposing wall. Note: the accessible route is permitted to be reduced to 32" for a maximum 24" depth. <ul style="list-style-type: none"> The baby changing room lacks the required min. 60" of turning space, due to the movable storage items. 	Widen the accessible route. Unit Cost: \$500 Quantity: 1 Relocate the storage items. Unit Cost: \$0 Quantity: 1

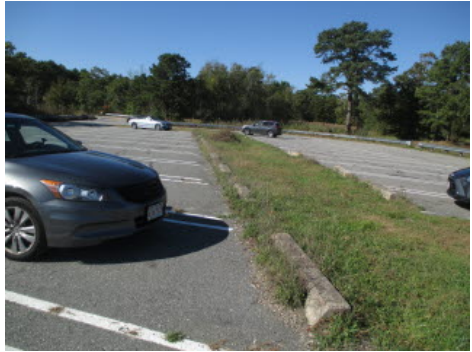
#	Issue	Mitigation	Photo	Cost
5.	Boat Ramp The parking lot at the boat ramp lacks accessible parking spaces.	Restripe a portion of the parking lot to add accessible parking spaces (including at least one van space), as well as their associated signs and access aisles. Unit Cost: \$300 ea. Est. Quantity: 6 (4 spaces + 2 access aisles)

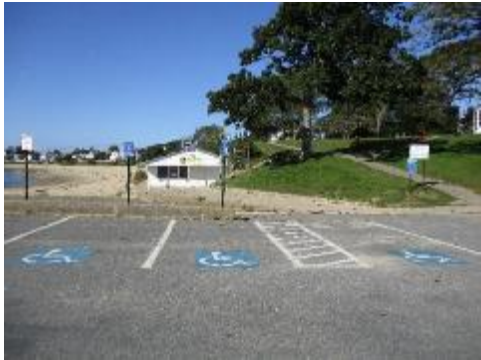
Town Wharf				
1.	Accessible Parking at Entrance <ul style="list-style-type: none"> One of the designated accessible parking spaces lacks an access aisle. One of the designated accessible parking spaces lacks a sign at the head of the space. 	<p>Restripe a portion of the parking lot to add a van accessible parking space, as well as the associated sign and access aisle.</p> <p>Unit Cost: \$300 ea.</p> <p>Quantity: 2 (1 space + 1 access aisle)</p> <p>Add a new van accessible sign to the existing designated accessible parking space.</p> <p>Unit Cost: \$100 per sign</p> <p>Quantity: 1</p>

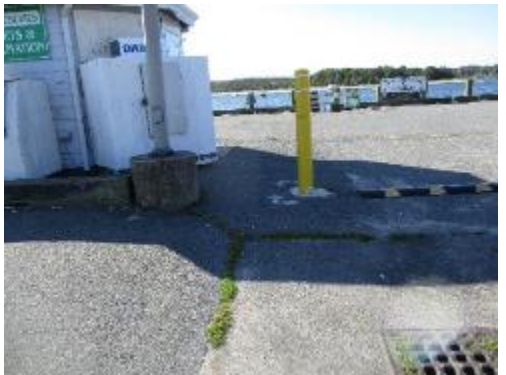
\$500
4.	Finger Piers Several piers appeared to be seasonal and were not installed at the time of KMA's site visit.	Town to confirm.	No Image	TBD
5.	Canal Cruise Accessible Route The accessible route from the accessible parking space has excessive slopes in both directions, @ up to 9.7%.	Re-grade the walkway. Unit Cost: \$75/sf Est. Quantity: 25 sf.

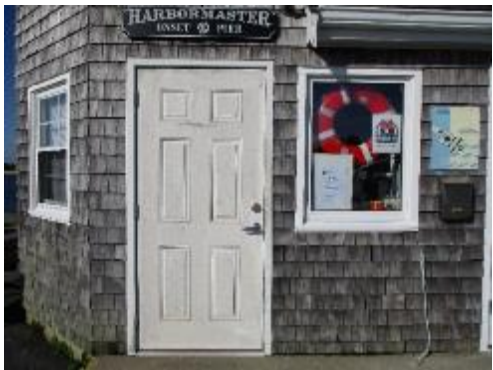
#	Issue	Mitigation	Photo	Cost
6.	Onset Pier Ticket Counter The ticket counter is >36" AFF, @ 40 ½".	Provide lowered counter or shelf. Unit Cost: \$250 Quantity: 1

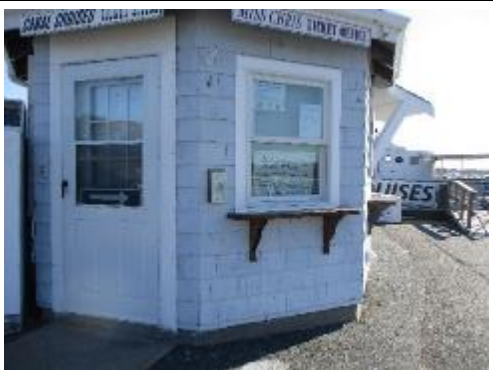
\$250
7.	Canal Cruises Ticket Counter <ul style="list-style-type: none"> The ticket counter is >36" AFF, @ 42 ½". The ticket counter lacks a level (no slopes >2%) adjacent 30"X48" clear floor space, @ up to 4.8% slopes. 	Provide lowered counter or shelf. Unit Cost: \$250 Quantity: 1 Regrade the pavement at the ticket counter. Unit Cost: \$75/sf Est. Quantity: 12 sf

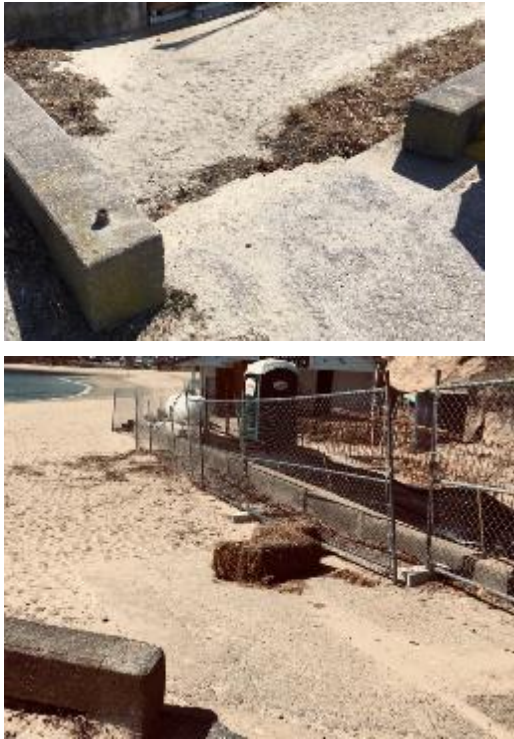
#	Issue	Mitigation	Photo	Cost
9.	Accessible route to the beach An accessible route to the beach is not provided.	Provide an accessible route to the boat areas. Additional study required. Unit Cost: \$5,000 Quantity: 1

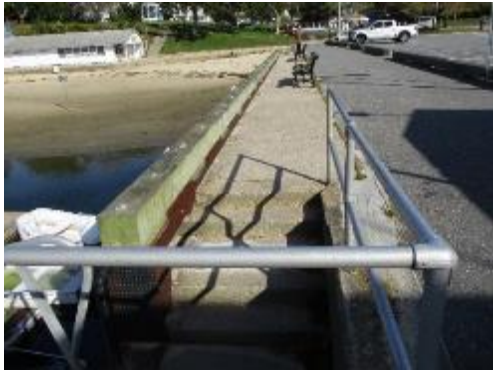
\$5,000
10.	Accessible Route to Boat Areas There is no accessible route provided to the boat areas.	Provide an accessible route to the boat areas. Additional study required. Unit Cost: \$10,000 Quantity: 1

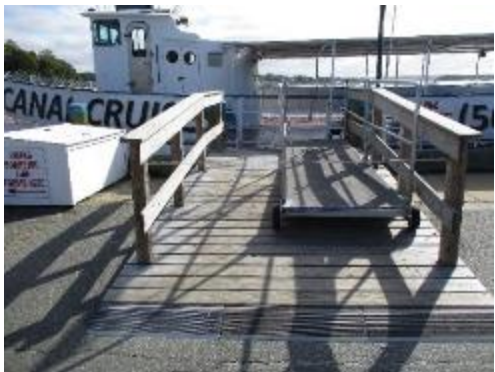
#	Issue	Mitigation	Photo	Cost
11.	Canal Cruise Boarding Ramp The boarding ramp has running slopes >8.3%, @ up to 32.6%.	Additional information is required as to the operator of the cruises. The obligation to provide access to the vessel is likely the responsibility of the operator.

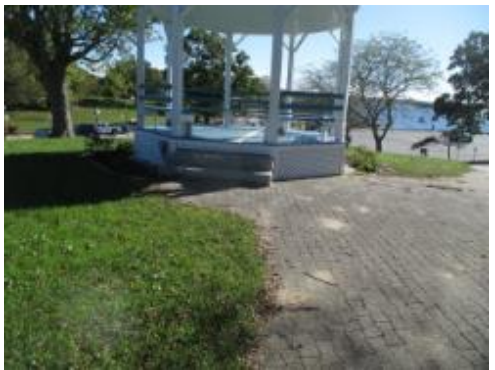
TBD
12.	Gazebo The gazebo is not located on an accessible route, due to the 25" change in elevation (steps).	Install a ramp. Unit cost: \$3,000 Quantity: 1

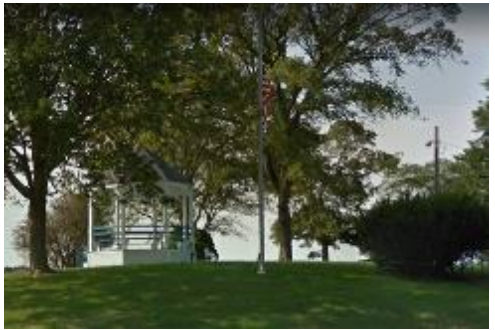
\$3,000
13.	Flag Pole The flag pole is not located on an accessible route.	No action necessary if flag is raised/lowered by municipal employees. Town to confirm. Unit Cost: \$0 Quantity: 1

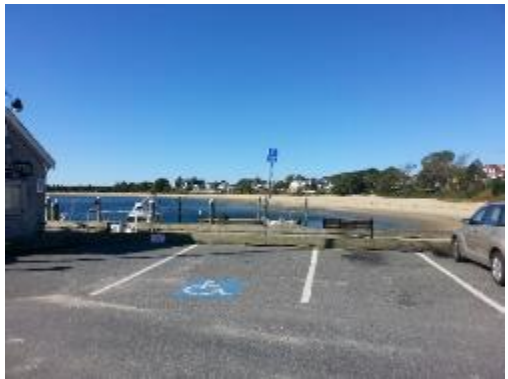
1.	Parking The accessible parking space servicing the Harbormaster building has slopes >2%, @ up to 2.4%.	Re-grade the parking spaces and their associated access aisle. Unit Cost: \$1,500 per space or aisle Quantity: 2 (1 space + 1 aisle)

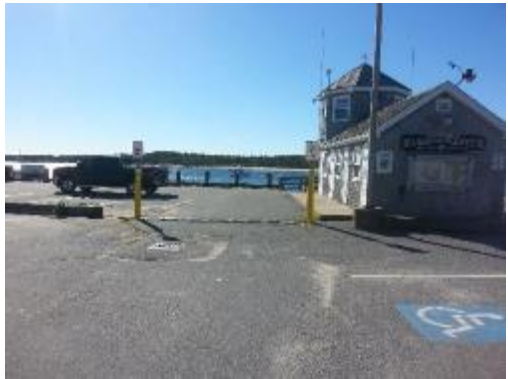
\$3,000
2.	Route from Accessible Parking The accessible route from the accessible parking space to the building entrance is obstructed (speed bump) and contains excessive cross slopes.	Remove the barriers and re-grade the sloped walkway entry. Unit Cost: \$75/sf Est. Quantity: 20 lf

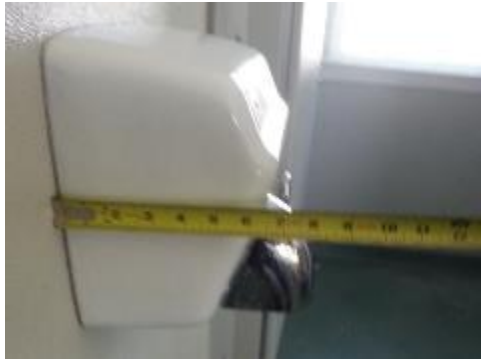
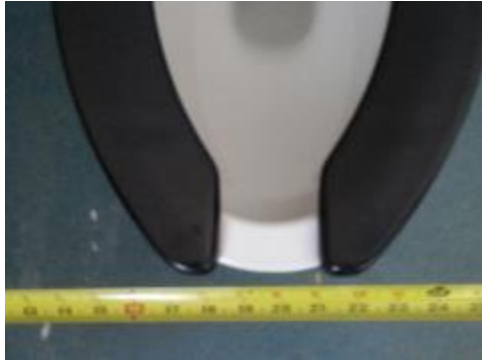
#	Issue	Mitigation	Photo	Cost
5.	Men's & Women's Toilet Rooms <ul style="list-style-type: none"> The hand dryers protrude >4" into the circulation space. The centerlines of the toilets at the accessible stalls are >18", @ up to 20" from the side wall. The sink in the Women's restroom lacks the required 36" width for a forward approach into an alcove >24", @ 35 ½". 	<p>Relocate the hand dryers.</p> <p>Unit Cost: \$300 ea. Quantity: 2</p> <p>Relocate the toilet so the centerline is 18" from the side wall.</p> <p>Unit cost: \$1,500 ea. Quantity: 2</p> <p>Relocate the lavatory.</p> <p>Unit cost: \$500 ea. Quantity: 1</p>

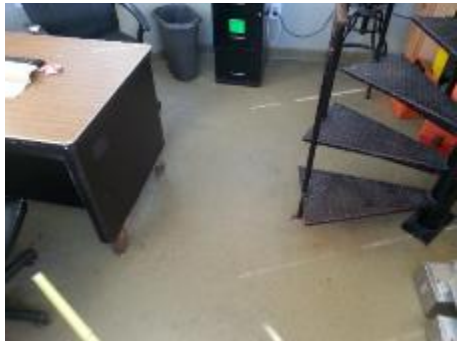
6.	Harbormaster Office The Harbormaster's office lacks the accessible clear floor space to be able to maneuver throughout the office.	<p>Additional study required</p> <p>Unit cost: \$1,000 Quantity: 1</p>

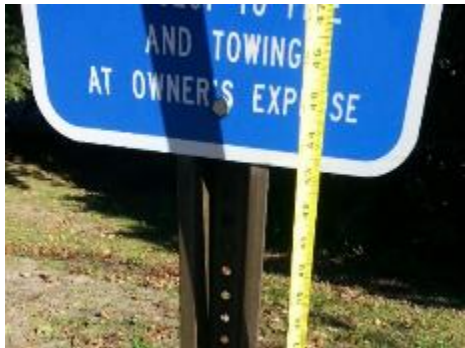
#	Issue	Mitigation	Photo	Cost
Onset Ave Comfort Station				
1.	Accessible Parking The bottom edge of the accessible parking signs is mounted <60" AFF.	Re-install the signs at 60" min. AFF, measured to the bottom of the sign. Unit Cost: \$100 ea. Quantity: 6

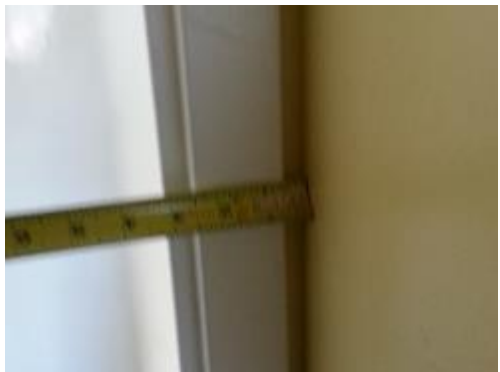
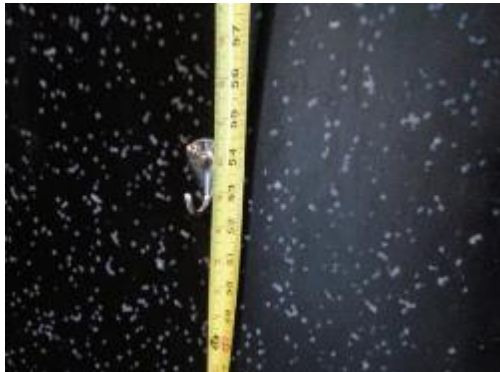
#	Issue	Mitigation	Photo	Cost
4.	Men's & Women's Toilet Rooms <ul style="list-style-type: none"> The doors to both the Men's and Women's restrooms lack the required min. 12" of maneuvering clearance on the latch push side for a forward approach, @ 3". The coat hooks in the accessible stalls are mounted >48" AFF, @ 54". 	<p>Install an automatic door opener. Unit cost: \$2,500 ea. Quantity: 2</p> <p>Install a coat hook mounted no higher than 48" AFF. Unit Cost: \$50 ea. Quantity: 2</p>

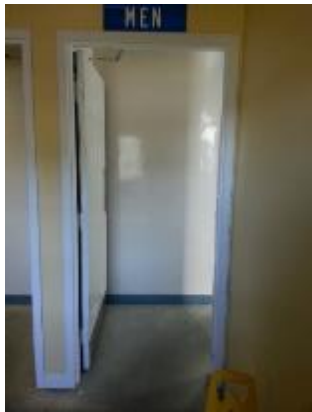
<p>\$5,000</p> <p>\$50</p>
5.	Men's Toilet Room The Men's restroom lacks the required tactile/braille signage at the latch side of the door.	<p>Install tactile/Braille signage on the latch side of the door. Coordinate with location and height requirements.</p> <p>Unit Cost: \$100 ea. Quantity: 1</p>

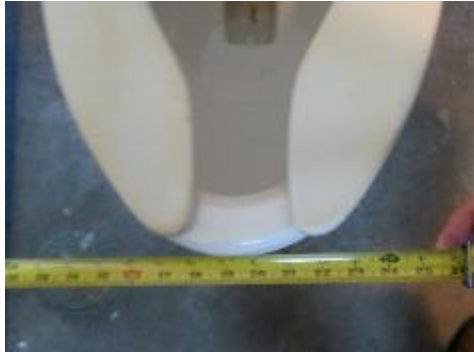
#	Issue	Mitigation	Photo	Cost
6.	Women's Toilet Room The centerline of the toilet in the Women's accessible stall is >18" from side wall, @ 19 ¼".	Reposition the toilet. Unit cost: \$1,500 ea. Quantity: 1

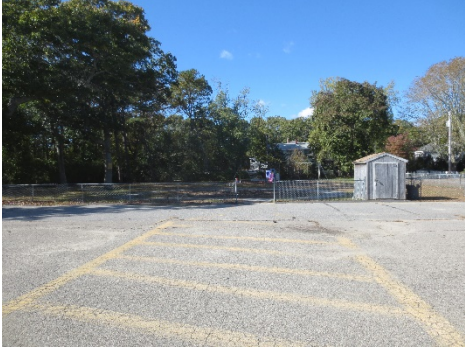
#	Issue	Mitigation	Photo	Cost
East Wareham School				
1.	Parking The parking lot lacks accessible parking spaces.	Restripe a portion of the parking lot to add accessible parking spaces (including at least one van space), as well as their associated signs and access aisles. Unit Cost: \$300 ea. Est. Quantity: 2 (1 space + 1 access aisle)

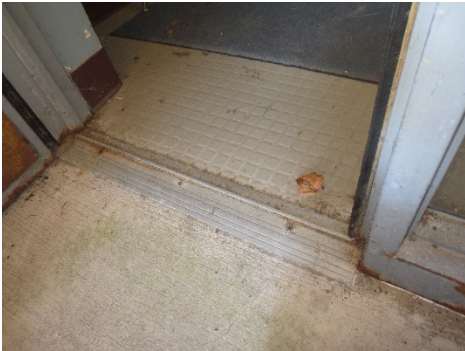
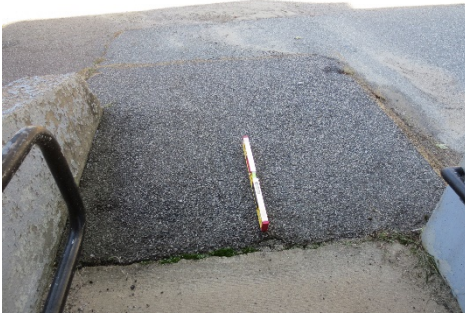
\$600
2.	Entrances <ul style="list-style-type: none"> Two of the three entrances are not accessible due to the stairs. The rear side entrance threshold is not beveled at 1:2. The rear side entrance ramp has an upper landing with slopes >2%, @ up to 6%, and a vertical change in level >1/4" AFF. 	Provide directional signage at the inaccessible entrances. Unit Cost: \$100 ea. Quantity: 2 Replace the threshold. Unit Cost: \$100 ea. Quantity: 1 Re-grade the landing surface. Unit cost: \$30/sf Est. Quantity: 25 sf

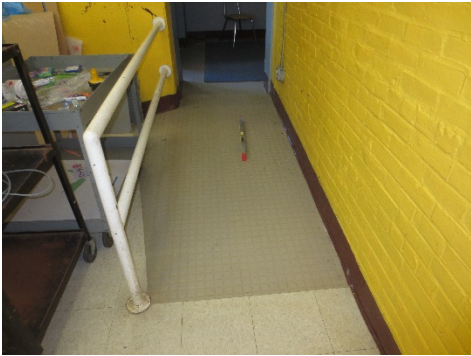
#	Issue	Mitigation	Photo	Cost
3.	Cafeteria Ramp <ul style="list-style-type: none"> The cafeteria ramp lacks the required handrails on both sides. The existing handrail is not mounted at a consistent height, it runs horizontal to the cafeteria floor. 	Install compliant handrails on both sides. Unit cost: \$50/lf Est. Quantity: 12 lf

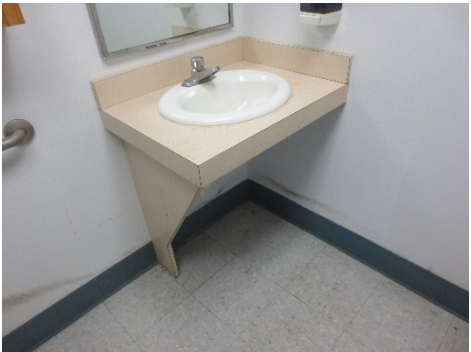
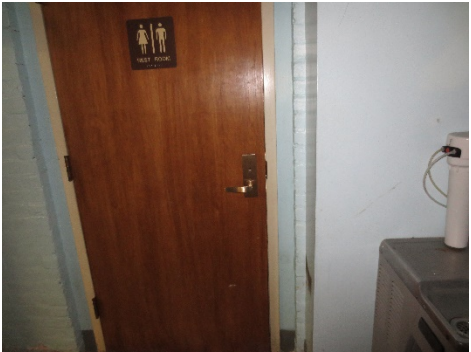
4.	Men's & Women's Toilet Room <ul style="list-style-type: none"> The door lacks the required min. 18" of maneuvering clearance on the latch pull side for a forward approach, @ 7". There is <60" of clearance at the toilet, @ 58" to the adjacent lavatory. The lavatory lacks the required 30" wide knee clearance for a forward approach, @ 26". The bathroom lacks a visual alarm. 	Install an automatic door opener. Unit cost: \$2,500 ea. Quantity: 1 Install a new lavatory. Unit Cost: \$500 ea. Quantity: 1 Install a visual/audible alarm in each toilet room. Unit cost: \$750 ea. Quantity: 1

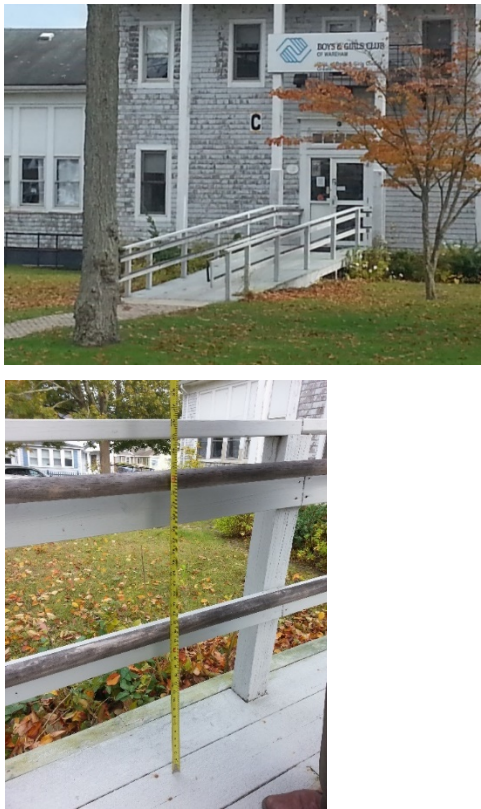
#	Issue	Mitigation	Photo	Cost
Hammond School				
1.	Entry Ramp <ul style="list-style-type: none"> The entry ramp that brings a visitor from the main walkway to the building entrance has a running slope >8.3%, @ 10.0%. The ramp handrails are mounted <34" above ramp surface. 	Rebuild the ramp. Unit Cost: \$7,500 Quantity: 1

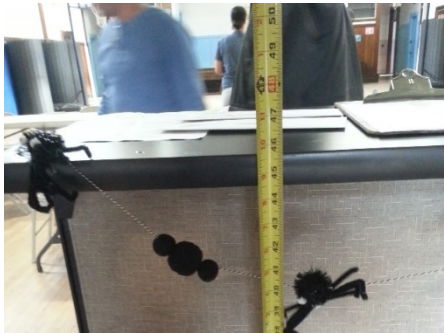
\$7,500
2.	Transaction Counters The transaction counter is > 36" AFF, @ 50".	Provide lowered counter or shelf. Unit Cost: \$250 Est. Quantity: 1

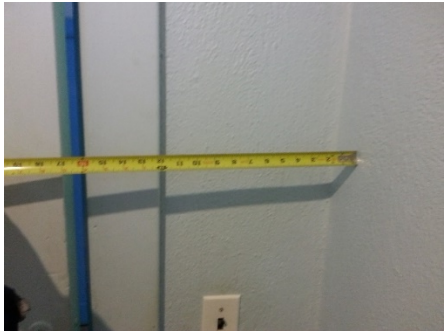
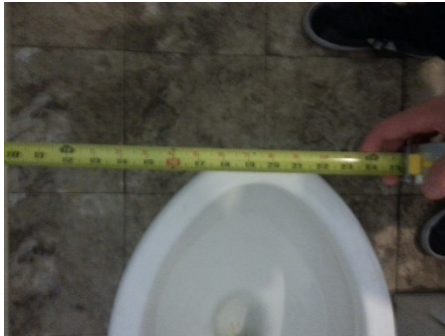
#	Issue	Mitigation	Photo	Cost
3.	Staff Toilet Room (used for voting) <ul style="list-style-type: none"> The staff toilet room door lacks the 18" required maneuvering clearance on the pull-side latch. The paper towel dispenser protrudes >4" max. into the accessible route. The toilet centerline is >18" from the side wall, @ 19 ½". The bottom of the reflective surface of the mirror is mounted >40" AFF, @ 50". 	Install an automatic door opener. Unit Cost: \$2,500 Quantity: 1 Relocate the dispenser. Unit cost: \$150 ea. Quantity: 1 Reposition the toilet. Unit cost: \$1,500 ea. Quantity: 1 Lower the mirror. Unit cost: \$500 ea. Quantity: 1

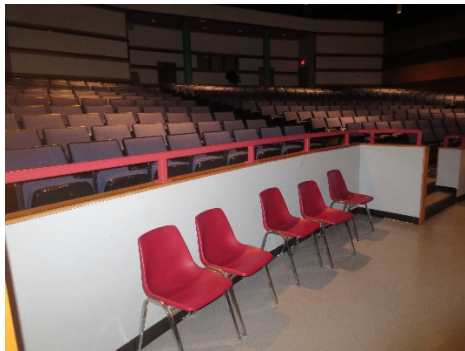
#	Issue	Mitigation	Photo	Cost
		Est. Quantity: 1		
4.	Auditorium Seating The accessible seating is not dispersed/ integrated throughout the auditorium.	Additional study required. Unit Cost: \$10,000 Quantity: 1

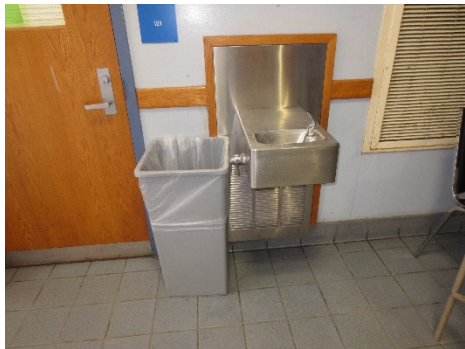
5.	Drinking Fountains <ul style="list-style-type: none"> Drinking fountains along the route to the auditorium protrude >4" into the circulation space. Drinking fountains lack the required min. 27" AFF knee space below for a forward approach, @ 26 1/2". 	Relocate the drinking fountain to a location where it is not a protruding object and provides the required knee clearance. Unit Cost: \$1,500 ea. Quantity: 2
