**ARCHITECTURE
+ ACCESSIBILITY**

ACCESSIBILITY AUDITS

WAREHAM, MA

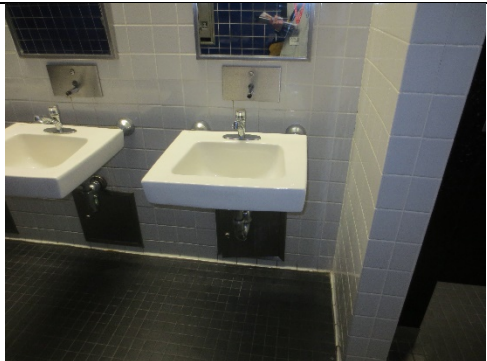
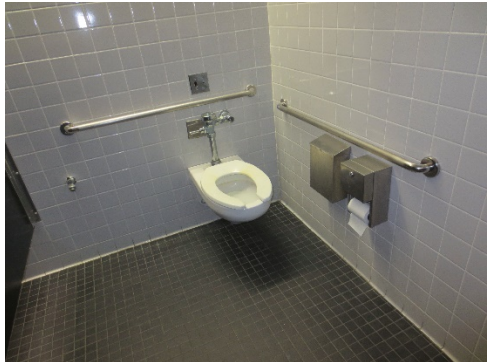
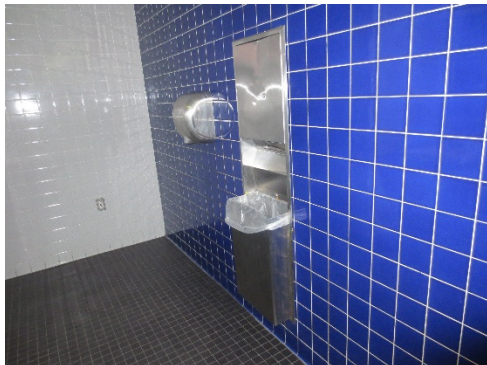
#	Issue	Mitigation	Photo	Cost
	<p>on the latch push side for a forward approach, @ 6".</p> <ul style="list-style-type: none"> The mirrors are mounted >40" AFF to the bottom of the reflective surface, @ 42 ½". The lavatory pipes are not insulated. The sidewall grab bars do not extend minimum 54" from the rear wall, @ 48". The sidewall grab bars are <34"-36" AFF to the top of the gripping surface, @ 31". The accessible toilet paper dispensers are mounted >7"-9" from the front edge of the toilet, @ 12". The coat hooks in the accessible stalls are mounted >48" AFF, @ 54". The hand dryers protrude >4" into the circulation space, @ 7". No visual alarms are provided in the bathrooms. 	<p>Quantity: 2 Lower the mirrors. Unit cost: \$500 ea. Quantity: 2 Insulate the pipes. Unit cost. \$50 Quantity: 2 Re-position the grab bars. Unit cost: \$150 ea. Quantity: 2 Relocate the toilet paper dispensers, the coat hooks, and the hand dryers. Unit Cost: \$100 ea. Quantity: 6</p> <p>Install a visual/audible alarm in each toilet room. Unit cost: \$750 ea. Quantity: 2</p>

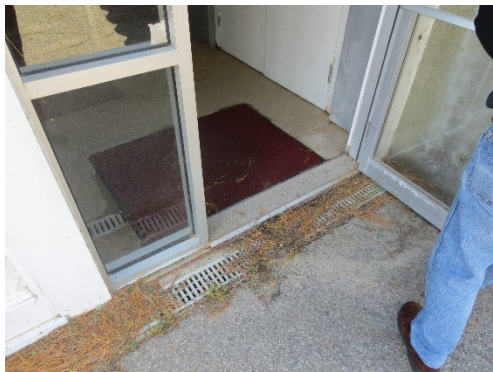
#	Issue	Mitigation	Photo	Cost
3.	Entry Door <ul style="list-style-type: none"> The entry door maneuvering clearance has slopes >2%, @ 3.7% on the exterior side. The entry threshold is >1/2" AFF beveled at 1:2, due to the 1" vertical change in level underneath the metal threshold. 	Install an automatic door opener. Unit cost: \$2,500 ea. Quantity: 1 Re-grade the landing surface. Unit cost: \$30/sf Est. Quantity: 25 sf

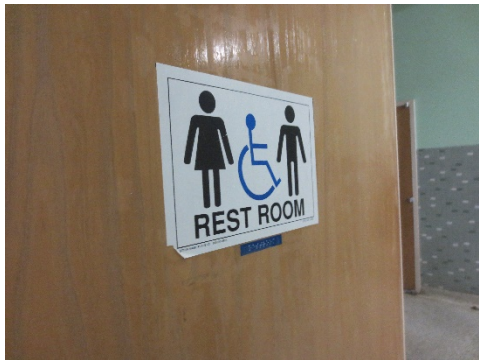
5.	Accessible Unisex Toilet Room Level 3 <ul style="list-style-type: none"> The entry door does not provide the required min. 32" of clear width, @ 31". The entry door lacks the required min. 18" of maneuvering clearance on the latch pull side for a forward approach, @ 7". 	Widen the doorway. Unit Cost: \$500 Quantity: 1 Install an automatic door opener: Unit Cost: \$2,500 Quantity: 1

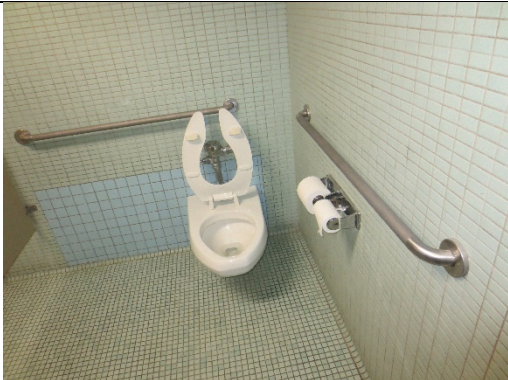
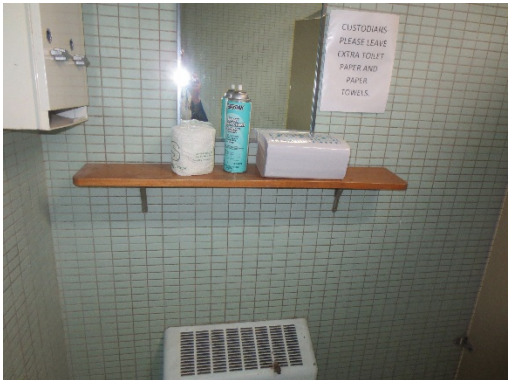
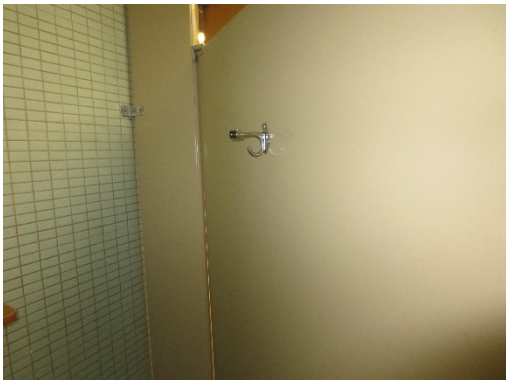
#	Issue	Mitigation	Photo	Cost
	<ul style="list-style-type: none"> The signage is not tactile and not mounted on the latch side of the door. The door hardware requires tight grasping and twisting of the wrist to operate. The rear wall grab bar is mounted >12" from the sidewall, @ 13". The toilet seat is <17"-19" AFF, @ 15". The bottom of the reflective surface of the mirror is mounted >40" AFF, @ 52". The coat hook is >48" AFF, @ 56". The tampon dispenser controls are >48" AFF, @ 60". The paper towel dispenser is mounted >48" AFF, @ 54". 	<p>Install tactile/Braille signage on the latch side of the door. Coordinate with location and height requirements.</p> <p>Unit Cost: \$100 Quantity: 1</p> <p>Replace the door hardware with lever type.</p> <p>Unit cost: \$300 ea. Quantity: 1</p> <p>Re-position the rear grab bar.</p> <p>Unit cost: \$150 ea. Quantity: 1</p> <p>Replace the toilet.</p> <p>Unit cost: \$1,500 ea. Quantity: 1</p> <p>Lower the mirror.</p> <p>Unit cost: \$500 ea. Quantity: 1</p> <p>Lower the coat hook and dispensers.</p> <p>Unit cost: \$100 Quantity: 3</p>

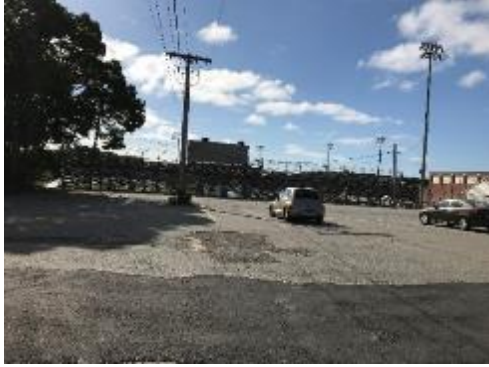
Basketball Courts Sylvester Gardens				
1.	Accessible Parking No designated accessible parking is provided.	Restripe a portion of the parking lot to add accessible parking spaces (including at least one van space), as well as their associated signs and access aisles. Unit Cost: \$300 ea. Est. Quantity: 2 (1 space + 1 access aisle)

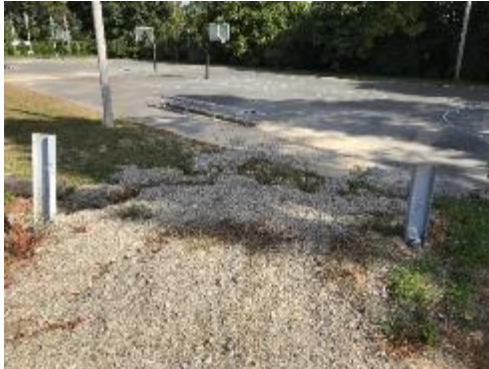
\$600
2.	Accessible Route No accessible route is provided to the basketball courts.	Provide an accessible route to at least one basketball court and all common use elements. Additional study required. Unit Cost: \$5,000 Quantity: 1

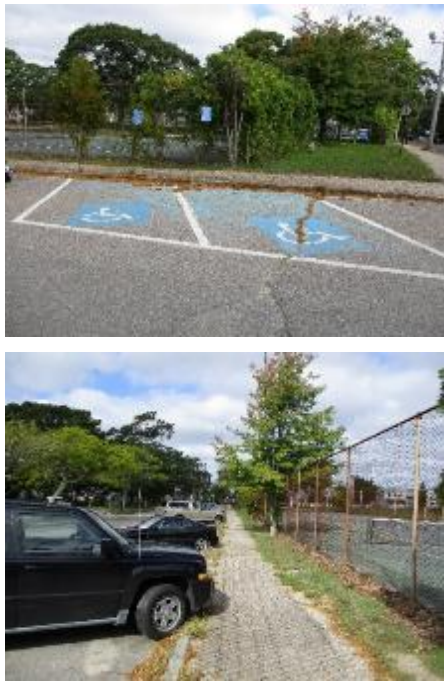
#	Issue	Mitigation	Photo	Cost
Brown Memorial Courts				
1.	Parking <ul style="list-style-type: none"> The designated accessible parking spaces lack an associated access aisle. The existing designated accessible parking spaces are not located on the shortest accessible route to the accessible entrance, @ the furthest from the gate entrance to the courts. 	Relocate/ restripe a portion of the parking lot to add accessible parking spaces (including at least one van space), as well as their associated signs and access aisles. Unit Cost: \$300 ea. Quantity: 3 (2 spaces + 1 aisle)

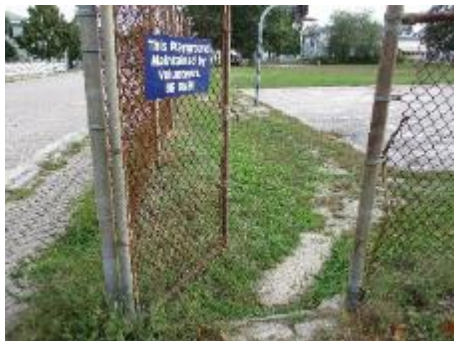
\$900
2.	Accessible Route No accessible route is provided to the basketball courts or the tennis courts.	Provide an accessible route to the courts. Additional study required. Unit Cost: \$3,000 Quantity: 1

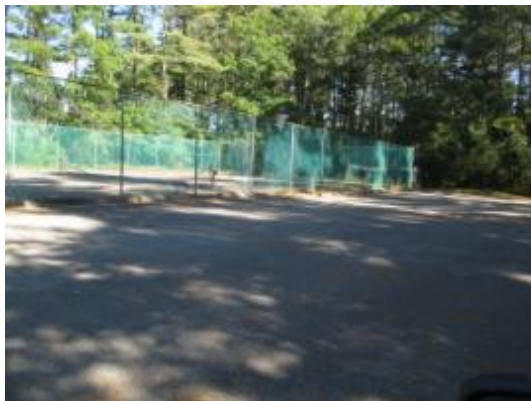
Carver Road Tennis Court/ Canoe Area				
1.	Parking No designated accessible parking is provided.	Restripe a portion of the parking lot to add accessible parking spaces (including at least one van space), as well as their associated signs and access aisles. Unit Cost: \$300 ea. Est. Quantity: 2 (1 space + 1 access aisle)

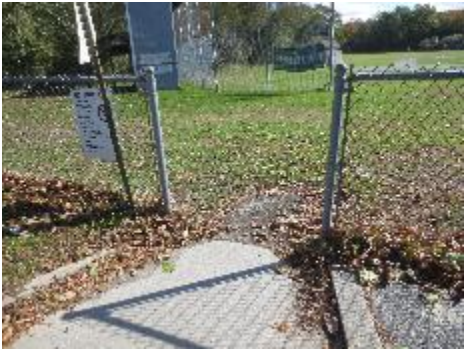
\$15,000
2.	Press Box The press box is not located on an accessible route, due to the stairs and change in surface material.	Additional study required Unit Cost: \$20,000 Quantity: 1

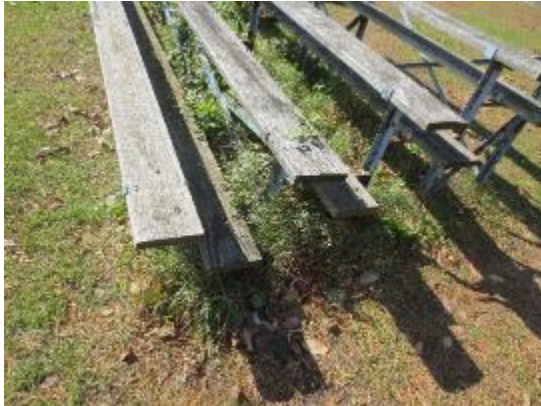
#	Issue	Mitigation	Photo	Cost
3.	Accessible Seating A wheelchair space is not provided at the bleachers.	Provide an accessible space on an accessible route next to the bleachers. Unit cost: 75 sq/ft Est. Quantity: 25 sq/ft

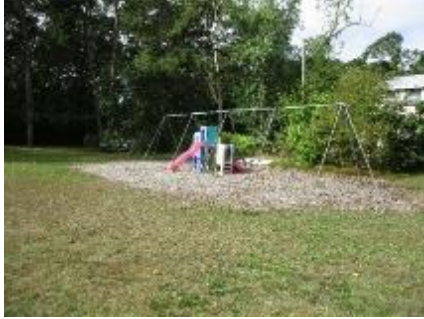
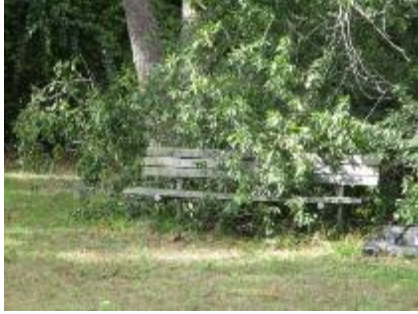
East Wareham Playground				
1.	Accessible Route <ul style="list-style-type: none"> No accessible route is provided to the playground and the benches. The playground lacks accessible elements and accessible route between elements. 	Provide an accessible route to the playground and the benches. Additional study required. Unit Cost: \$10,000 Quantity: 1

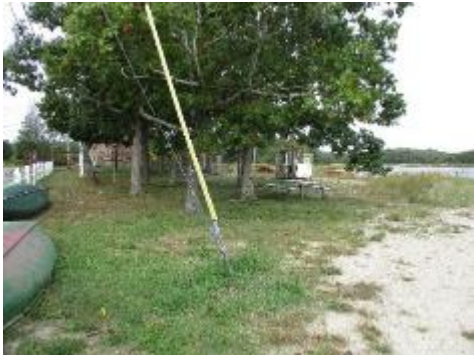
#	Issue	Mitigation	Photo	Cost
Ellis Playground				
1.	Accessible Route No accessible route is provided to the playground.	Provide an accessible route to the playground and all unique common use elements. Additional study required. Unit Cost: \$5,000 Quantity: 1

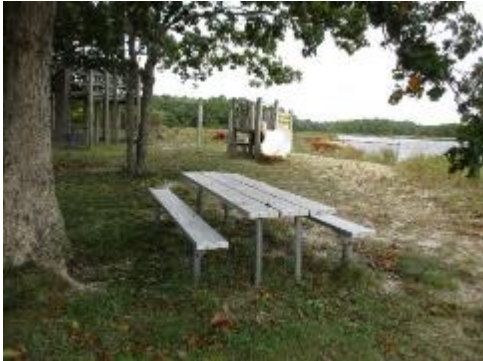
\$5,000
2.	Playground The playground lacks accessible elements and accessible route between elements.	Additional study required. Unit Cost: \$3,000 Est. Quantity: 1	No Image	\$3,000
3.	Seating Picnic tables lack an accessible seating location.	Provide at least one table, and no less than 5% of the total number of tables, that provides compliant knee and toe clearance. Unit cost: \$250 ea. Est. Quantity: 1

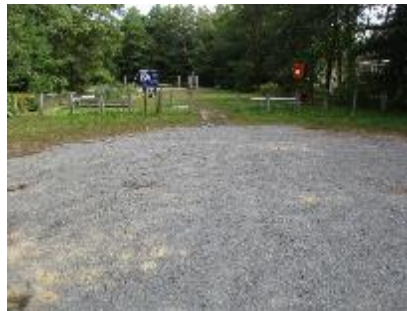
#	Issue	Mitigation	Photo	Cost
Indian Mound Playground				
1.	Parking No accessible parking is provided.	Pave a portion of the parking lot to add accessible parking spaces (including at least one van space), as well as the associated signs and access aisles. Unit Cost: \$1,500 ea. Est. Quantity: 2 (1 space + 1 access aisle)

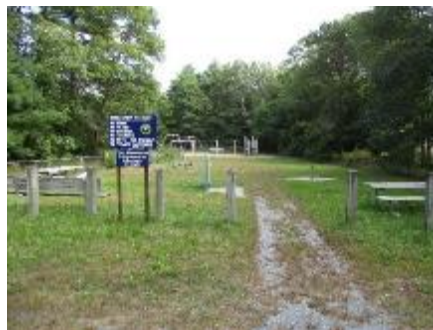
2.	Accessible Route <ul style="list-style-type: none"> No accessible path of travel is provided to the playground. The playground lacks accessible elements and accessible route between elements. 	Provide an accessible route to the playground. Additional study required. Unit Cost: \$5,000 Quantity: 1

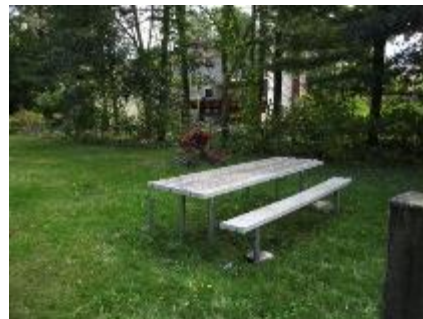
3.	Seating Picnic tables lack an accessible seating location.	Provide at least one table, and no less than 5% of the total number of tables, that provides compliant knee and toe clearance. Unit cost: \$250 ea. Est. Quantity: 1

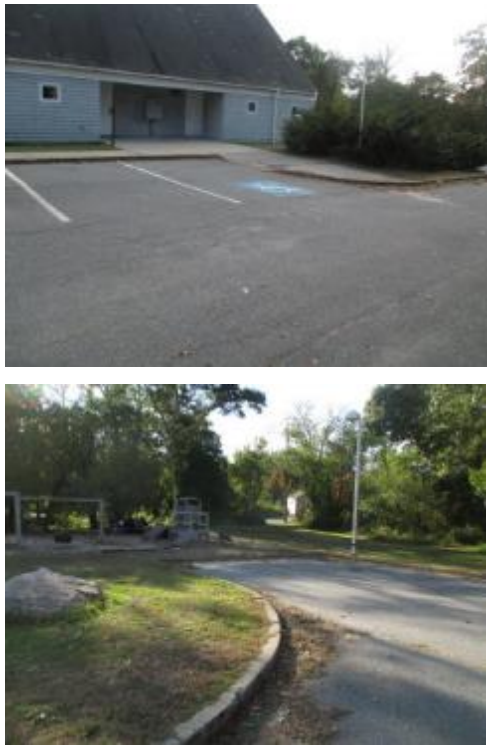
#	Issue	Mitigation	Photo	Cost
Library Playground				
1.	Parking <ul style="list-style-type: none"> The designated accessible parking space is not located on the shortest accessible route to the playground. The designated accessible parking space lacks an access aisle and the required signage. 	Relocate/ restripe a portion of the parking lot to add a van accessible parking space, as well as the associated sign and access aisle. Unit cost: \$300 ea. Quantity: 2 (1 space + 1 access aisle)

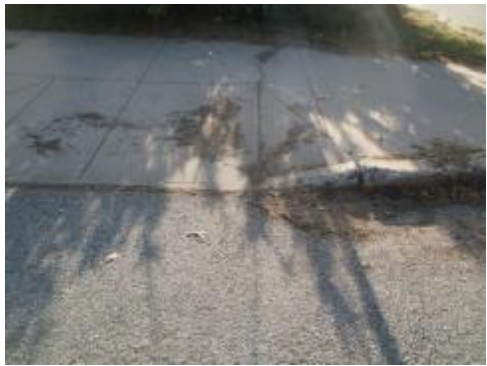
\$600
2.	Curb Ramp The slope of the flared sides of the curb ramp adjacent to the designated accessible parking space is > 10%, @ up to 14%.	See item # 1 above

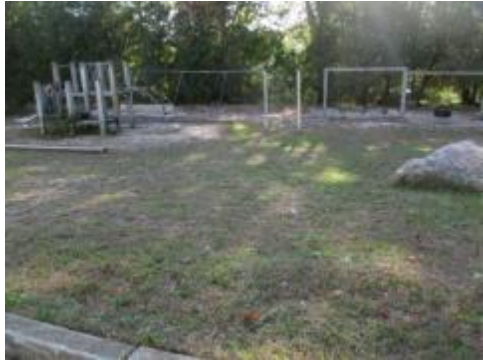
#	Issue	Mitigation	Photo	Cost
3.	Playground The playground lacks accessible elements and accessible route between elements.	Additional study required. Unit Cost: \$5,000 Est. Quantity: 1

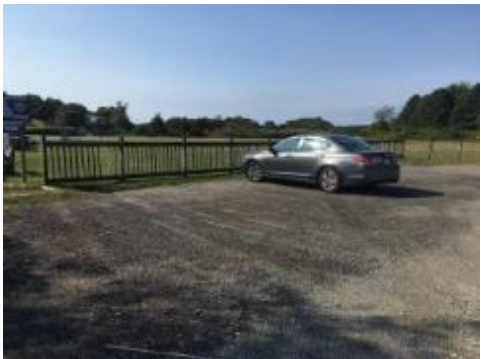
#	Issue	Mitigation	Photo	Cost
Lopes Playground and Basketball Courts				
1.	Parking No accessible parking is provided.	Pave a portion of the parking lot to add accessible parking spaces (including at least one van space), as well as the associated signs and access aisles. Unit Cost: \$1,500 ea. Est. Quantity: 3 (2 spaces + 1 access aisle)

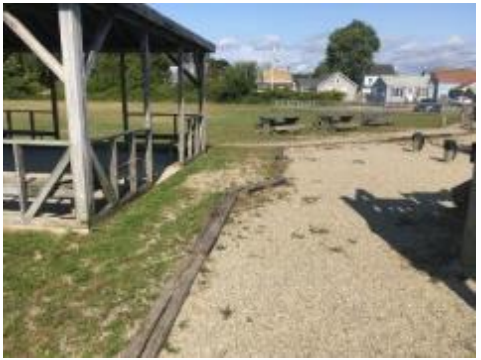
\$4,500
2.	Accessible Route No accessible route is provided to pavilion, basketball court or ball field.	Install an accessible walkway. Additional study required. Unit Cost: \$5,000 Quantity: 1

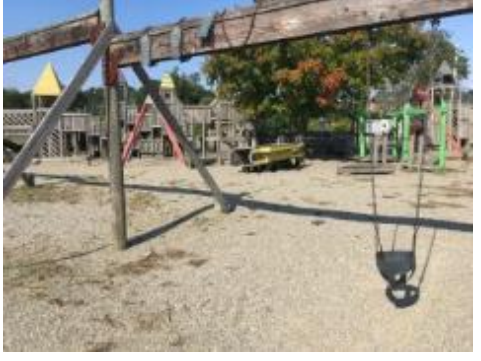
\$5,000
3.	Playground Playground lacks accessible elements and accessible route between elements.	Additional study required. Unit Cost: \$5,000 Est. Quantity: 1

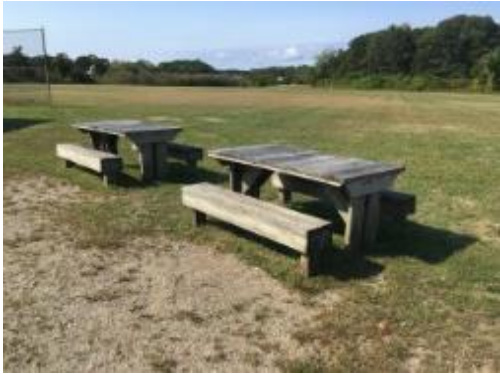
#	Issue	Mitigation	Photo	Cost
4.	Seating Picnic tables lack an accessible seating location.	Provide at least one table, and no less than 5% of the total number of tables, that provides compliant knee and toe clearance. Unit cost: \$250 ea. Est. Quantity: 1

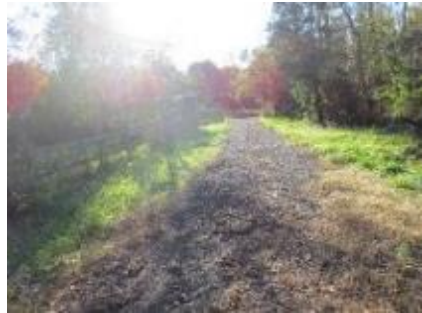
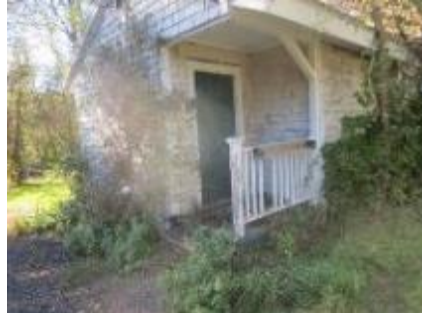
Mill Street Gazebo, Pavilion, and Playground				
1.	Accessible Route No accessible route is provided to the playground, the pavilion, or the gazebo due to excessive slopes, stairs, and changes in surface material.	Provide an accessible route to the playground, the pavilion, the gazebo, and all unique common use elements. Additional study required. Unit Cost: \$25,000 Quantity: 1

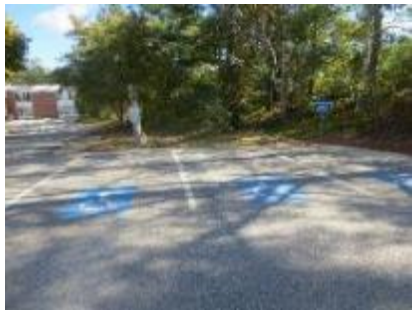
#	Issue	Mitigation	Photo	Cost
Minot Forest School Playground				
1.	Accessible Parking The accessible parking spaces serving the playground lack access aisles and the required signage.	Restripe a portion of the parking lot to add a van accessible parking space, as well as the associated sign and access aisle. Unit Cost: \$300 ea. Quantity: 2 (1 space + 1 access aisle)

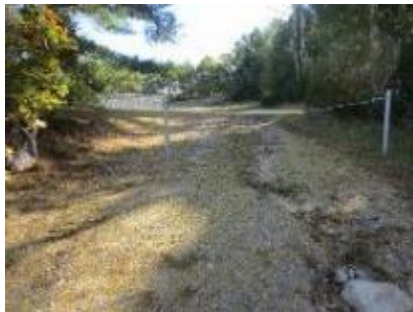
\$600
2.	Accessible Route No accessible route is provided to the playground due to excessive slopes, stairs, and changes in surface material.	Provide an accessible route to the playground. Additional study required. Unit Cost: \$10,000 Quantity: 1

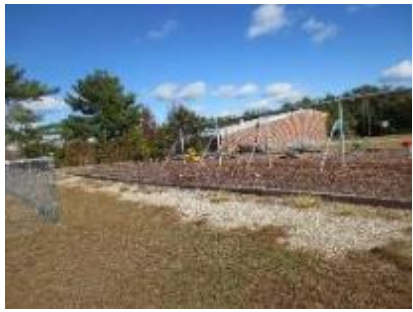
\$10,000
3.	Playground The playground lacks accessible elements and accessible route between elements.	Additional study required. Unit Cost: \$3,000 Est. Quantity: 1

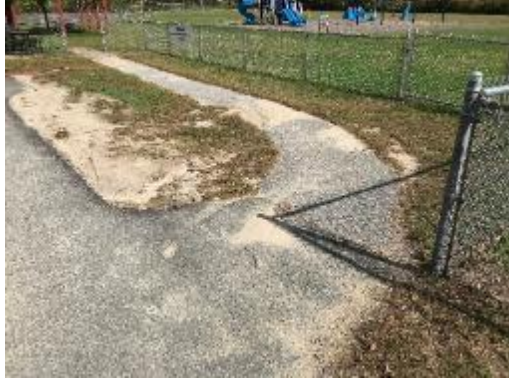
1.	Accessible Route from Parking The accessible route from the street to the playground has cross slopes >2% and areas of uneven paving surface.	Re-grade the walkway. Unit Cost: \$16 ln/ft Est. Quantity: 50 lf

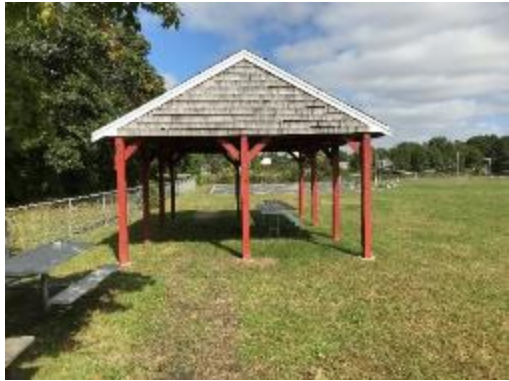
\$3,750
2.	Accessible Route to Pavilion/ Basketball Court/ Playground No accessible route is provided to pavilion, basketball court or playground.	Provide an accessible route to each field and all unique common use elements. Additional study required. Unit Cost: \$7,000

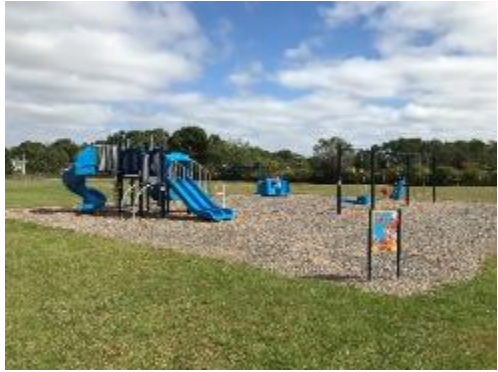
#	Issue	Mitigation	Photo	Cost
3.	Playground The playground lacks accessible elements and accessible route between elements.	Provide an accessible route. Additional study required. Unit Cost: \$5,000

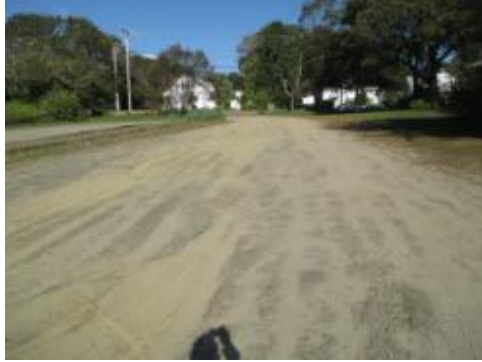
#	Issue	Mitigation	Photo	Cost
Palmer Field				
1.	Accessible Parking No designated accessible parking is provided.	Pave a portion of the parking lot to add a van accessible parking space, as well as the associated signs and access aisles. Unit Cost: \$1,500 ea. Est. Quantity: 5 (3 spaces + 2 access aisles)

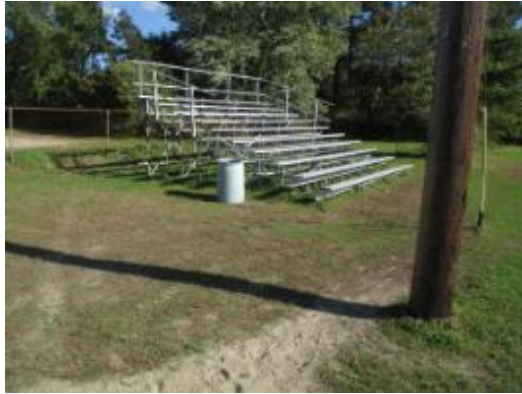
#	Issue	Mitigation	Photo	Cost
3.	Accessible Seating A wheelchair space is not provided at the bleachers.	Provide an accessible space on an accessible route next to the bleachers. Unit cost: 75 sq/ft Est. Quantity: 25 sq/ft

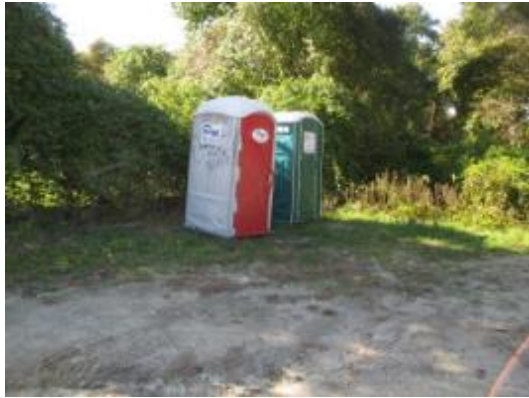
\$1,875
4.	Bathrooms An accessible portable toilet is not provided.	Provide an accessible portable toilet. Unit cost: \$1,500 per season Quantity: 1

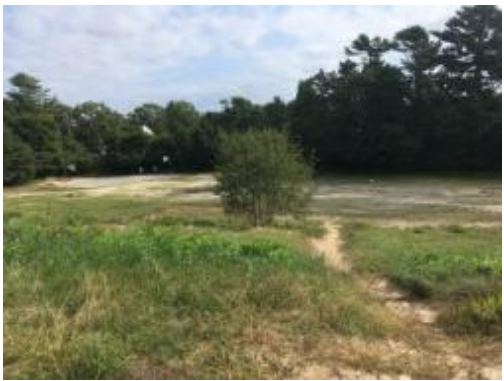
ShangriLa				
1.	Accessible Route <ul style="list-style-type: none"> No accessible path of travel is provided from the street. The playground lacks accessible elements and accessible route between elements. 	Provide an accessible route to the playground and basketball courts. Additional study required. Unit Cost: \$12,500 Quantity: 1

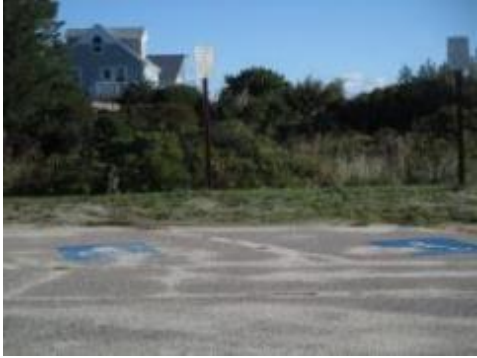
#	Issue	Mitigation	Photo	Cost
Swift's Beach Playground and Basketball Court				
1.	Accessible Parking <ul style="list-style-type: none"> The designated accessible parking spaces lack the required access aisles. One of the accessible parking spaces lacks signage indicating it is accessible. 	Restripe a portion of the parking lot to add accessible parking spaces (including at least one van space), as well as their associated signs and access aisles. Unit cost: \$300 ea. Quantity: 3 (2 spaces + 1 access aisle)

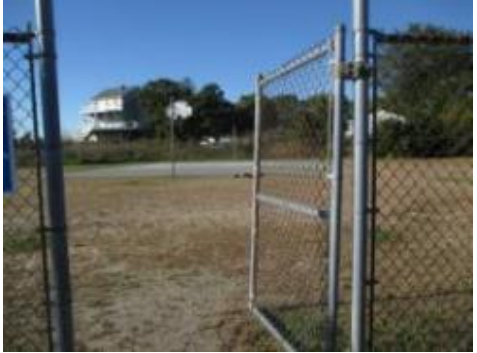
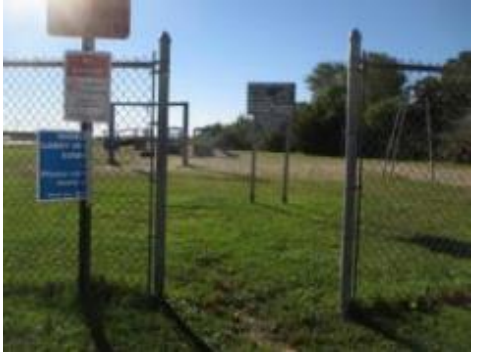
\$900
2.	Accessible Route No accessible route is provided to the basketball court or the playground.	Provide an accessible route to the basketball court and the playground. Additional study required. Unit Cost: \$5,000 Quantity: 1

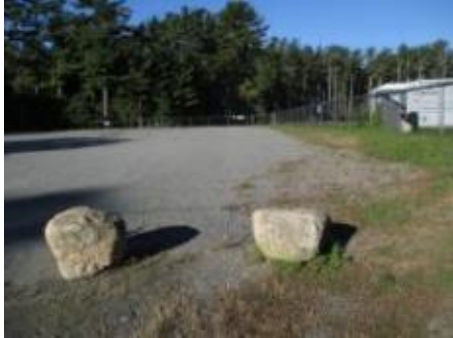
#	Issue	Mitigation	Photo	Cost
Westfield Playground				
1.	Accessible Parking No designated accessible parking is provided.	Provide accessible parking spaces (including at least one van space), as well as their associated signs and access aisles. Unit Cost: \$1,500 ea. Est. Quantity: 5 (3 spaces + 2 access aisles)

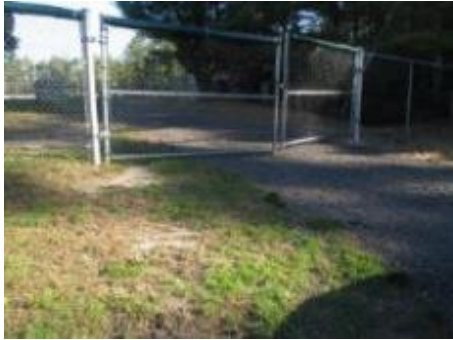
\$7,500
2.	Accessible Route No accessible route is provided to the field and common use elements (picnic tables, toilets, etc.).	Provide an accessible route to at least one field and all common use elements. Additional study required. Unit Cost: \$10,000 Quantity: 1

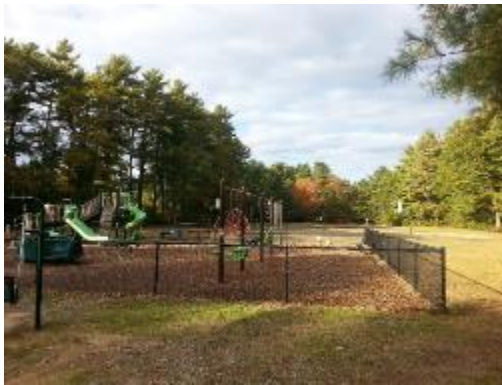
1.	Accessible Parking No accessible parking is provided.	Pave a portion of the parking lot to add a van accessible parking space, as well as the associated signs and access aisles. Unit Cost: \$1,500 ea. Est. Quantity: 2 (1 space + 1 access aisle)	 	\$3,000
2.	Accessible Route No accessible route is provided to pavilion, playground or basketball court.	Provide an accessible route to the pavilion, basketball court and the playground. Additional study required. Unit Cost: \$5,000 Quantity: 1

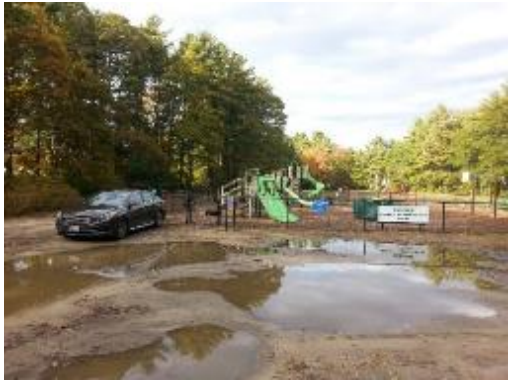
#	Issue	Mitigation	Photo	Cost
3.	Playground Playground lacks accessible elements and accessible route between elements.	Additional study required. Unit Cost: \$5,000 Est. Quantity: 1

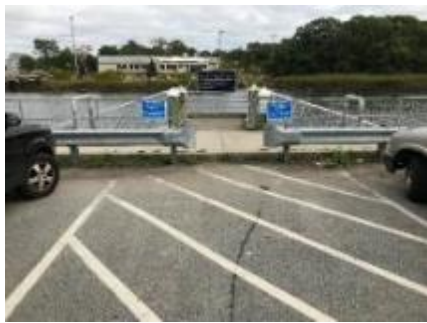
#	Issue	Mitigation	Photo	Cost
3.	Accessible Route from Accessible Parking (along waterfront) There is no accessible route from the access aisle to the walkway along the waterfront.	Install a curb ramp. Unit Cost: \$1,250 ea. Quantity: 1

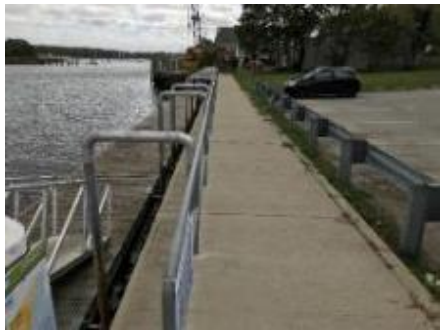
\$1,250
4.	Accessible Route There are excessive cross slopes along some of the walkways from the accessible parking to the fishing pier, @ up to 5.0%.	Regrade sections of the walkways. Unit cost: \$50/lf Est. Quantity: 50 lf

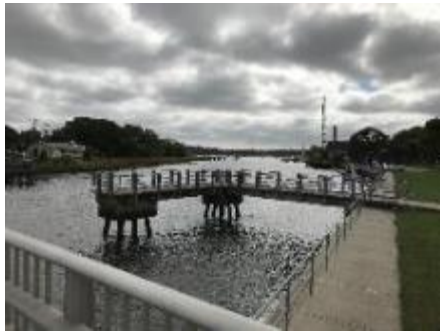
\$2,500
5.	Fishing Pier The fishing deck surface does not extend min. 12" beyond the inside face of the railing.	Extend the decking. Additional study required. Unit Cost: \$5,000 Quantity: 1

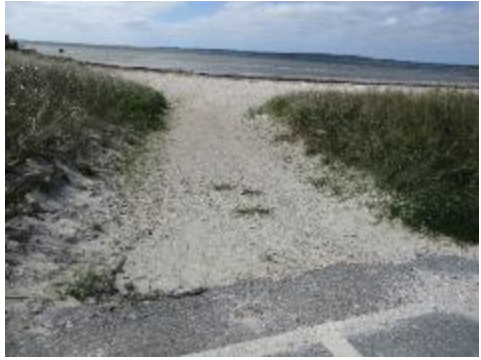
Little Harbor Beach				
1.	Accessible Route There is no accessible route to the beach.	Provide an accessible route to the beach. Additional study required. Unit Cost: \$6,000 Quantity: 1

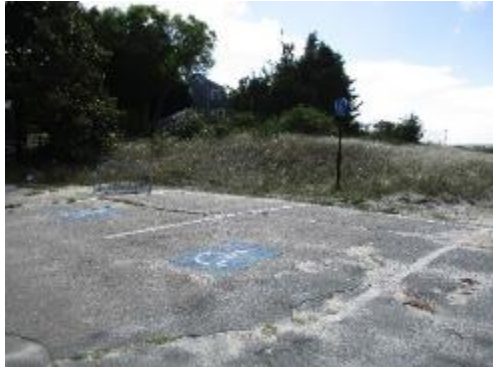
\$6,000
2.	Accessible Parking <ul style="list-style-type: none"> The designated accessible parking spaces meet the dimensional requirements for a van accessible space. However, it is not designated as van accessible and does not have an access aisle. The designated accessible parking space has a slope >2%, @ up to 2.6%. 	Re-grade and re-stripe the existing designated parking spaces and their associated access aisles. Unit Cost: \$1,500 per space or aisle Quantity: 2 (1 space + 1 access aisle) Install a van accessible sign at the existing designated accessible parking space. Unit Cost: \$100 per sign Quantity: 1

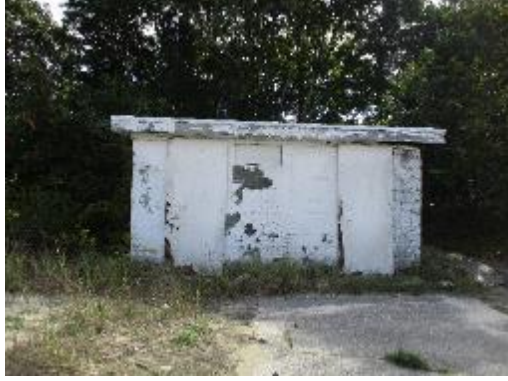
#	Issue	Mitigation	Photo	Cost
3.	Comfort Station The comfort station could not be accessed during the site visit, however it appears to lack any accessible elements.	Additional study required. Unit Cost: \$TBD Quantity: 1

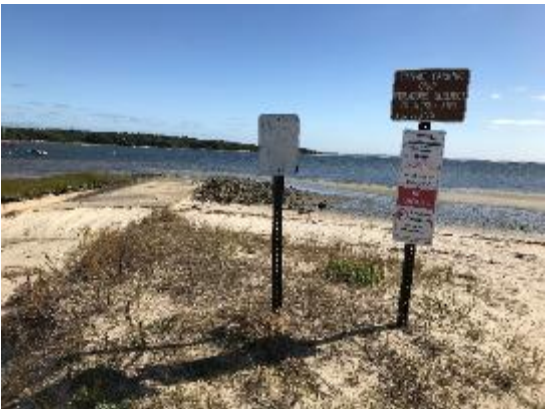
Boat Ramp Swifts Neck				
1.	Accessible Parking The bottom edge of the accessible parking signs is mounted <60" AFF.	Re-install the signs at 60" min. AFF, measured to the bottom of the sign. Unit Cost: \$100 ea. Quantity: 1

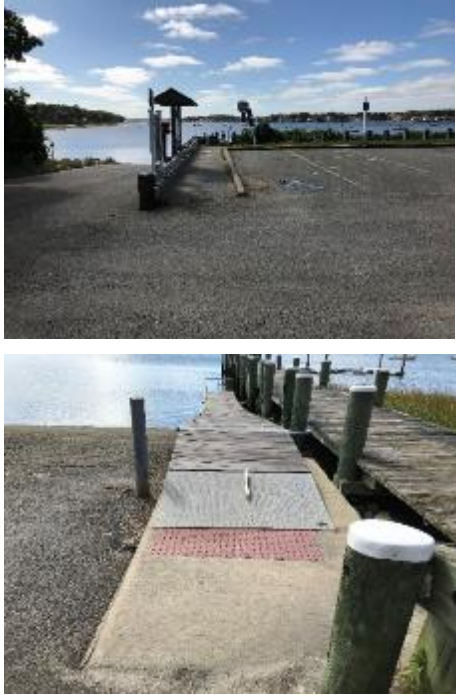
Tempest Knob Boat Ramp				
1.	Accessible Route to Boat Ramp/ Dock The accessible route from the accessible parking to the boat ramp and the dock has excessive cross slopes >2%.	Provide an accessible route to the boat ramp and the dock. Additional study required. Unit Cost: \$5,000 Quantity: 1

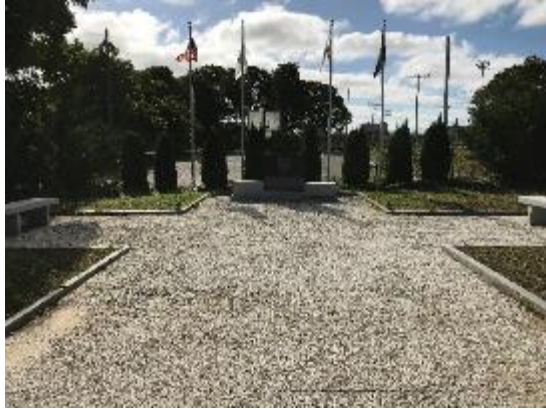
Police Memorial				
1.	Accessible Route The accessible route to the memorial has excessive cross slopes and uneven surfaces.	Regrade the surface accessing the memorial and ensure that it is smooth. Unit Cost: \$75/sf Est. Quantity: 100 sf

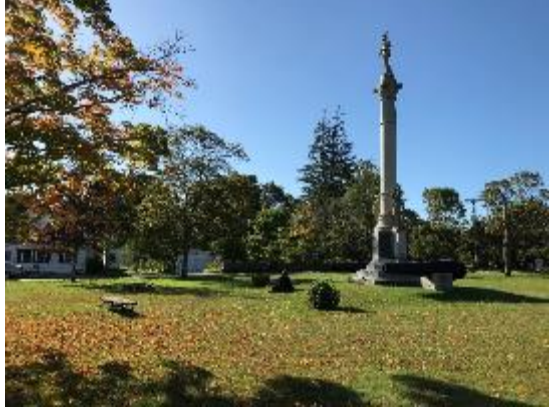
Soldier's Monument & Flagpole				
1.	Accessible Route No accessible route is provided to the memorial.	Provide an accessible route to the memorial. Additional study required. Unit Cost: \$5,000 Quantity: 1

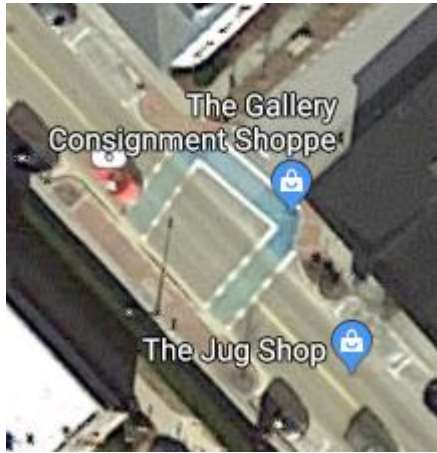
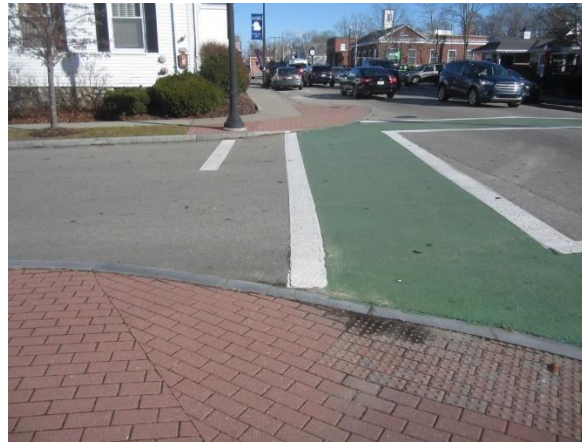
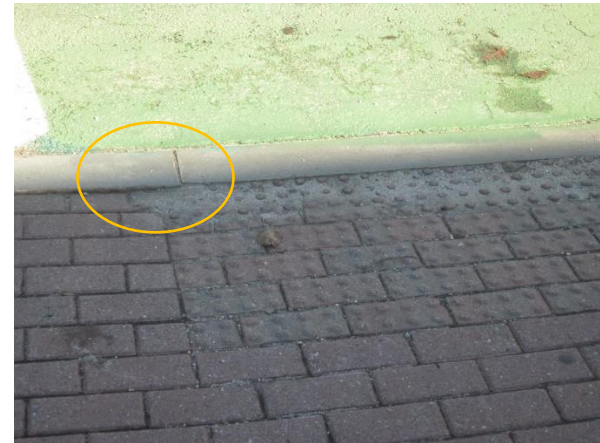
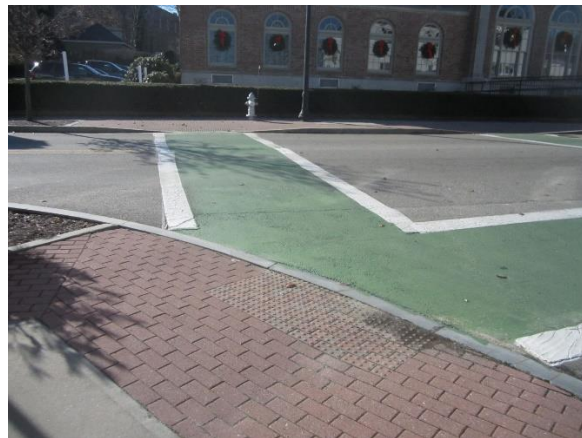
226 Main Street This intersection has one curb ramp with a change in level $> \frac{1}{2}$ " at one limited area.

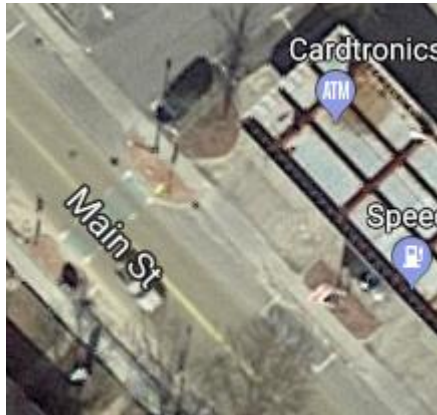
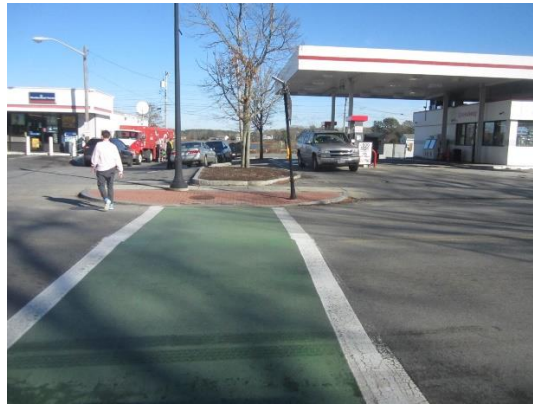
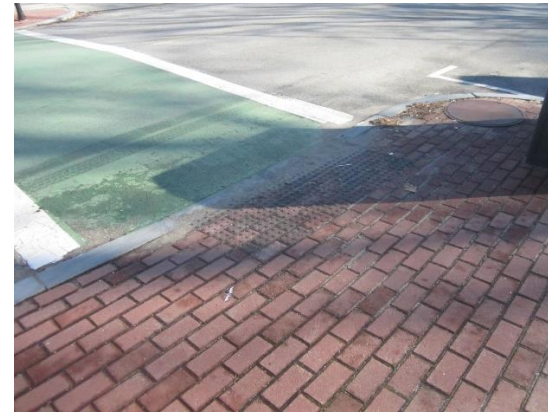
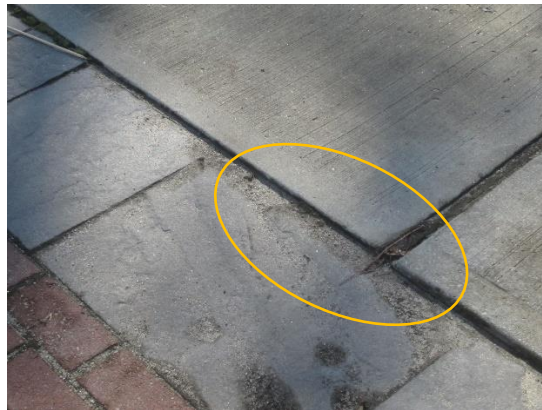
169 Main Street This intersection has one curb ramp with a change in level $> \frac{1}{2}$ " at one limited area
