RESPONSES TO CHARLES ROWLEY, PE, PLS COMMENTS  
BAY POINTE CEDA; WAREHAM, MA  
DECEMBER 8, 2021

**IMPACT STATEMENT REPORT-CEDA**

**Bay Pointe Mixed-Use Development Project-CEDA**

Principe Engineering, Inc.  
27 Sakonnet Ridge Drive  
Tiverton, Rhode Island

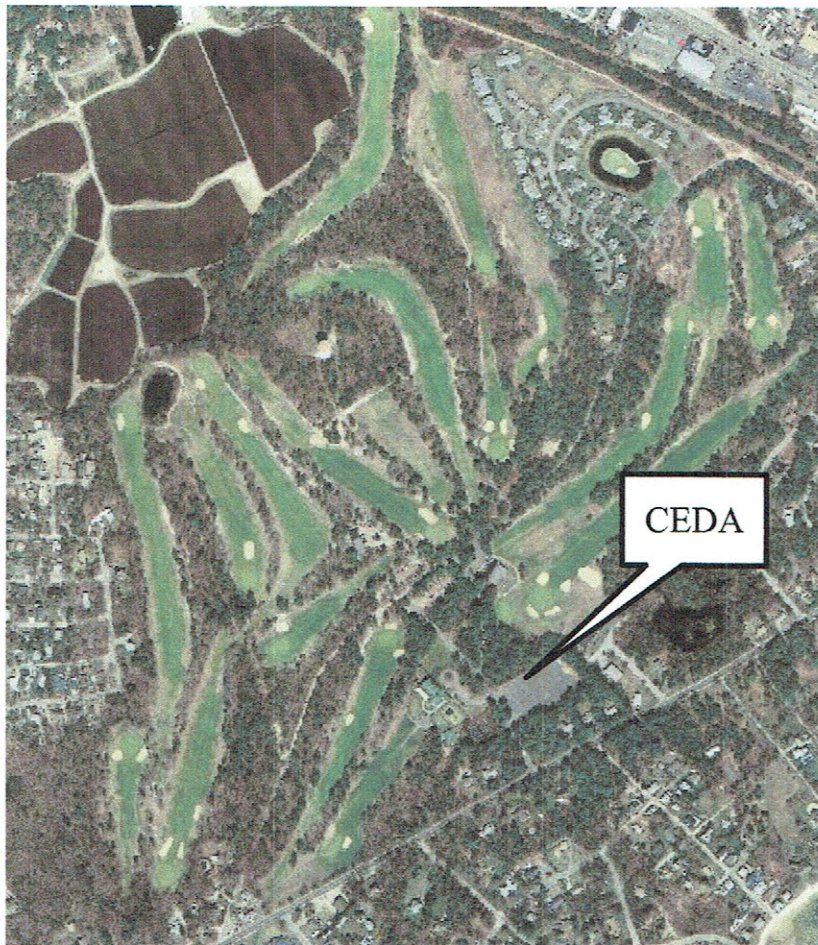
### AERIAL MAP:

This aerial map illustrates the existing 18-hole public golf course and shows the irrigation pond is located on the north westerly portion of the property, as well as many other landscape features. The location of the CEDA project is also identified. This portion of the site contains an existing “Pro Shop”, existing parking areas, wooded areas, and a portion of the existing golf course. Access for the site is from the existing Bay Pointe Drive on the north and east sides of the development area.

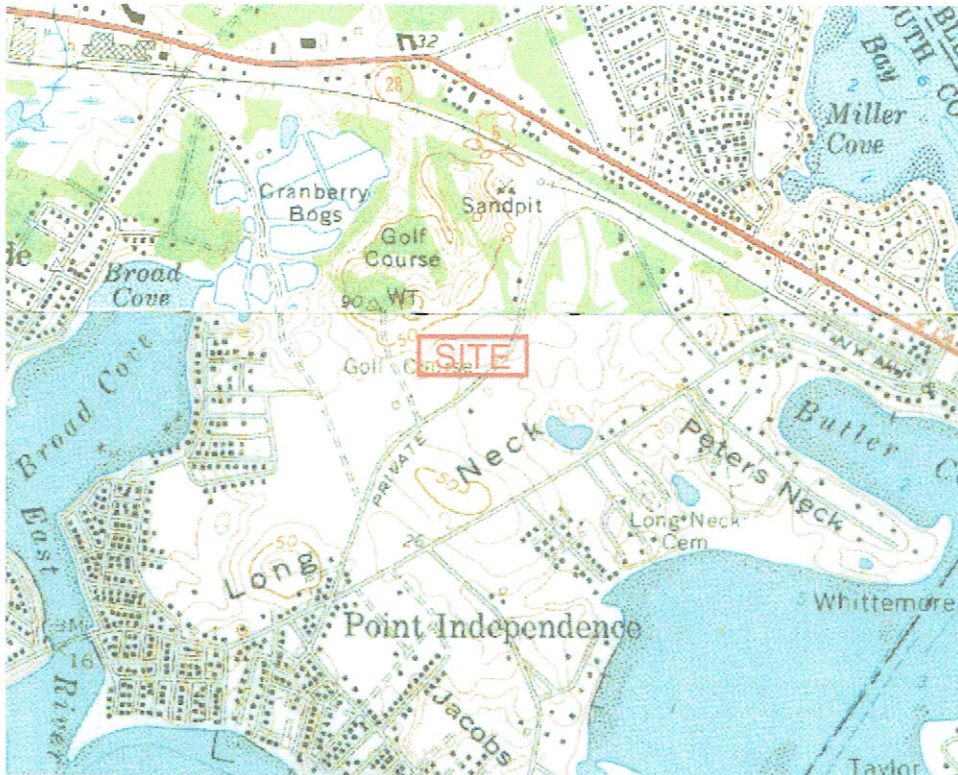
The portion of the overall site that is impacted in this project ranges in elevation from 50 feet to 18 feet. The site generally has moderate to steep slopes ranging from 1% to 25%. Figure 1 indicates the location of the proposed development on a United States Geological Survey Map.

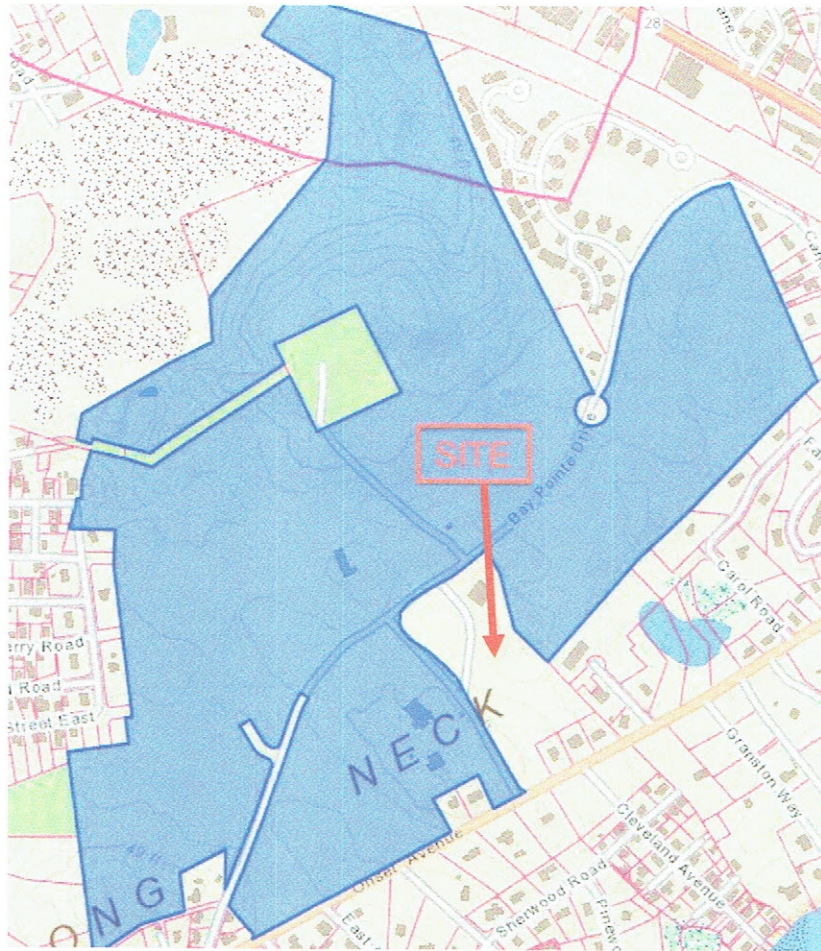
**Ground Water Resources**

The overall Bay Pointe site is NOT located within a wellhead protection. There is a small portion of the property to the north, which is within a Zone II. There will be no development in this area.

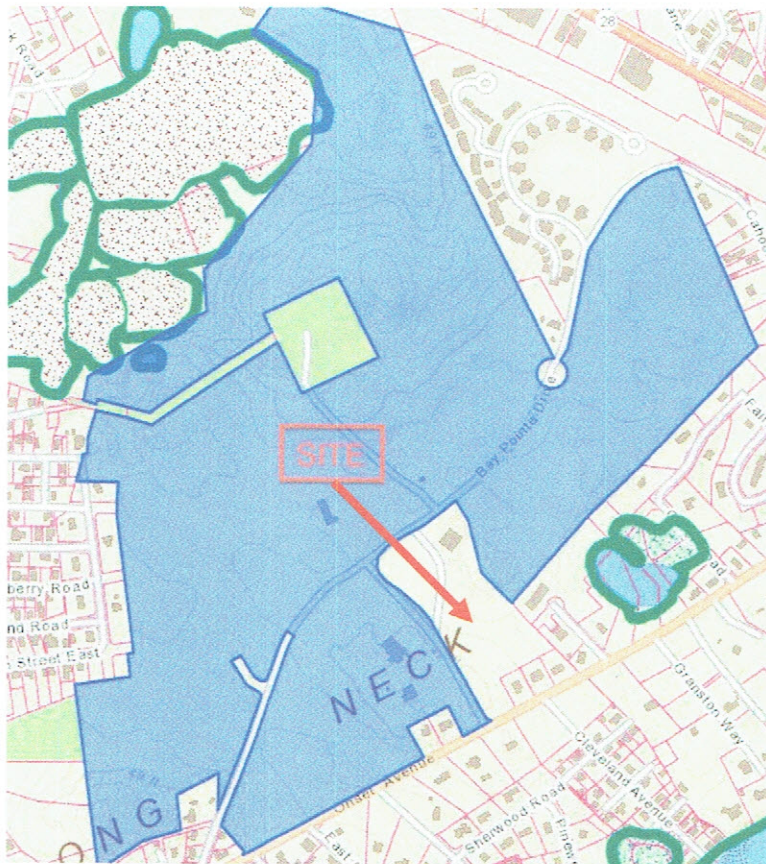
**Title V Buffers**

There are no wetlands on the Bay Pointe overall site, except for the existing irrigation pond located on the northwesterly portion of the site. The additional storm water runoff produced from the CEDA development will be used to recharge the aquifer.

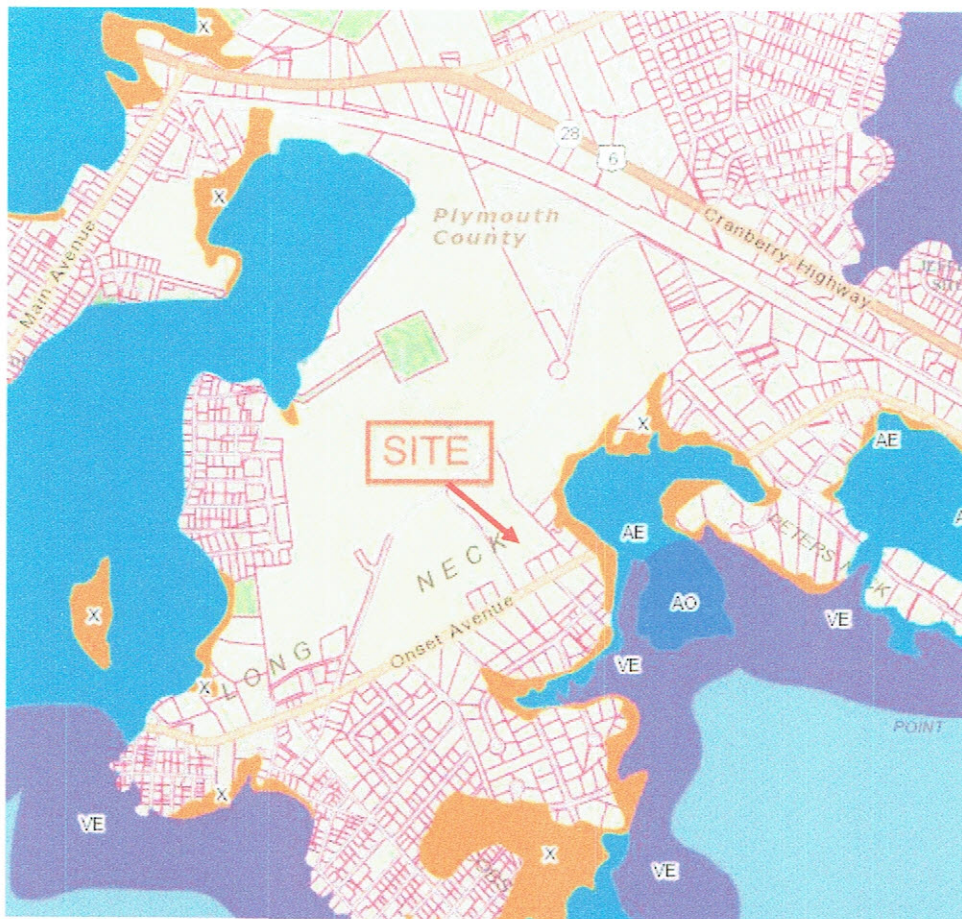
**FEMA FLOOD MAPS**

This site is NOT located within any flood zone according to the latest FEMA flood maps. Refer to map numbers 25023C0582K & 25023C0494K.

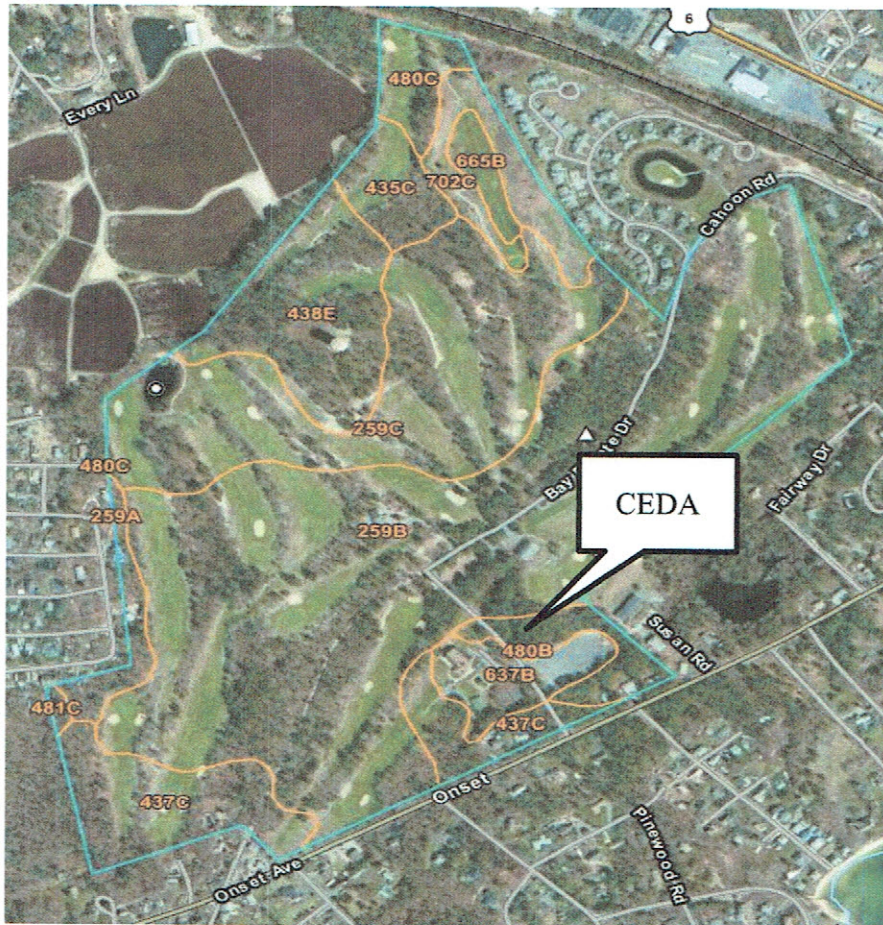
**Soil Hydrology**

The soils within the development area, based upon the Natural Resource Conservation Service (NRCS) are (637B) Carver -Urban land complex, (480B) Plymouth-Carver complex, (665B) Udipsamments. All of these series consists of very deep, excessively drained sandy soils formed in glaciofluvial deposits of coarse and very coarse sands.
